September 7, 2017

Re: Monroe Townhomes: Arborist Report

The Watershed Company Reference Number: 170802

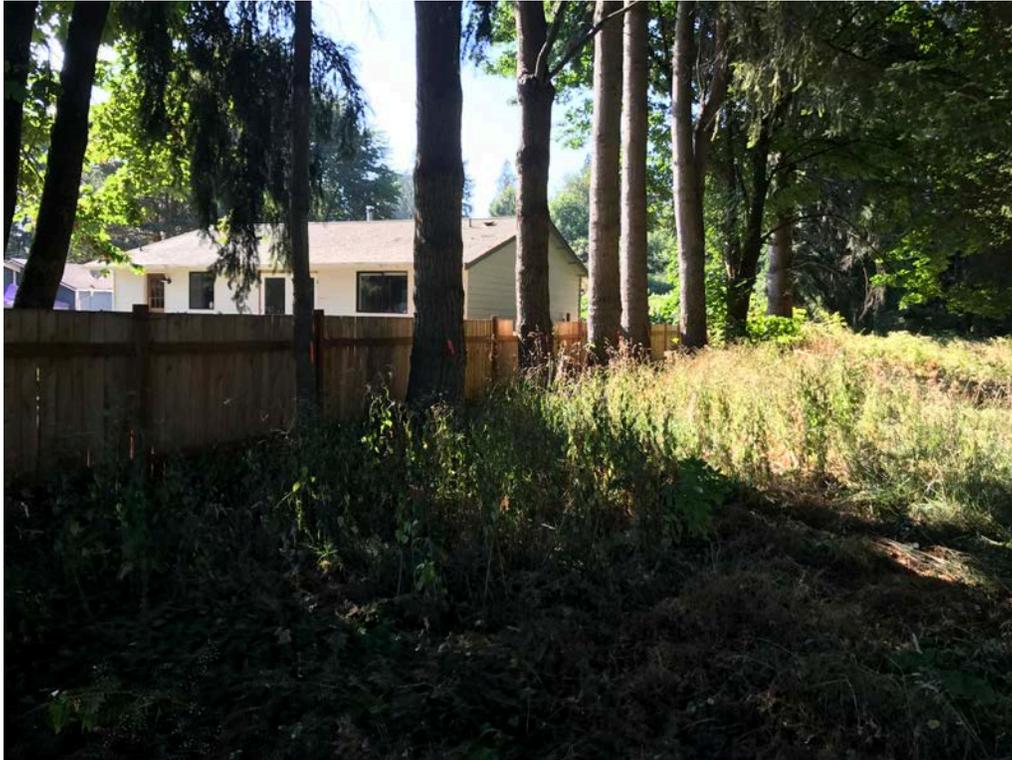
Figure 2– View of Douglas-fir row located along the western study area boundary.

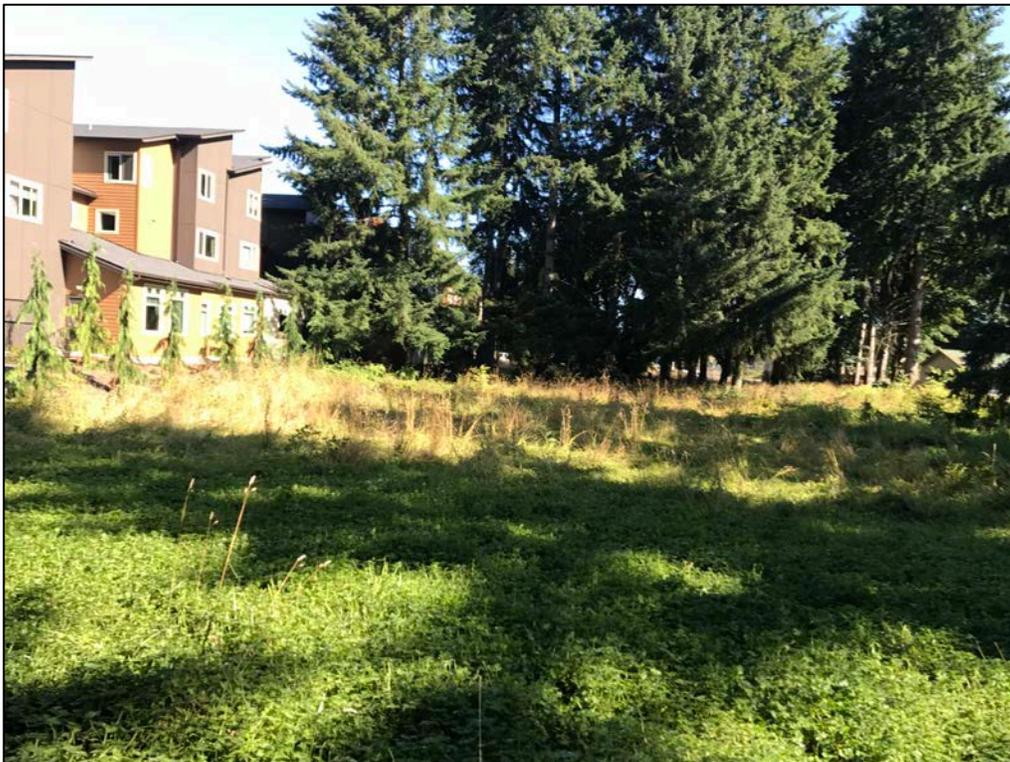
Figure 3 – View looking north towards northern study area.

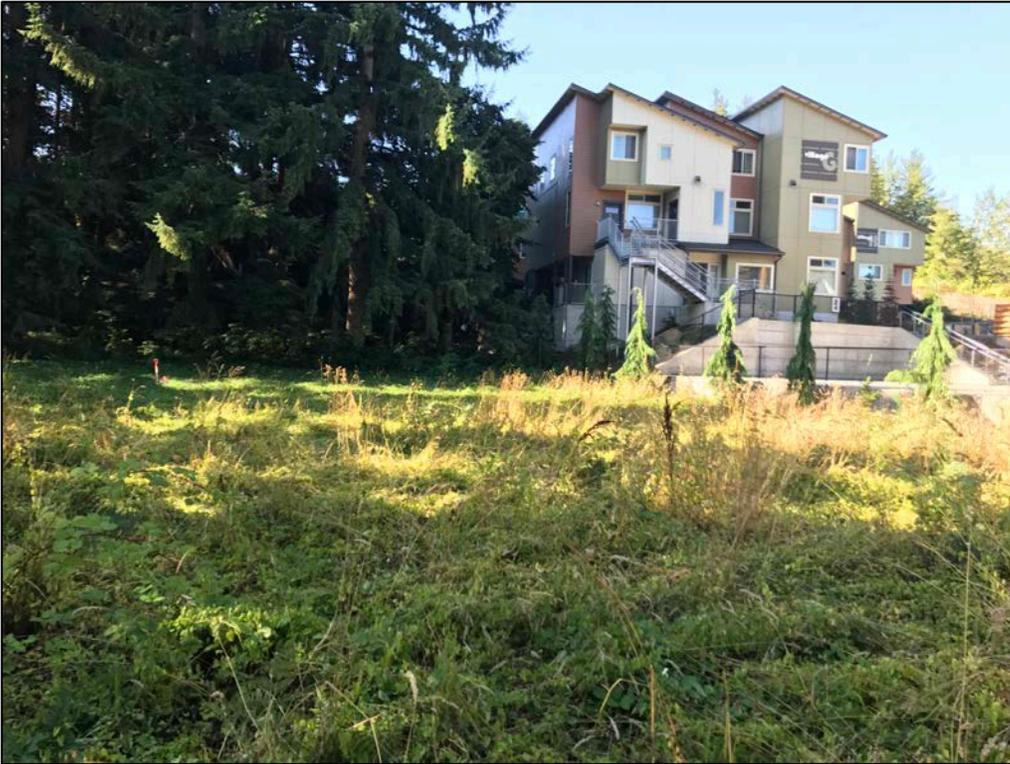
Figure 4 – View looking west towards newly constructed townhomes on the adjacent parcel.

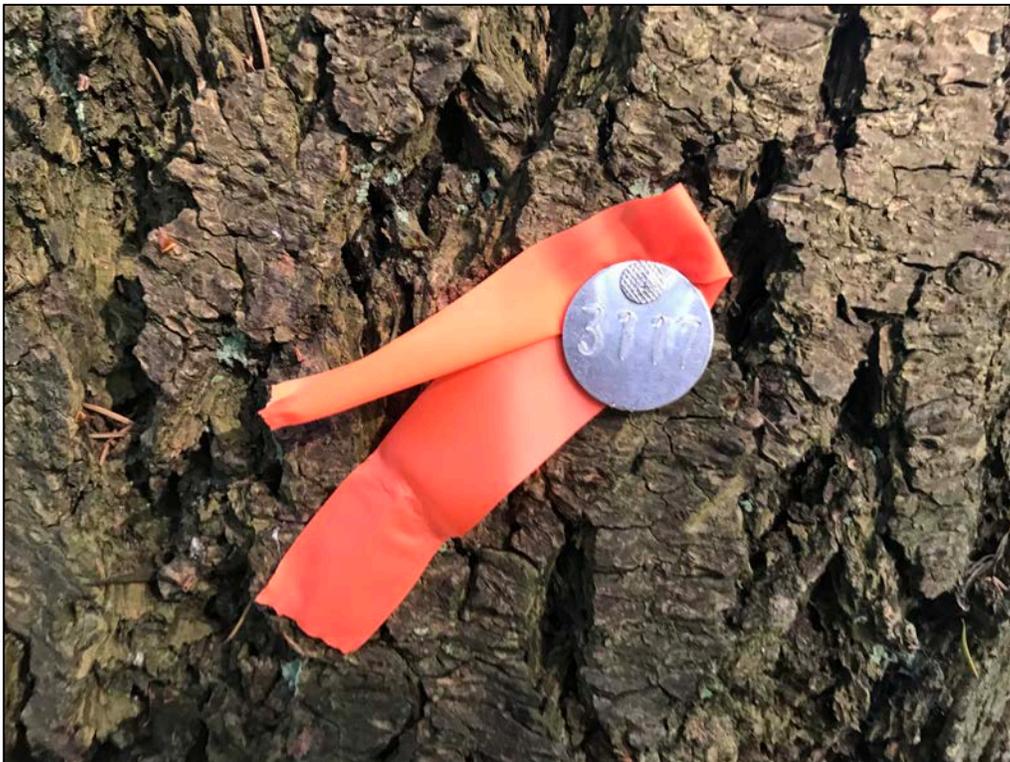
Figure 5 – Photo of tree tag on Tree# 3117.

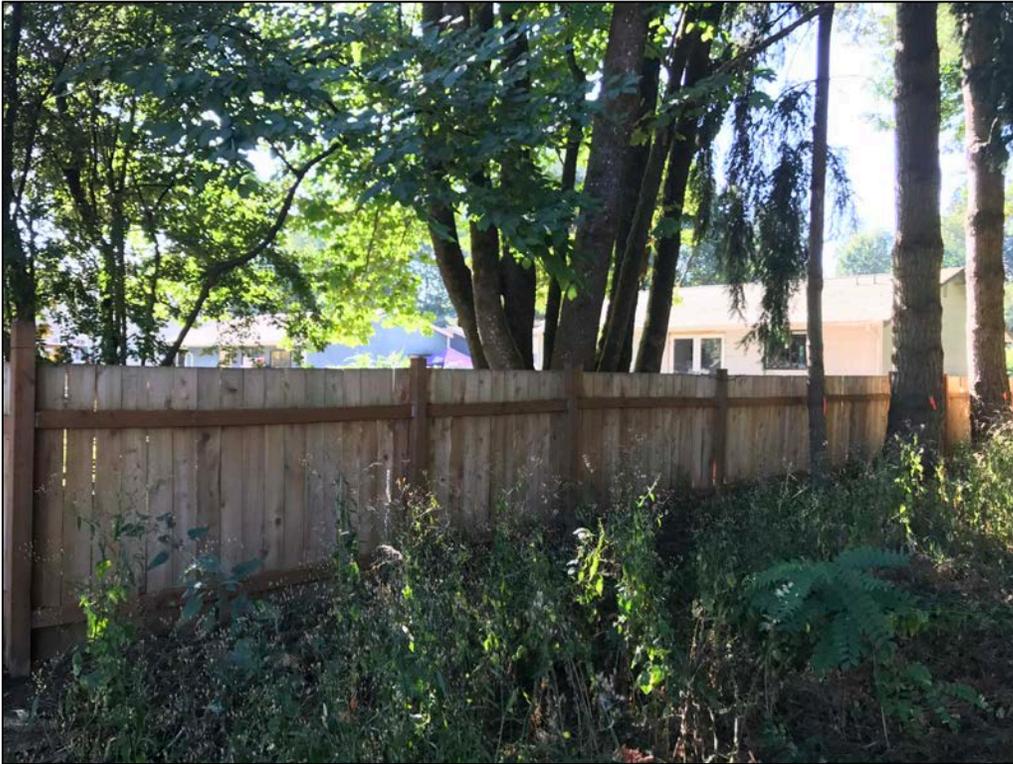
Figure 6 – Off-site maple that could be impacted by grading within study area.

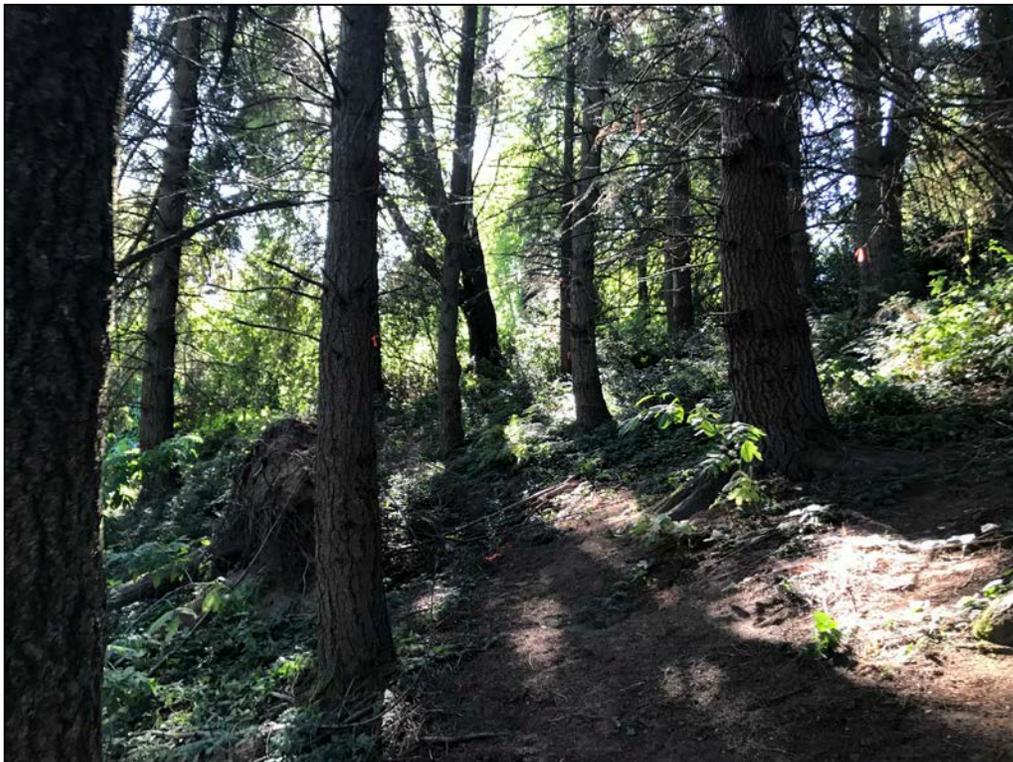
Figure 7 – Southern slope that makes up the majority of the Douglas-fir canopy.
