Preliminary Storm Drainage Report

Garibaldi PRD

CPH Project No. 0054-18-028

March 4, 2021

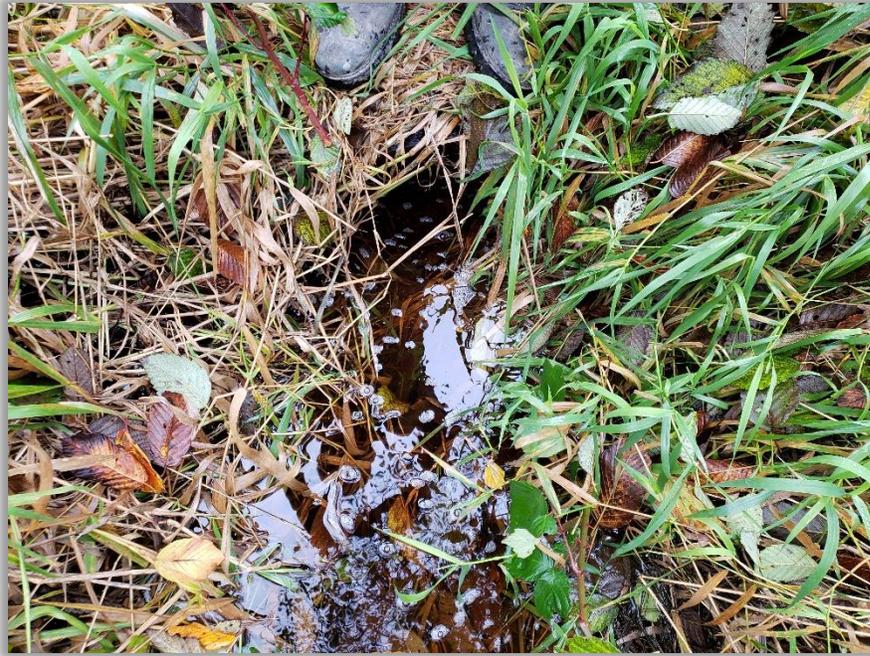
Photo N3, above: Runoff is conveyed through 12" PVC pipe in great condition and extends 4.7' from grade to wetland area where runoff daylights and discharges to open channel flow. Photo taken approximately 90 feet downstream.

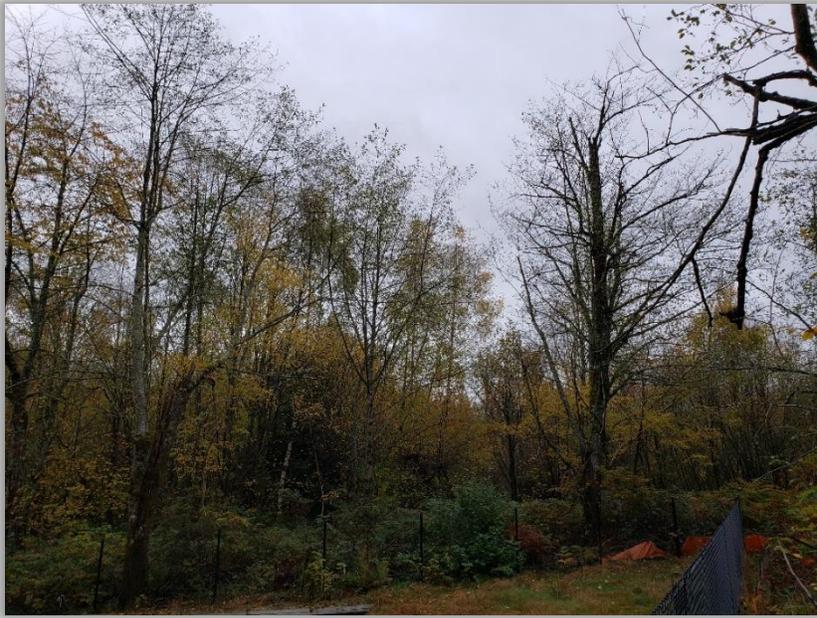
Photo N5, above: Photo taken approx. 230 LF outside the downstream path of conveyance. Runoff continues downstream within the densely-vegetated wetland area and likely turns southerly.

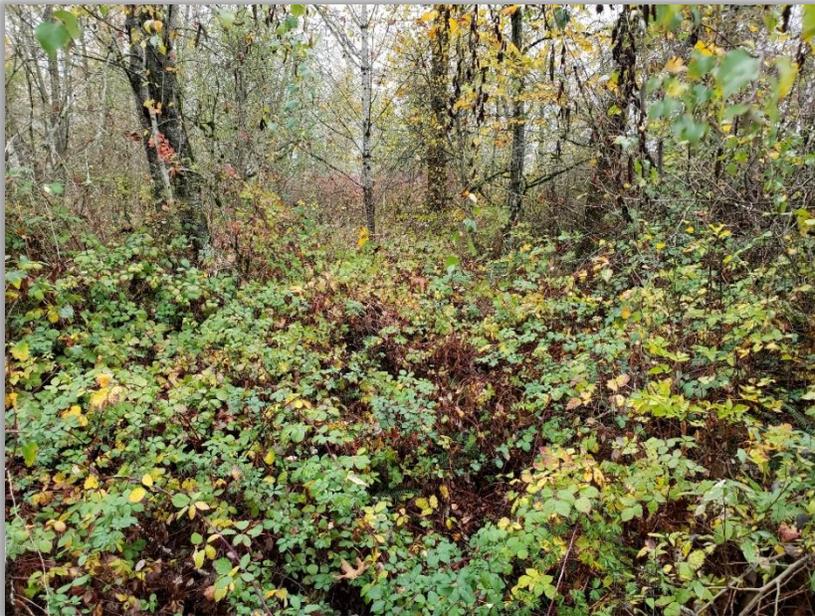
Photo N6, below: Photo taken past the quarter (0.25) mile threshold at approximately 1,700 feet downstream, runoff reaches a culvert downstream in densely-vegetated wetland area and enters a likely functional culvert with no visible potential problems.

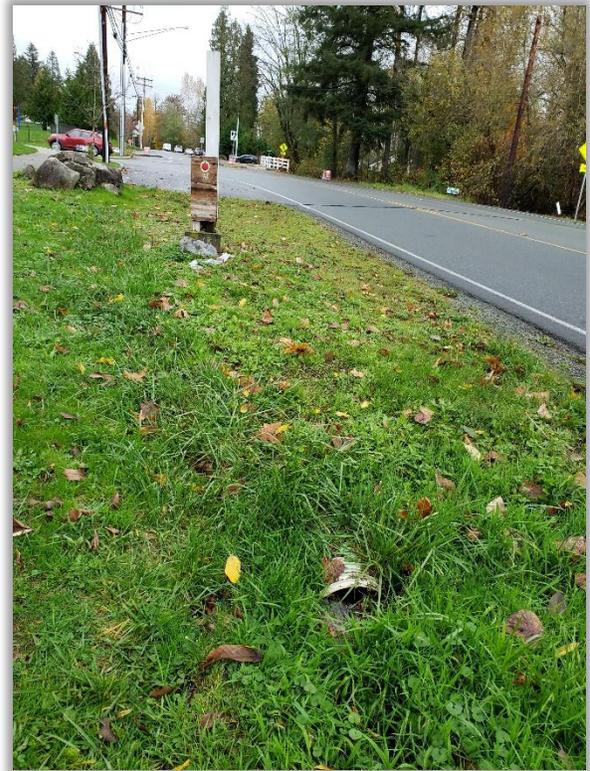
Photo 8, right: Looking north, 12” PVC pipe daylights approximately 1344 feet downstream, beyond the 1,320 feet (1/4 mile) threshold, which ends the South Basin downstream analysis. Runoff continues downstream in ditch to Woods Creek, to the Skykomish River as part of the Snohomish River watershed.
