Preliminary Storm Drainage Report

Garibaldi PRD

CPH Project No. 0054-18-028

September 17, 2021

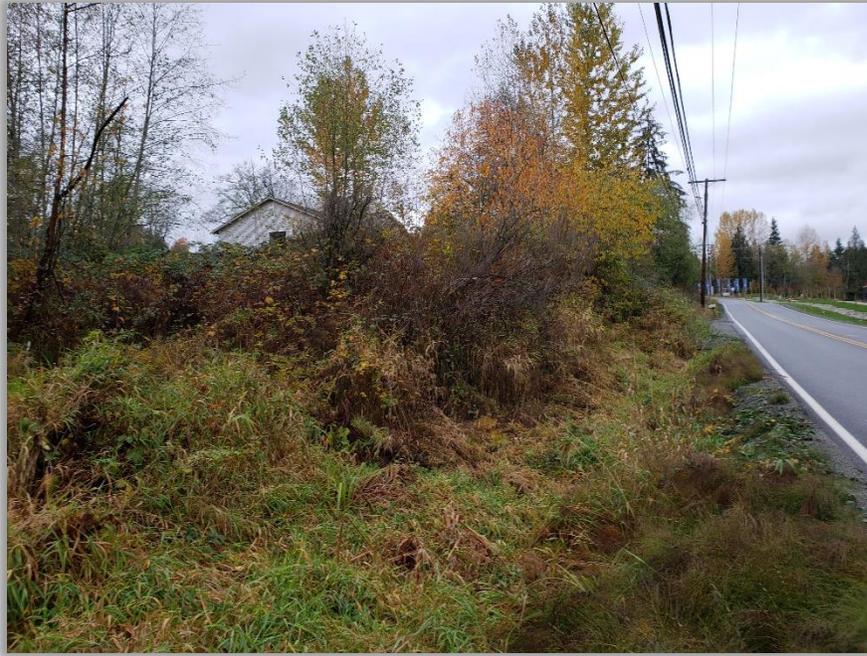
Photo N1, left: Looking north, sheet flow from site’s north basin flows easterly to ditch along west frontage of Chain Lake Road right-of-way and converges to a single natural discharge point as shown in photo.

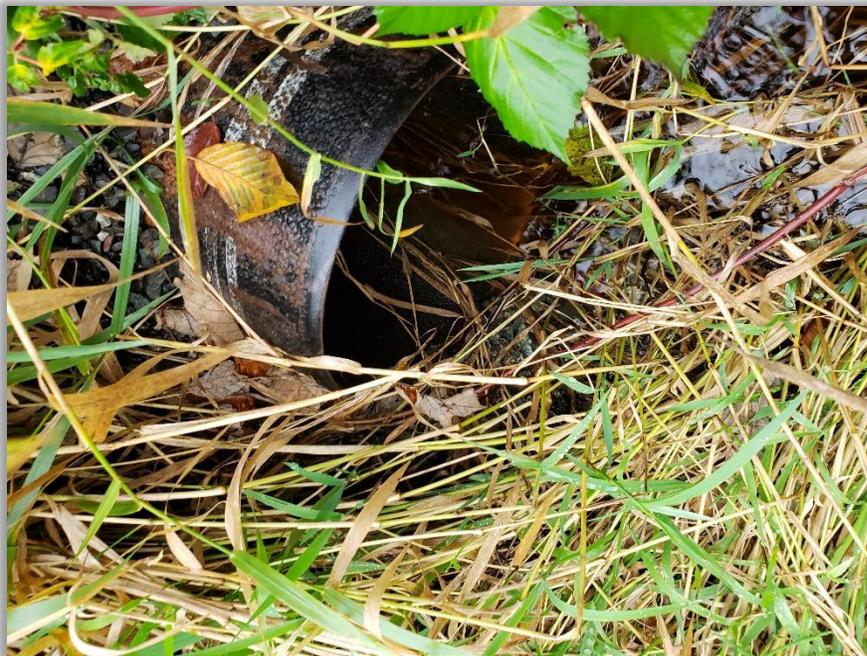
Photo N2, below: Looking southerly, a close-up photo of a 12” PVC pipe culvert in great condition conveys runoff 44 LF southeasterly where runoff daylights into vegetated stream.

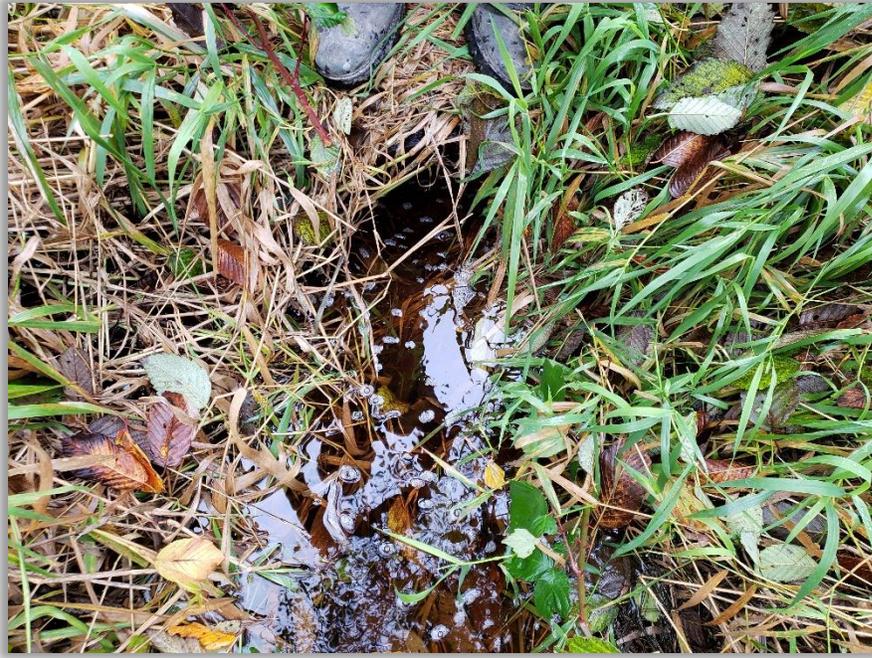
Photo N3, above: Runoff is conveyed through 12" PVC pipe in great condition and extends 4.7' from grade to wetland area where runoff daylights and discharges to open channel flow. Photo taken approximately 90 feet downstream.

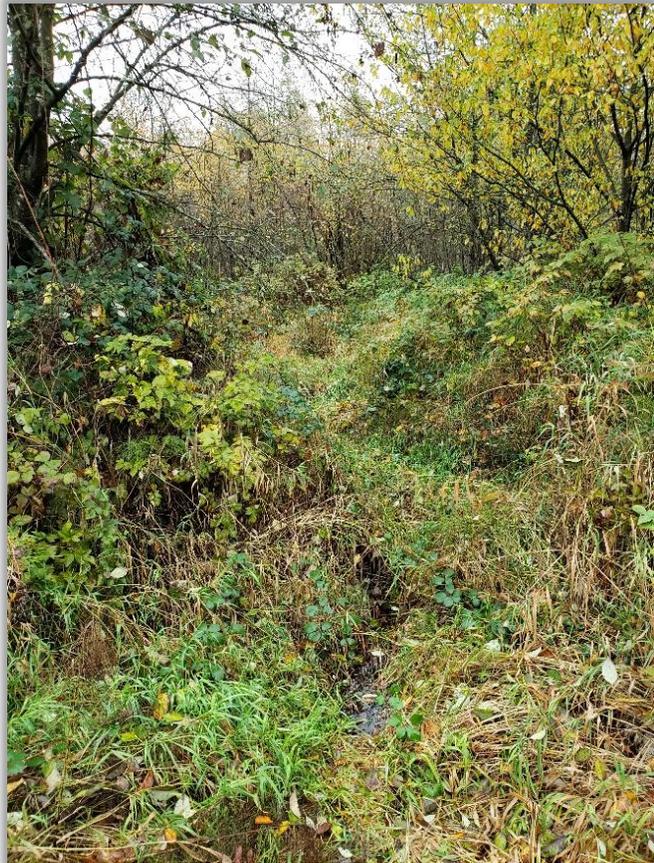
Photo N4, right: Runoff is conveyed along an open channel at this location within a wetland area and continues downstream in densely-vegetated conditions. The downstream path could not be followed further due to private property restrictions and impenetrable vegetation. However, from the topography of the area it is believed that the runoff continues southeast as open channel flow and stream-like conveyance beyond the quarter (0.25) mile downstream threshold.

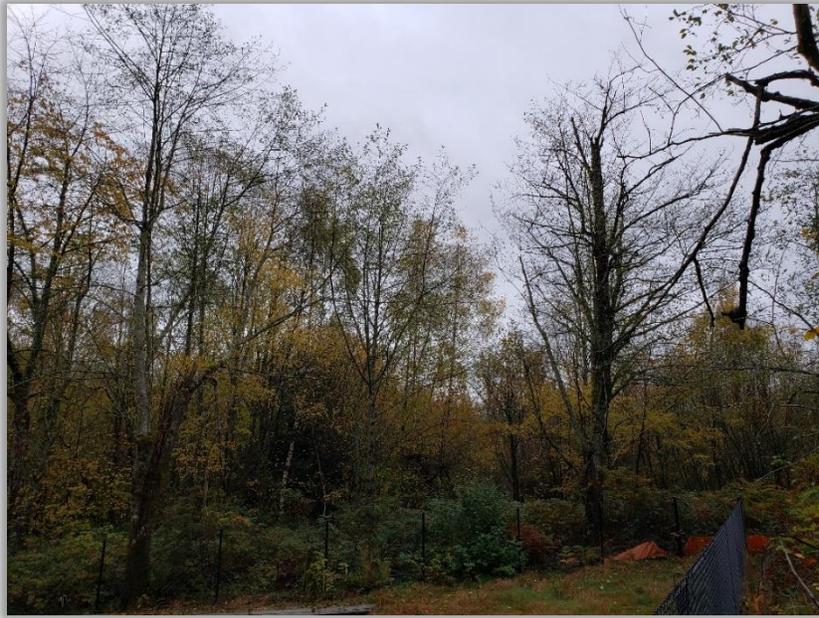
Photo N5, above: Photo taken approx. 230 LF outside the downstream path of conveyance. Runoff continues downstream within the densely-vegetated wetland area and likely turns southerly.

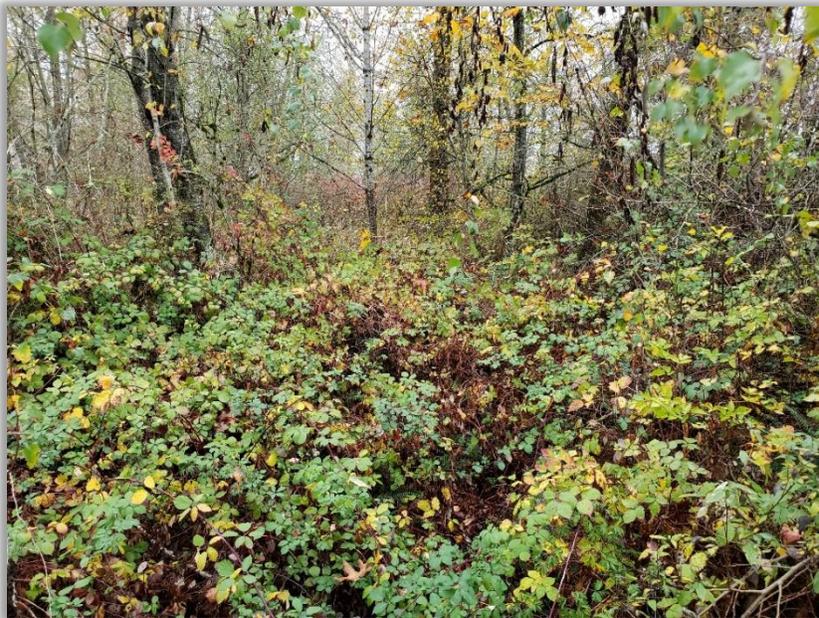
Photo N6, below: Photo taken past the quarter (0.25) mile threshold at approximately 1,700 feet downstream, runoff reaches a culvert downstream in densely-vegetated wetland area and enters a likely functional culvert with no visible potential problems.

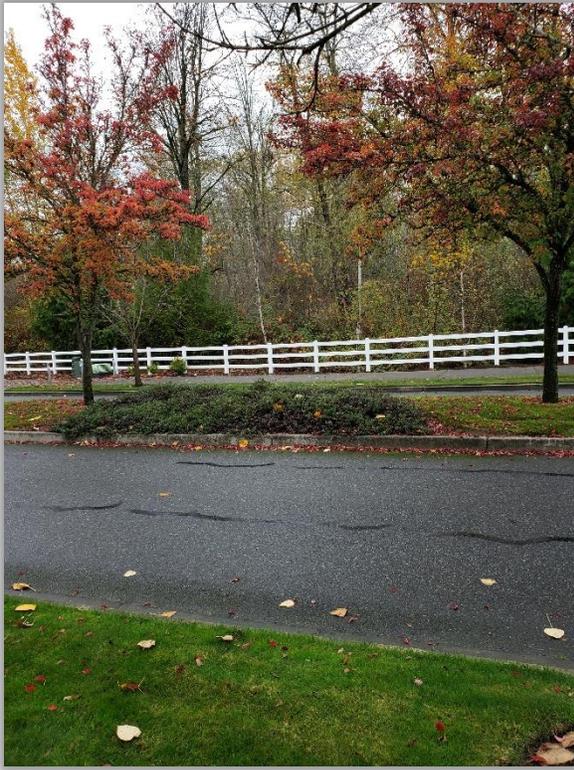
Photo N7, left: Runoff is conveyed through culvert not visible from level 1 downstream analysis and no potential problems are visible. This photo was taken beyond the quarter (0.25) mile downstream threshold.

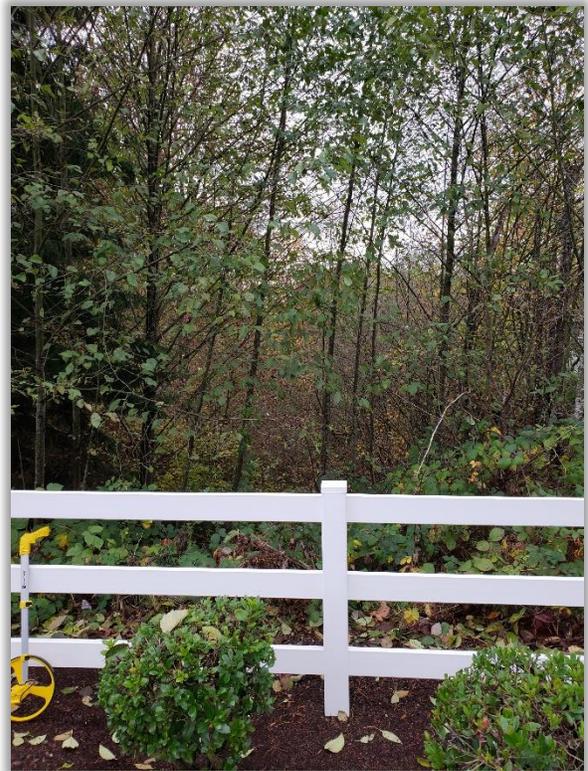
Photo N8, right: Photo taken approximately 1,750 feet downstream, runoff daylight at end of existing culvert with no visible existing problems nor potential problems evident and continues downstream beyond the quarter (0.25) mile downstream threshold where a series of wetland areas and culverts convey surface water to the Skykomish river as part of the Snohomish river watershed.

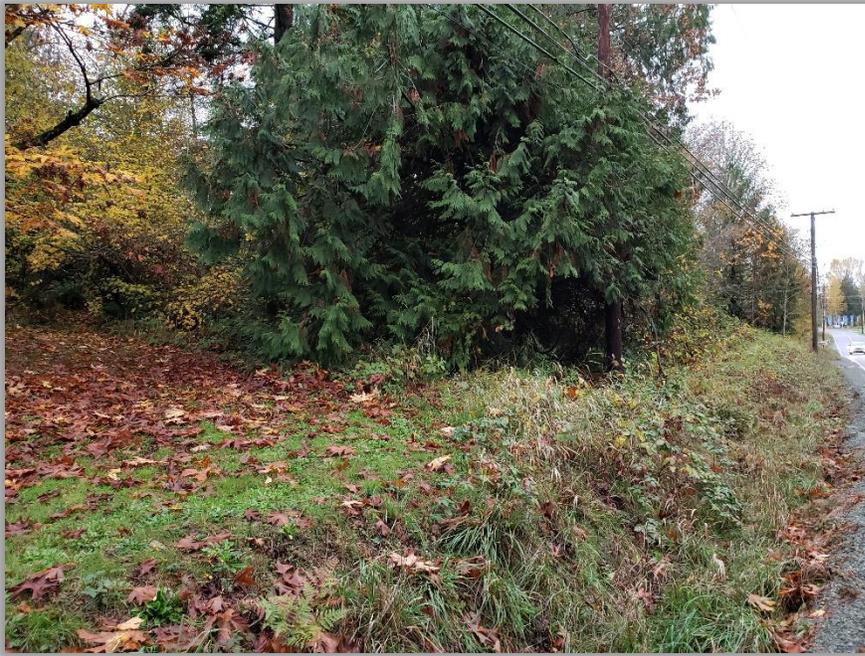
Photo S1, above: Looking north at the southeast corner of the site, runoff sheet flows southerly from on-site topographic ridge and easterly to vegetated ditch along Chain Lake Road right-of-way. The site is developed and comprised of pasture, single family homes, and outlying structures.

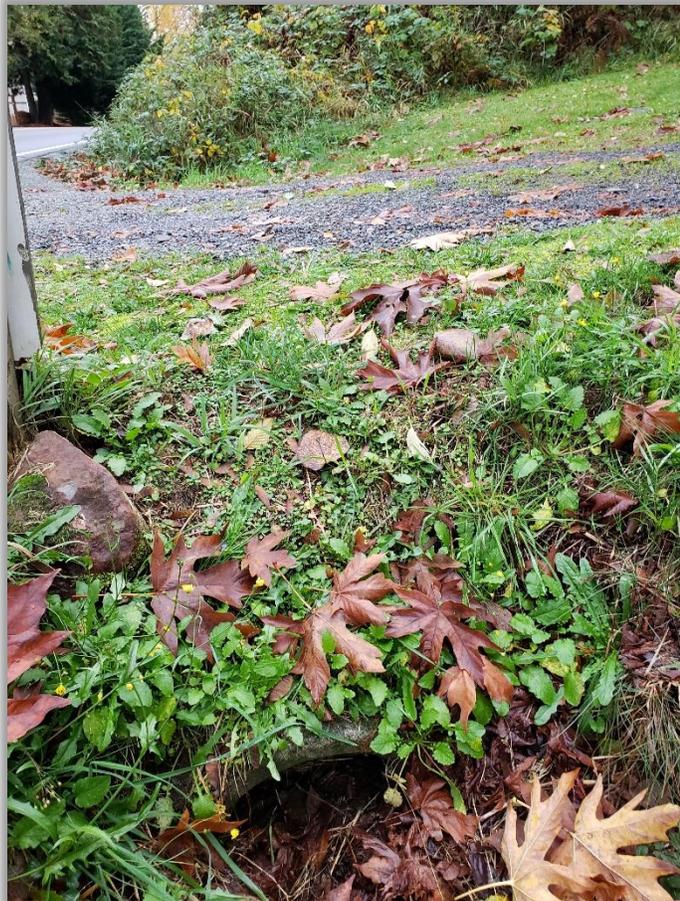
Photo S2, right: Looking southerly, runoff continues downstream in right-of-way ditch and enters 12" concrete culvert 64 feet from site.

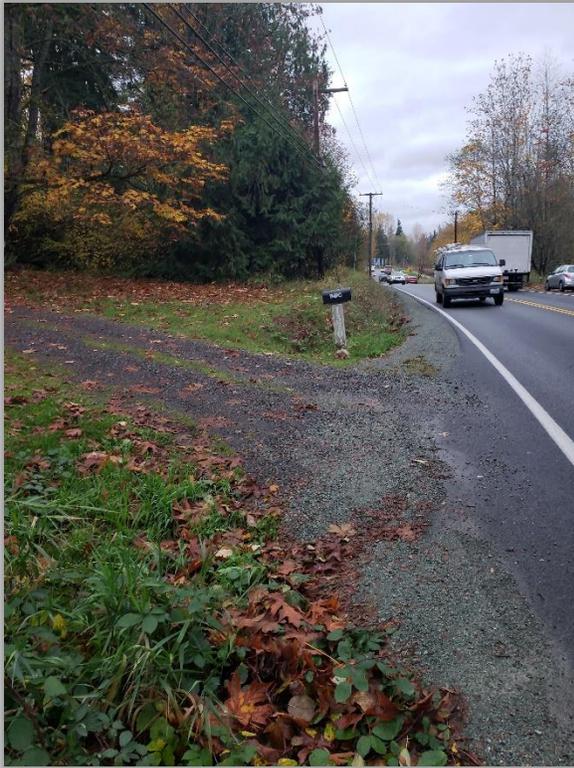
Photo S3, left: Looking north, ditch continues southerly and flow through 12” concrete culvert shown in Photo #2 and daylight 22 LF south, 82 feet from site.

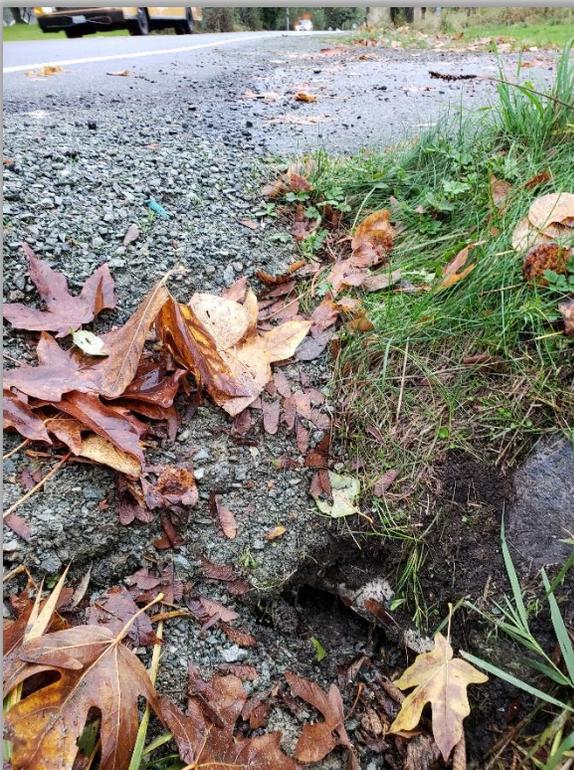
Photo S4, left: Looking south, a buried culvert of unidentified material conveys runoff in ditch under second driveway. Photo taken approximately 532 feet downstream.

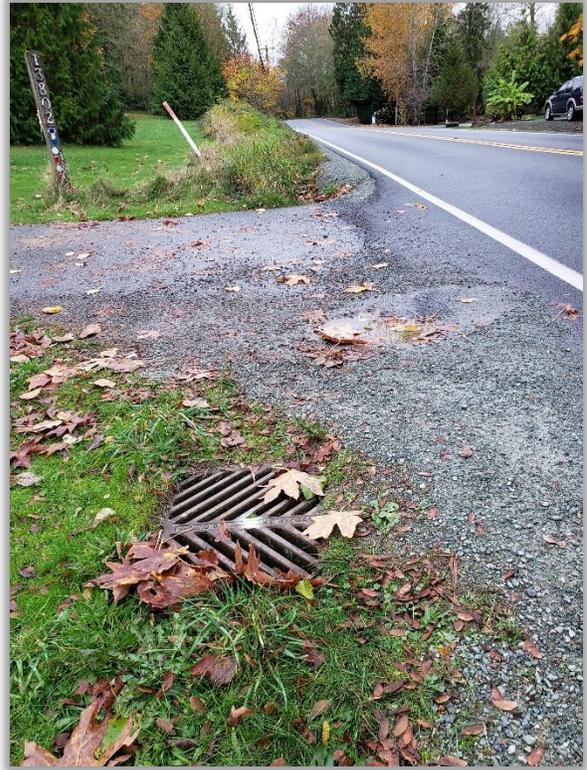
Photo S5, right: Looking north, 12” PVC pipe ends at open grate catch basin approximately 554 feet downstream, which conveys runoff in ditch under second driveway.

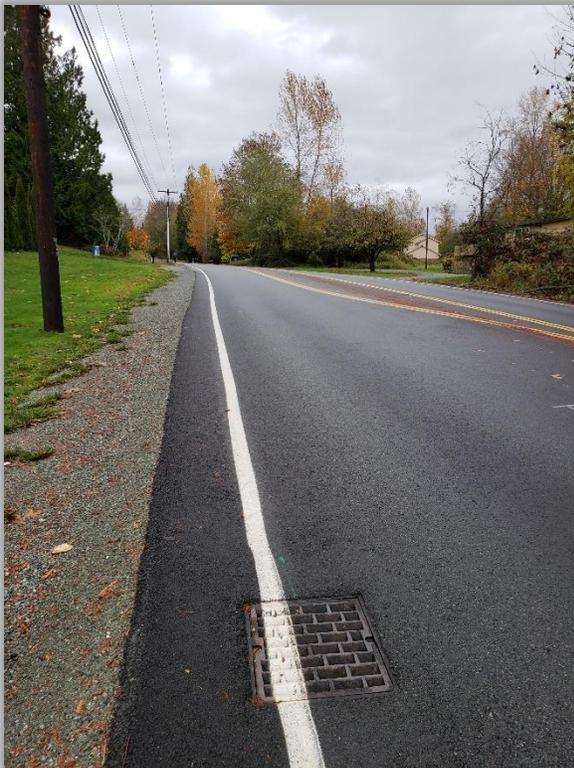
Photo S6, left: Looking north, 12” PVC pipe ends at open grate catch basin approximately 823 feet downstream, which conveys runoff in existing storm drainage infrastructure.

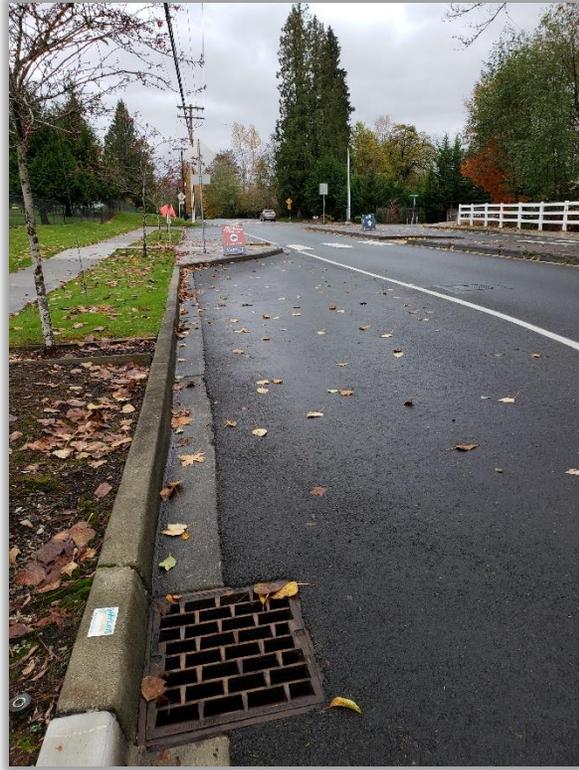
Photo S7, left: Looking north, 12” PVC pipe ends at open grate catch basin approximately 1,152 feet downstream, which conveys runoff in existing storm drainage infrastructure.

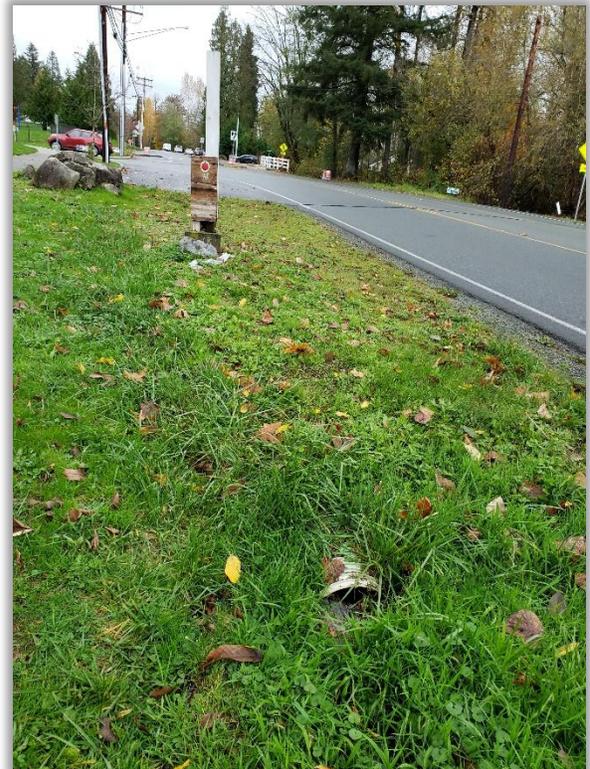
Photo 8, right: Looking north, 12” PVC pipe daylights approximately 1344 feet downstream, beyond the 1,320 feet (1/4 mile) threshold, which ends the South Basin downstream analysis. Runoff continues downstream in ditch to Woods Creek, to the Skykomish River as part of the Snohomish River watershed.
