**CRITICAL AREAS STUDY AND CONCEPTUAL MITIGATION
PLAN**

GARIBALDI PRD

MONROE, WASHINGTON

28 November 2018
(Revised 4 March 2021)

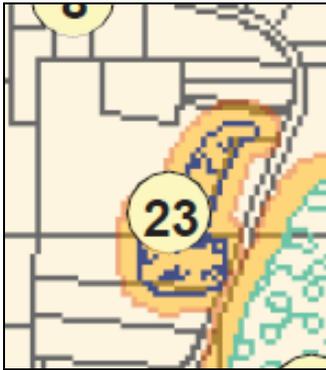
Photo 1. Snip from City of Monroe Wetland Inventory Map, showing Wetland #23

City of Monroe critical areas maps indicate one feature, labeled as Wetland Inventory #23, occurring on the eastern half of the Site. Only a small portion of the southern portion of this mapped feature exists and was identified as Wetland A (see Section 4.2). The remainder of this mapped feature did not meet the wetland criteria.

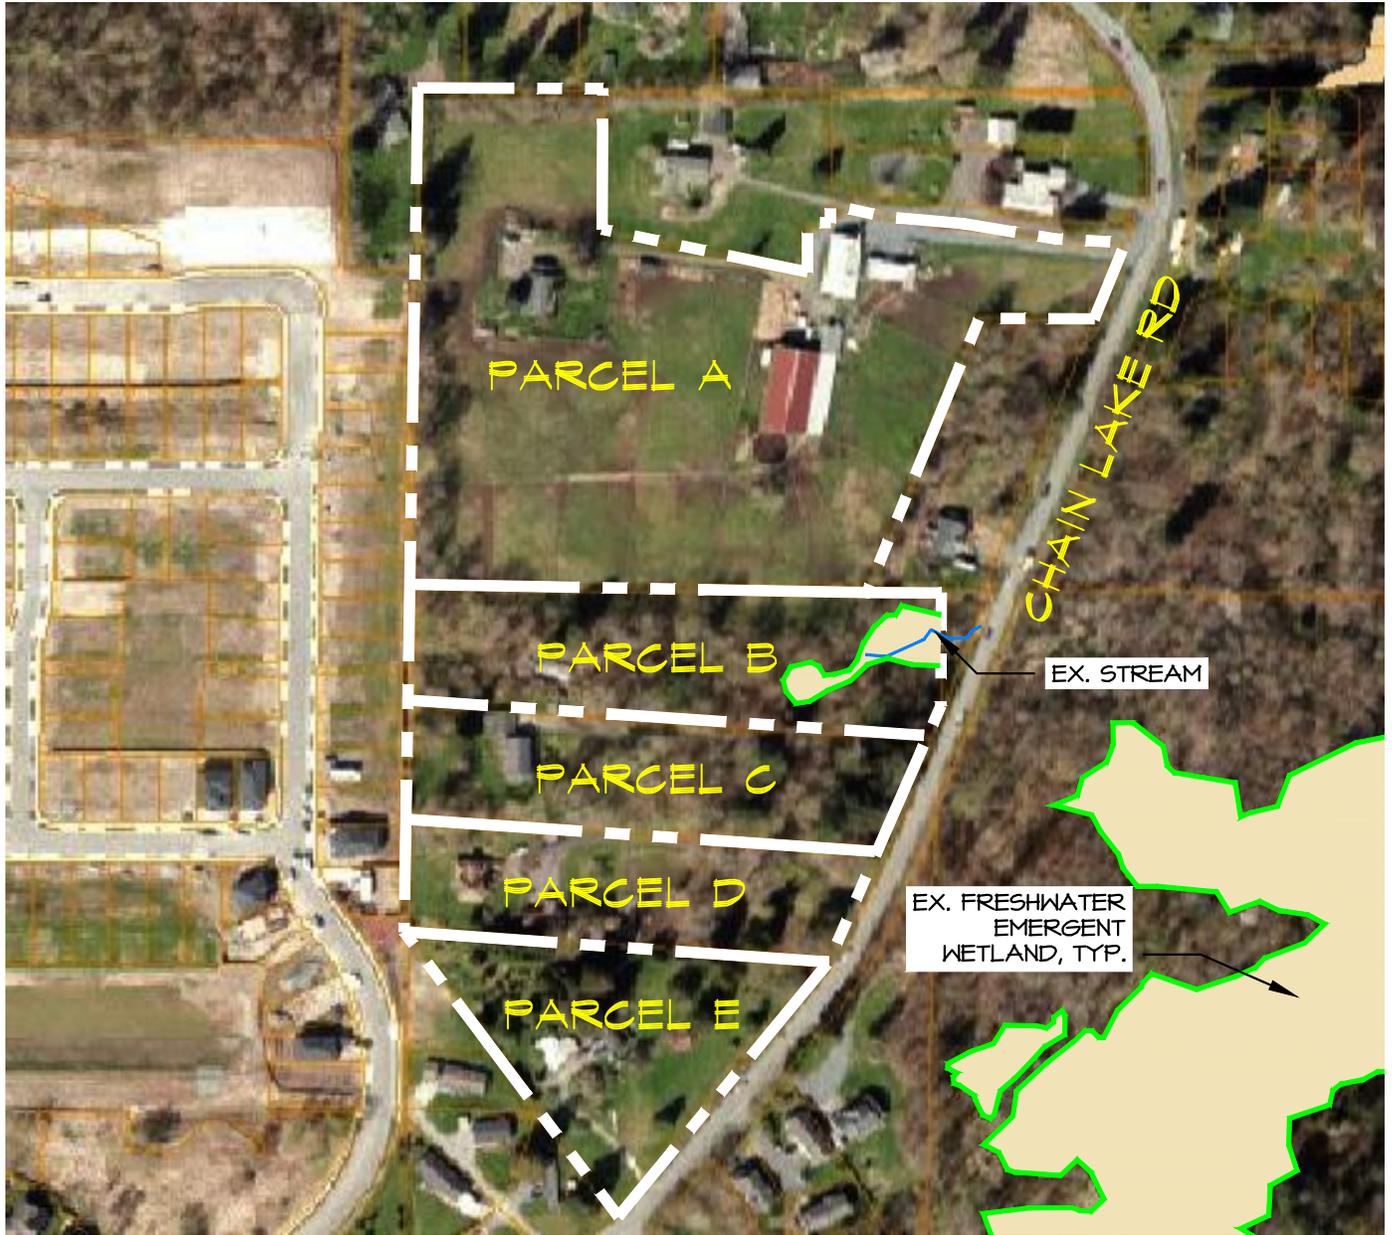
FIGURE #2

The Garibaldi PRD site is an approximately 18.22-acre assemblage of five (5) parcels located in the City of Monroe (**Figure 1**). It is bounded to the north and south by single family residences, to the west by a new single-family development, and to the east by Chain Lake Road. The Snohomish County Tax Parcel numbers for the site are 28073100200800 (Parcel A), 28073100201600 (Parcel B), 28073100203900 (Parcel C), 28073100202800 (Parcel D), and 28073100202900 (Parcel E) (**Figure 2**). The Public Land Survey System location for this assemblage is the NW $\frac{1}{4}$ of Section 31, Township 28 North, Range 7 East, Willamette Meridian (W.M.).

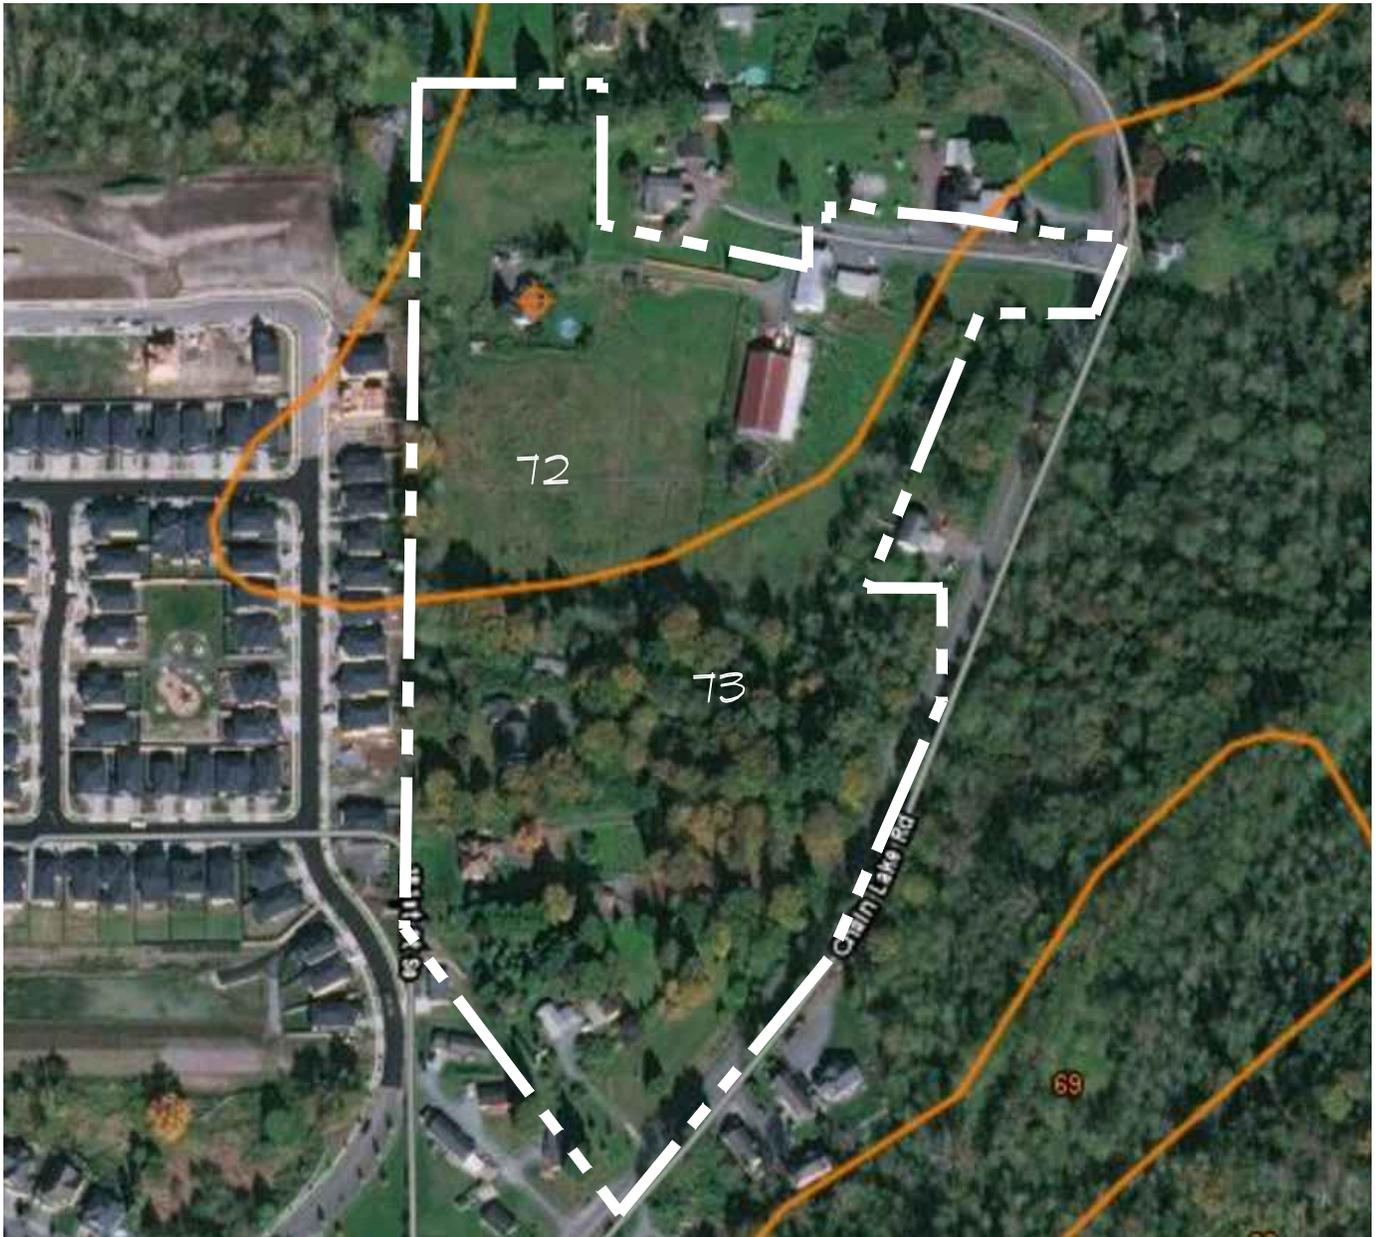
TYPE	DESCRIPTION, SLOPES
72	TOKUL MEDIAL LOAM, 8 TO 15 PERCENT SLOPES.
73	TOKUL MEDIAL LOAM, 0 TO 8 PERCENT SLOPES.

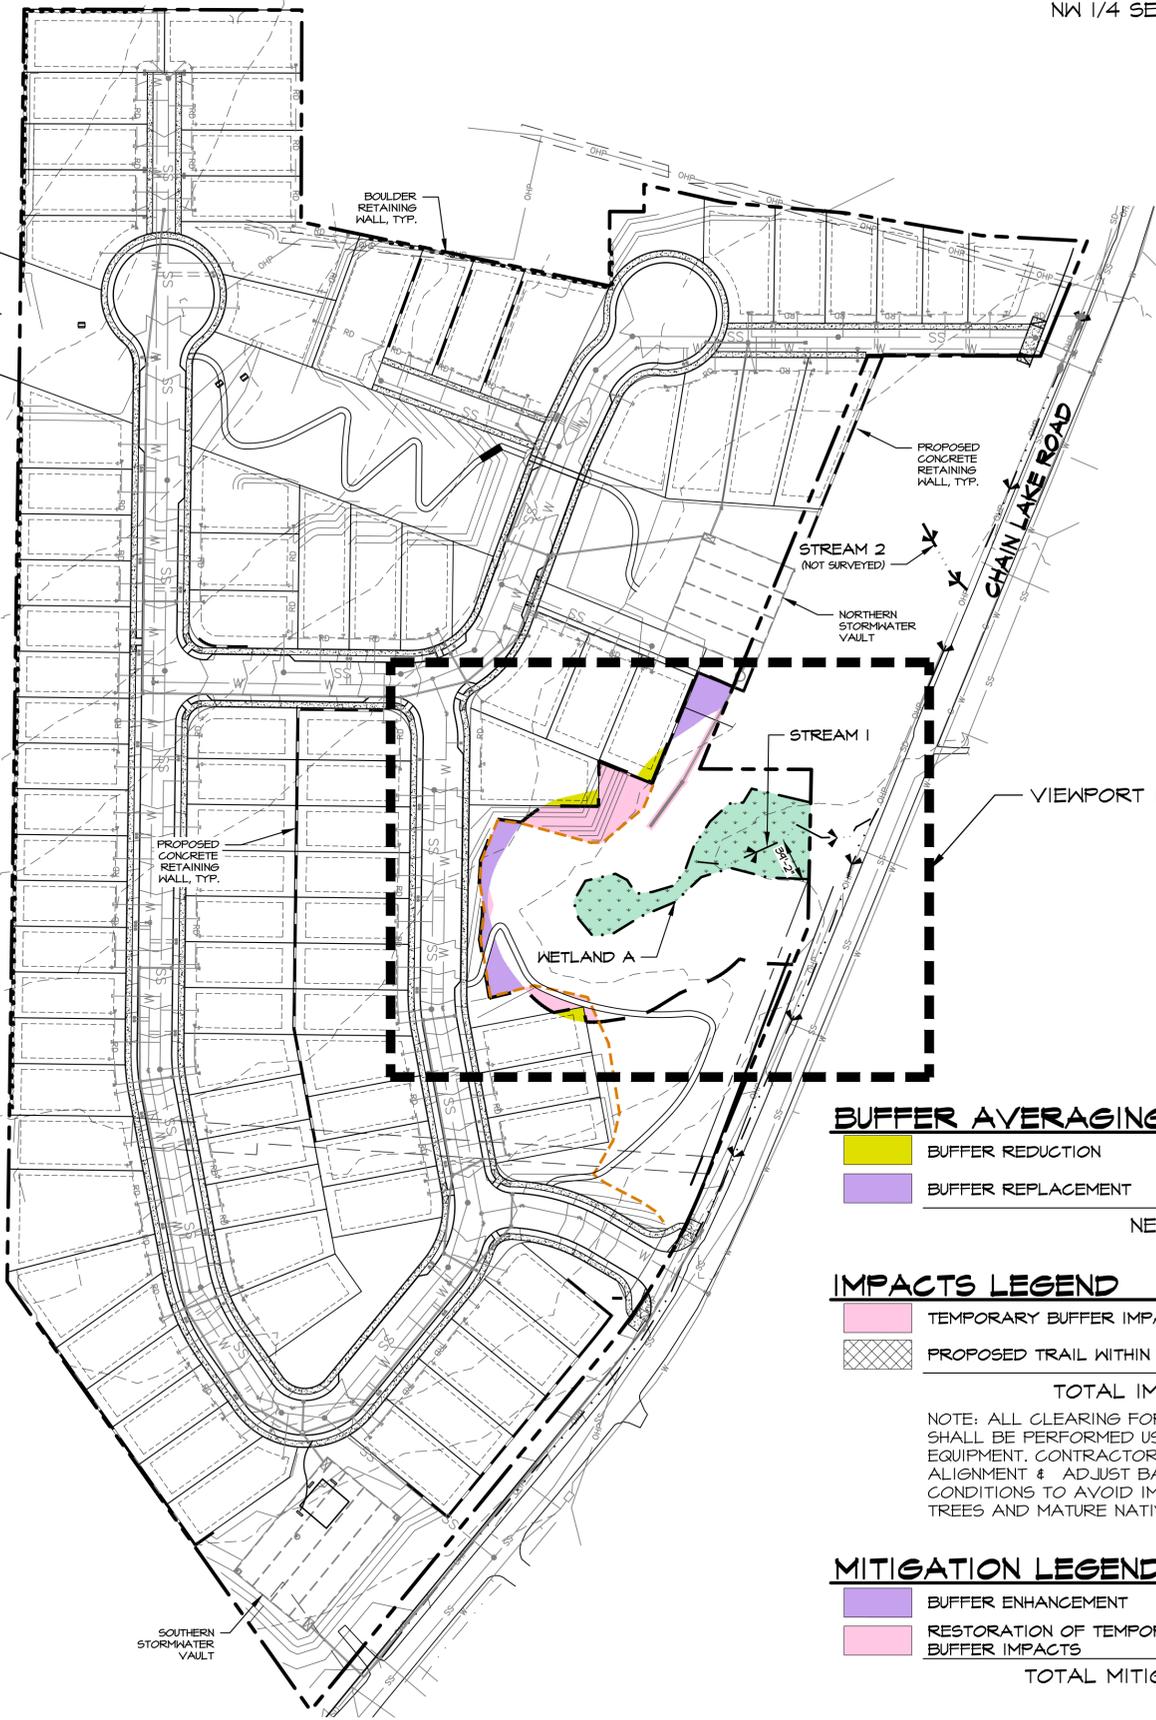
Sheet W1.1: Proposed Site Plan, Impacts & Mitigation Overview Plan

BUFFER REDUCTION	900 SF
	BUFFER REPLACEMENT	3,213 SF
NET GAIN:		2,313 SF

Reduced buffer areas and trail building will be mitigated for through buffer replacement, resulting in a net gain in buffered area. The buffer replacement area totals 3,213 sf and the net gain in buffer area will be 2,313 sf. Buffer replacement areas and temporary buffer impact areas will be enhanced through the removal of invasive species and the planting of a diversity of native species. The 3,213 square-foot of replaced wetland buffer will be enhanced and 4,783 sf of temporary buffer impact will be enhanced. The proposed mitigation is described below.

Approximately 900 square feet of wetland buffer will be reduced in order to accommodate a viable Site Plan. The area of buffer reduction will be replaced by 3,213 sf of enhanced buffer area. Buffer averaging will result in a net gain of 2,313 sf of buffer. All buffer replacement areas will be enhanced through the removal of invasive species and replacement of native species.
