BARGHAUSEN

PRELIMINARY STORMWATER REPORT

Cooper Ridge
19785 137th Street Southeast
Monroe, WA 98272

Our Job No. 21609

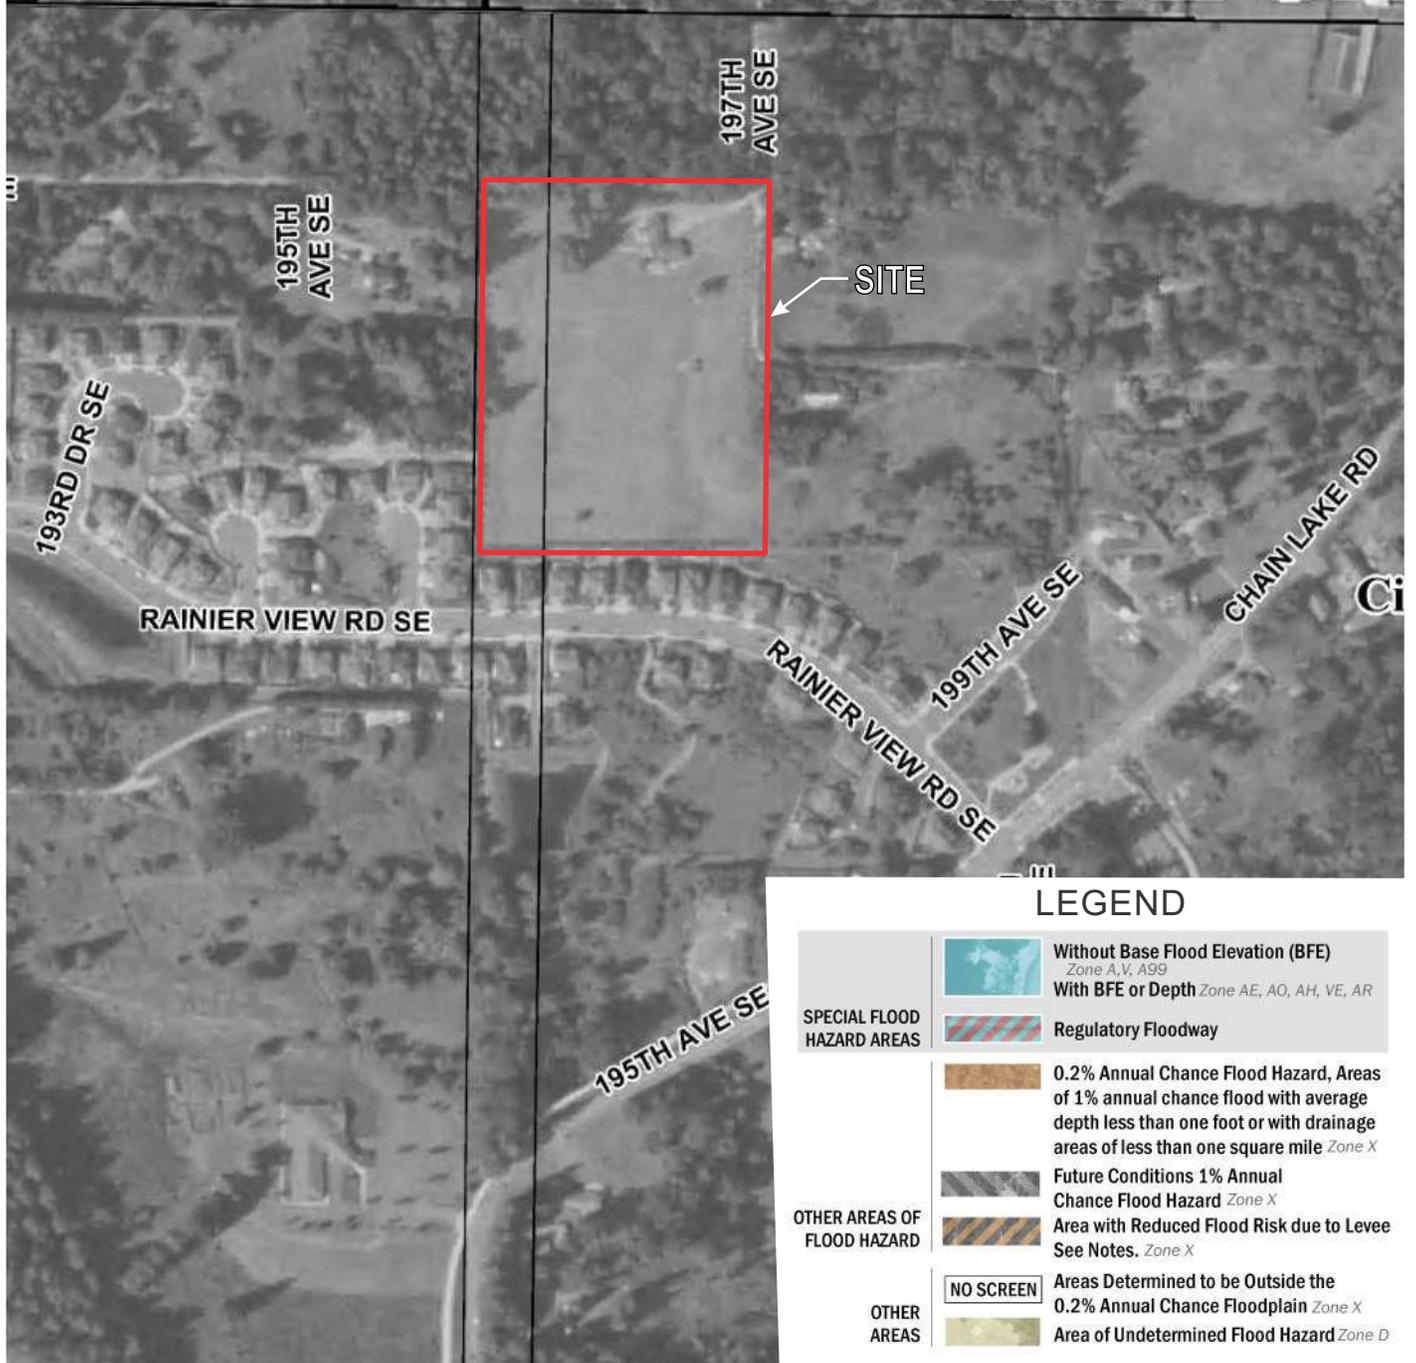
REFERENCE: Federal Emergency Management Agency (Portion of Map 53061C1377F, June 2020)

- **Adopted Basin Plans:** The site is part of the Lower Woods Creek Basin.
- **Finalized Drainage Studies:** This is not applicable.
- **Floodplain and Floodway FEMA Maps:** Based on FEMA flood zone mapping, this site is not located in a floodplain.
- **Sensitive Areas Folios:** Based on a review of available GIS mapping, it was found that the subject site does not contain any seismic hazards, coal mines, landslide hazards, or erosion hazards.
- **Road Drainage Problems:** No road drainage problems have been identified.
- **United States Department of Agriculture Soils Survey:** Based on the soils map for this area, the site is primarily comprised of Tokul gravelly medial loam. This soil class is moderately well drained but the capacity of the most limiting layer to transmit water is very low to moderately low.
- **Migrating River Studies:** This is not applicable.

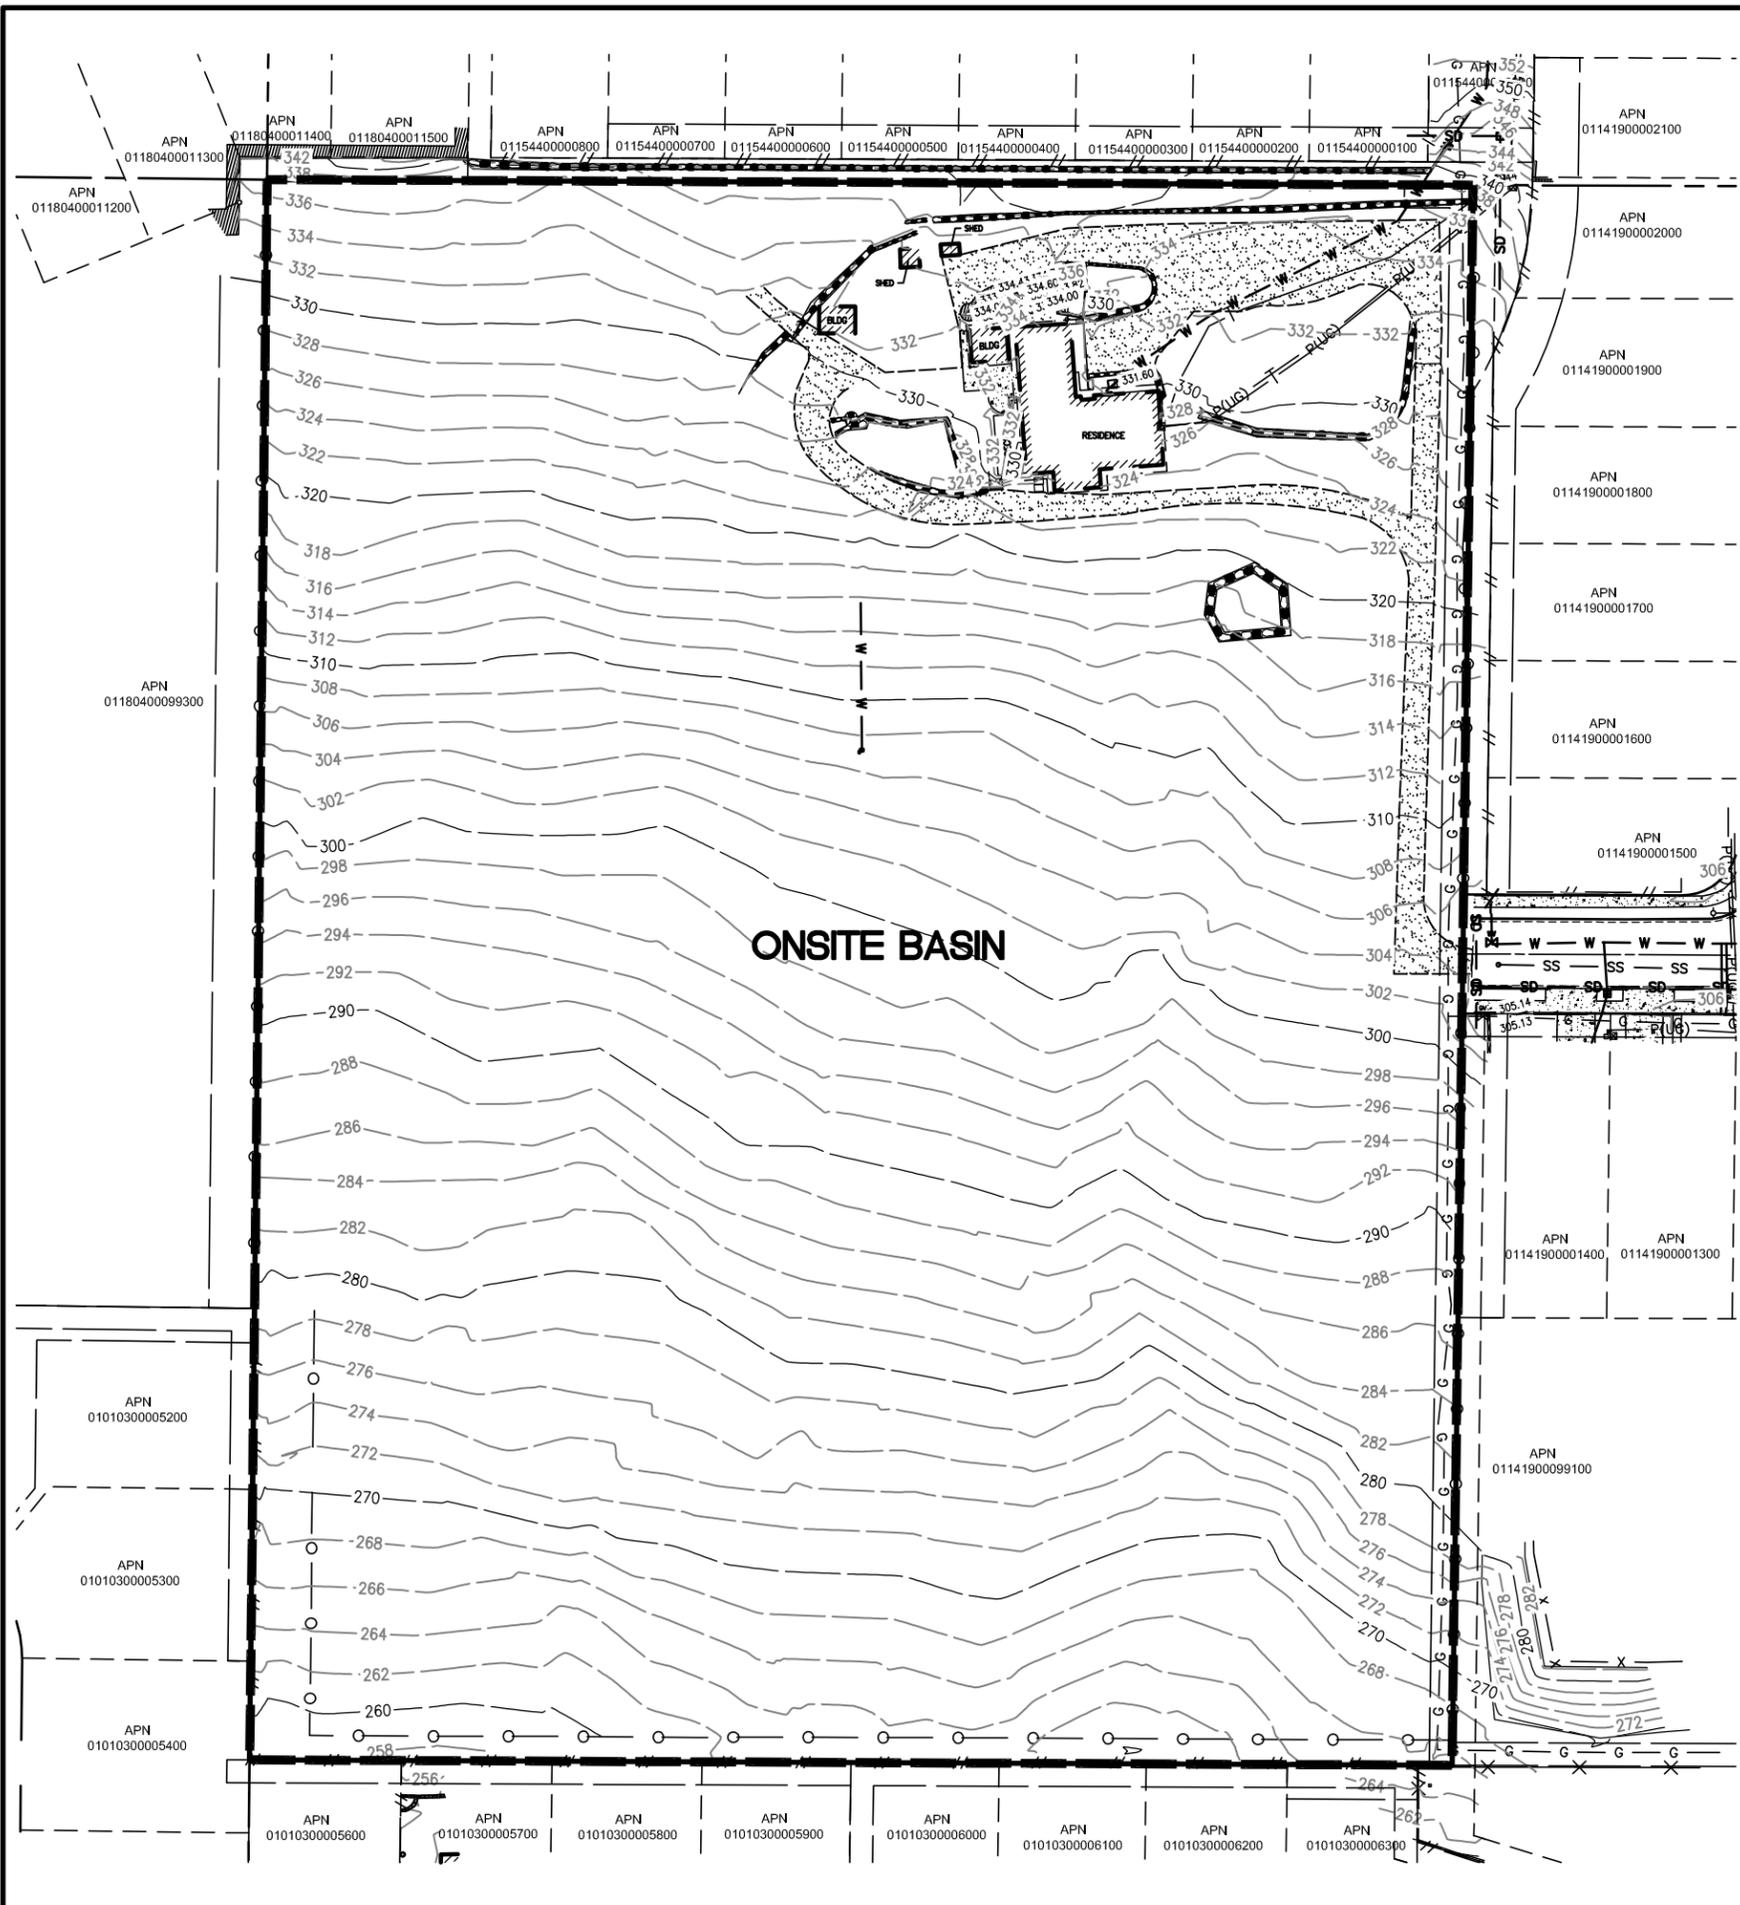
ONSITE BASIN = 8.35 AC
(FOR MODELLING PURPOSES)
 TILL FOREST (MODERATE) = 8.35 AC

ONSITE BASIN = 8.35 AC
(EXISTING SURFACES)
 PASTURE (MODERATE) = 7.898 AC
 ROOF AREA = 0.097 AC
 DRIVEWAY/PARKING = 0.355 AC

The site consists of one 8.35-acre parcel with an existing single-family residence. The remainder of the site contains pasture with trees along the eastern, southern, and western borders. Please refer to the Pre-Developed Basin Map for existing site conditions.

Since the site requires Standard Flow Control per the SMMWW. A Type C forested land cover condition was assumed for the existing condition for hydrologic modeling purposes.

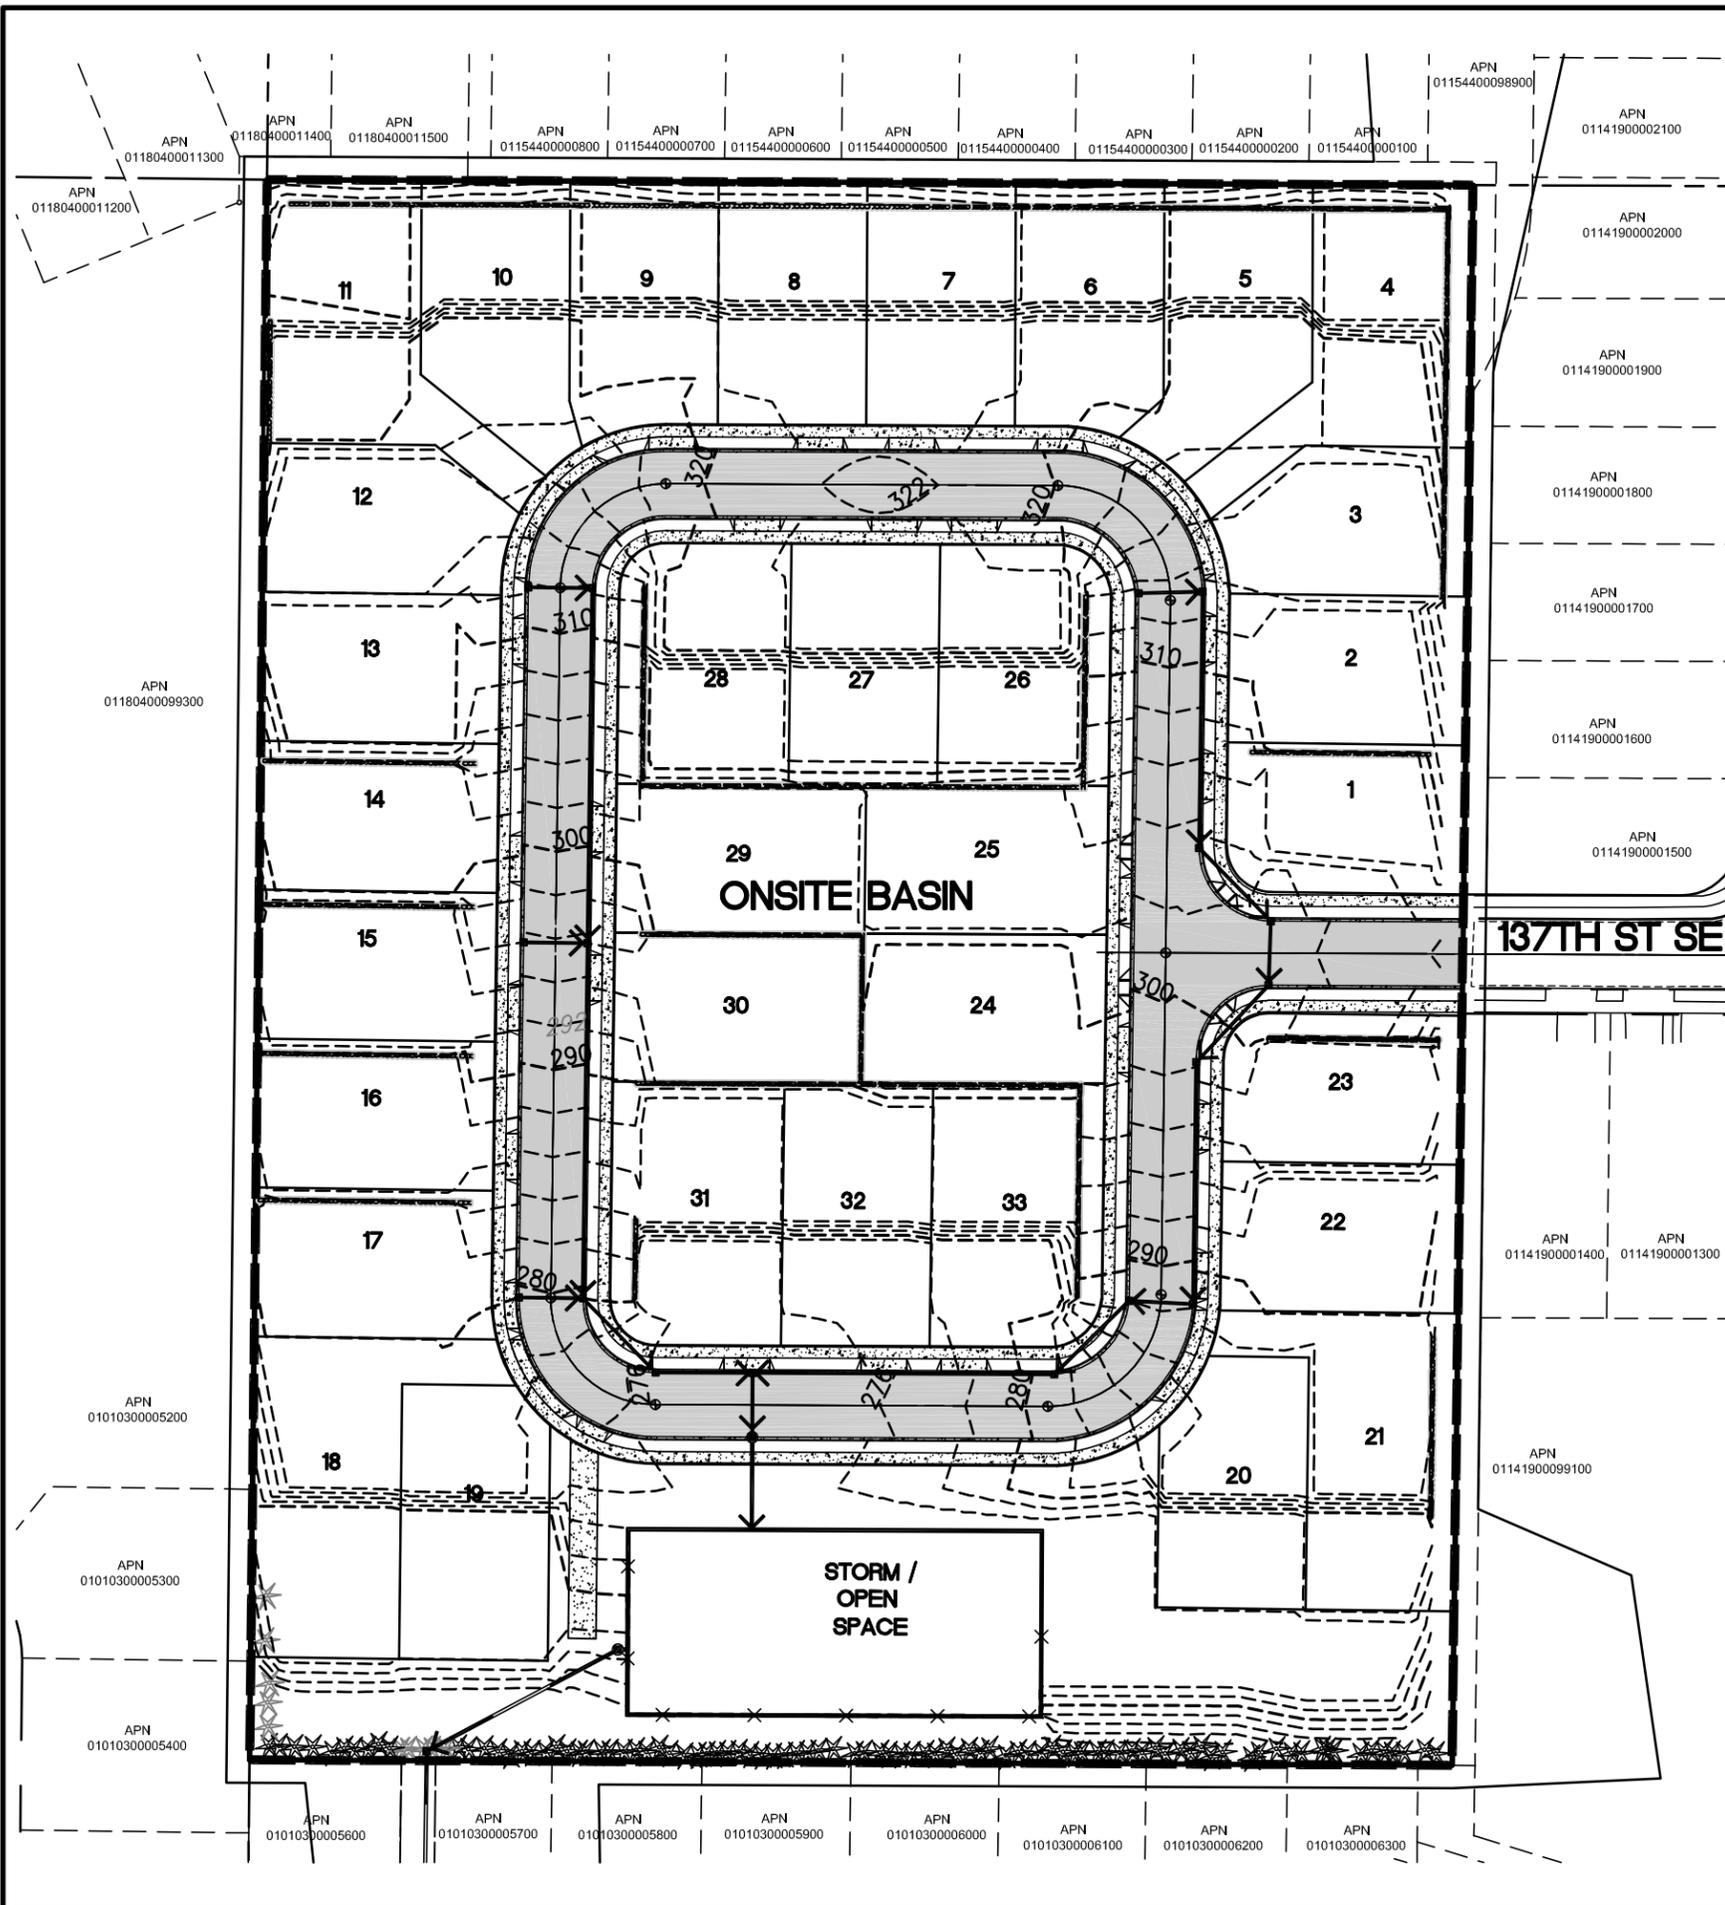
TOTAL PERVIOUS SURFACES = 4.016 AC

PASTURE (FLAT)	= 2.008 AC
PASTURE (MODERATE)	= 2.008 AC

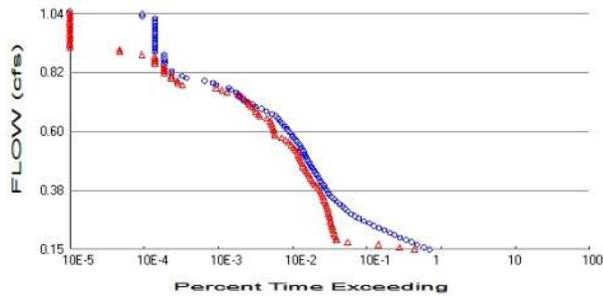
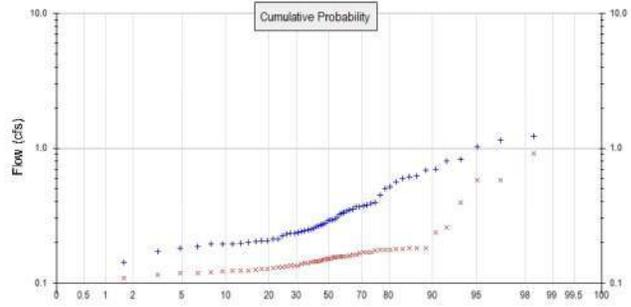
POC 1

+ Predeveloped x Mitigated

Flow(cfs)	Predev	Mit	Percentage	Pass/Fail
0.1543	14859	9364	63	Pass
0.1633	12429	5890	47	Pass
0.1722	10262	3059	29	Pass
0.1812	8577	1177	13	Pass
0.1901	7144	836	11	Pass

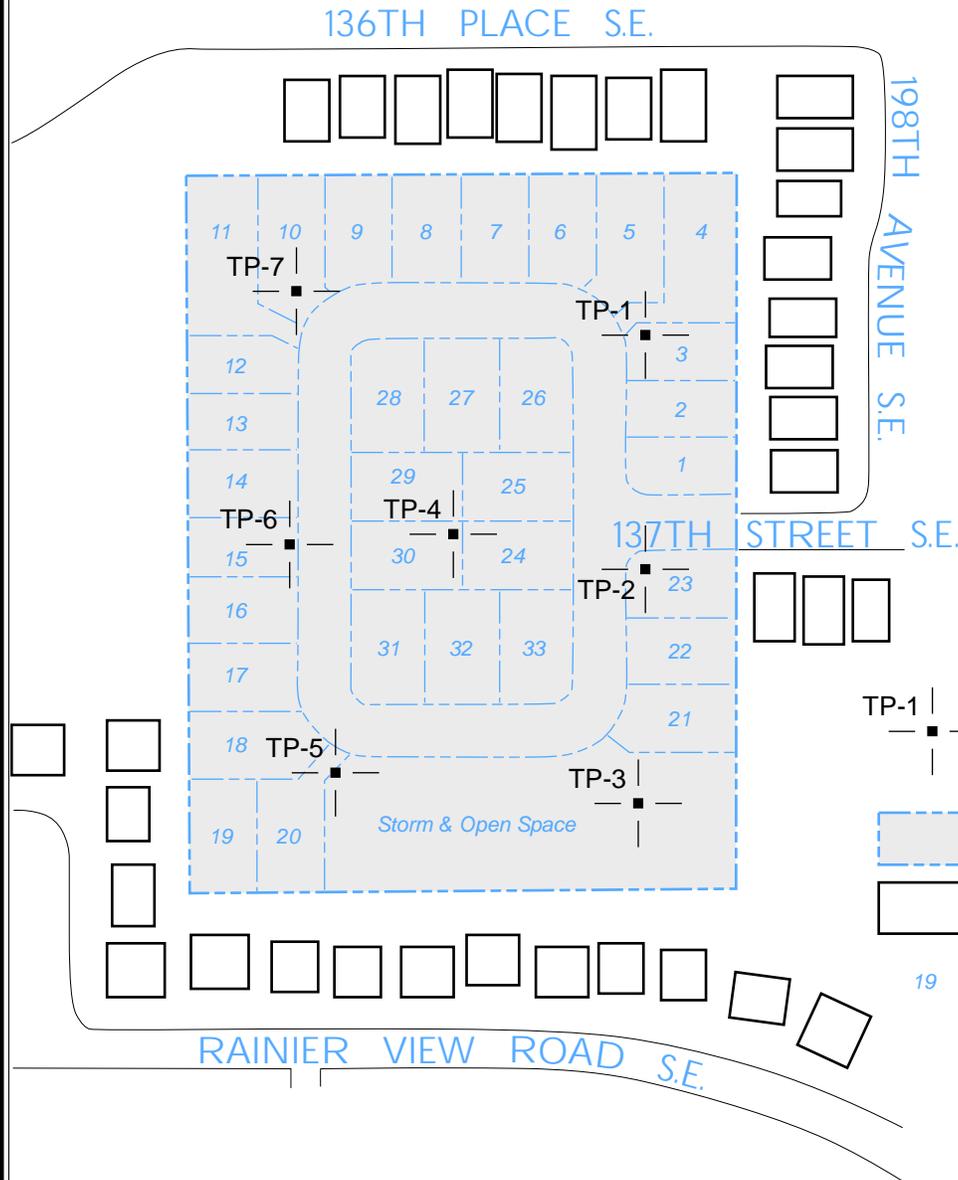
**Test Pit Location Plan
Chebuhar Short Plat
Monroe, Washington**

Drwn. CAM	Date 04/14/2021	Proj. No. 7734
Checked SSR	Date Apr. 2021	Plate 2

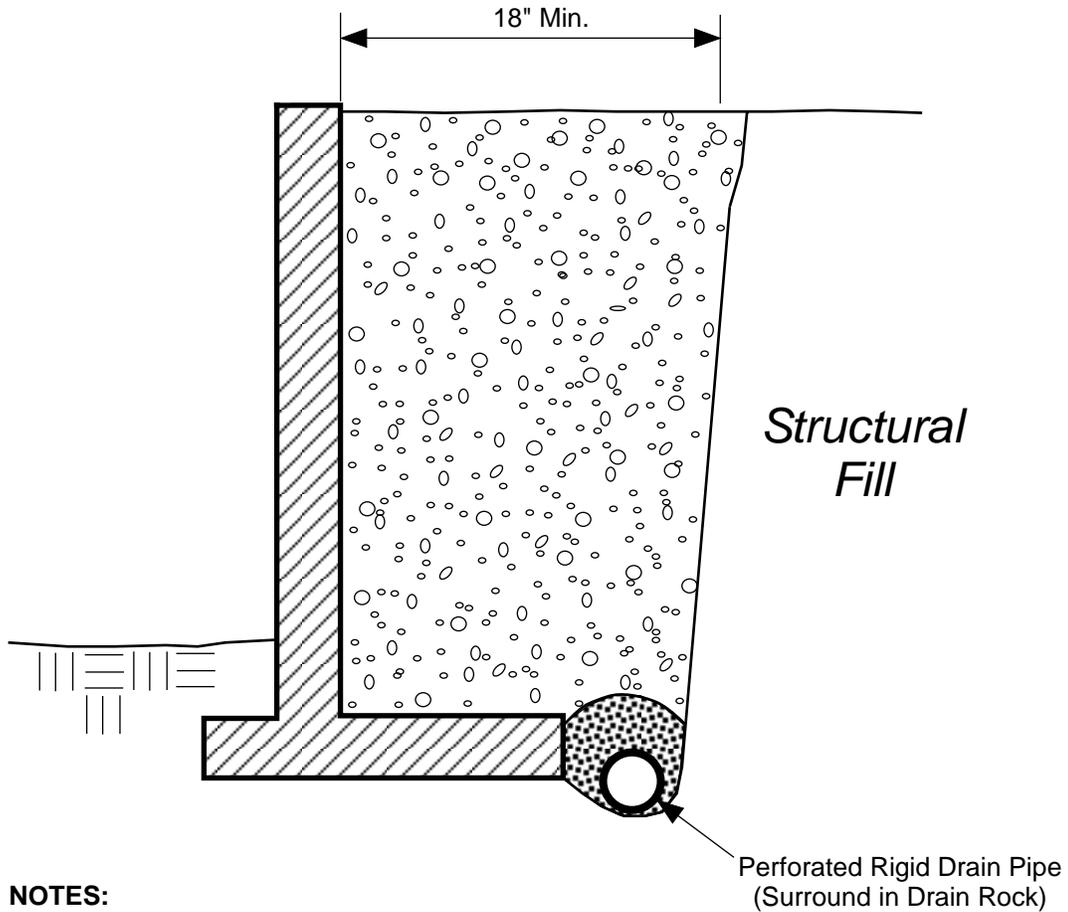
Earth Solutions NW_{LLC} Geotechnical Engineering, Construction Observation/Testing and Environmental Services
Retaining Wall Drainage Detail Cebuhar Short Plat Monroe, Washington		
Drwn. CAM	Date 04/14/2021	Proj. No. 7734
Checked SSR	Date Apr. 2021	Plate 3

- Free-draining Backfill should consist of soil having less than 5 percent fines. Percent passing No. 4 sieve should be 25 to 75 percent.
- Sheet Drain may be feasible in lieu of Free-draining Backfill, per ESNW recommendations.
- Drain Pipe should consist of perforated, rigid PVC Pipe surrounded with 1-inch Drain Rock.

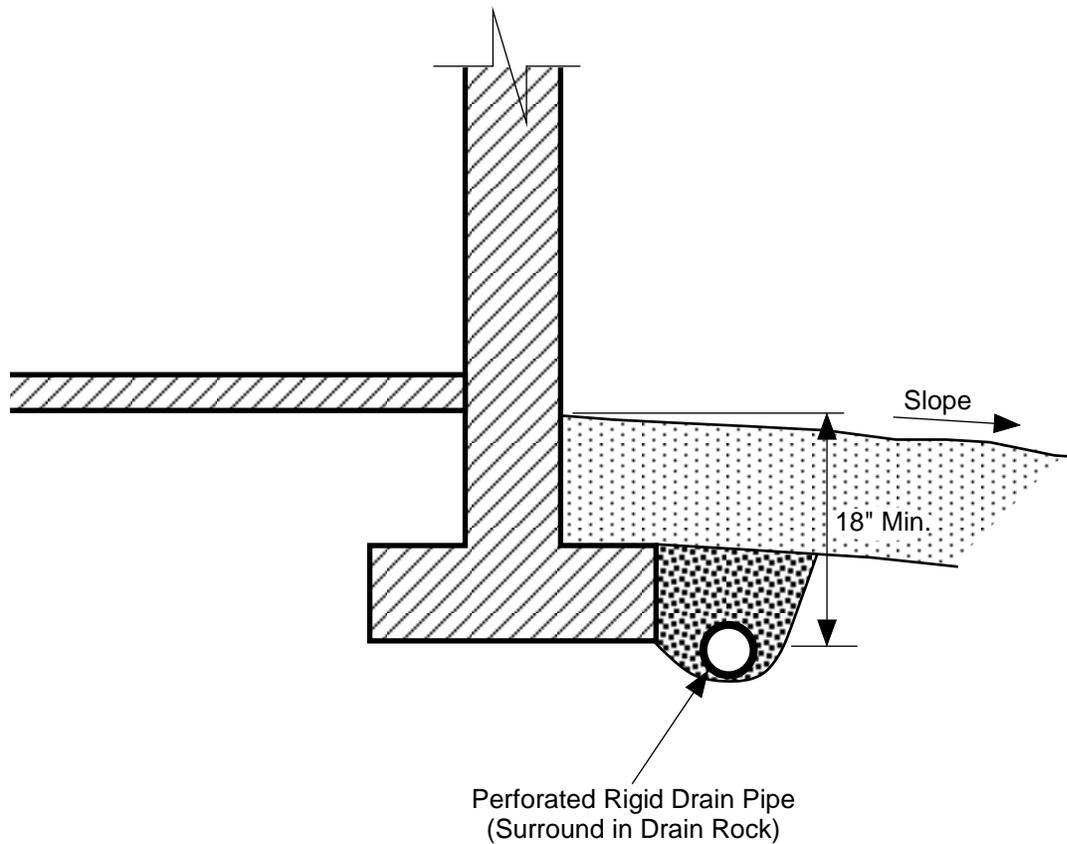
- Do NOT tie roof downspouts to Footing Drain.
- Surface Seal to consist of 12" of less permeable, suitable soil. Slope away from building.

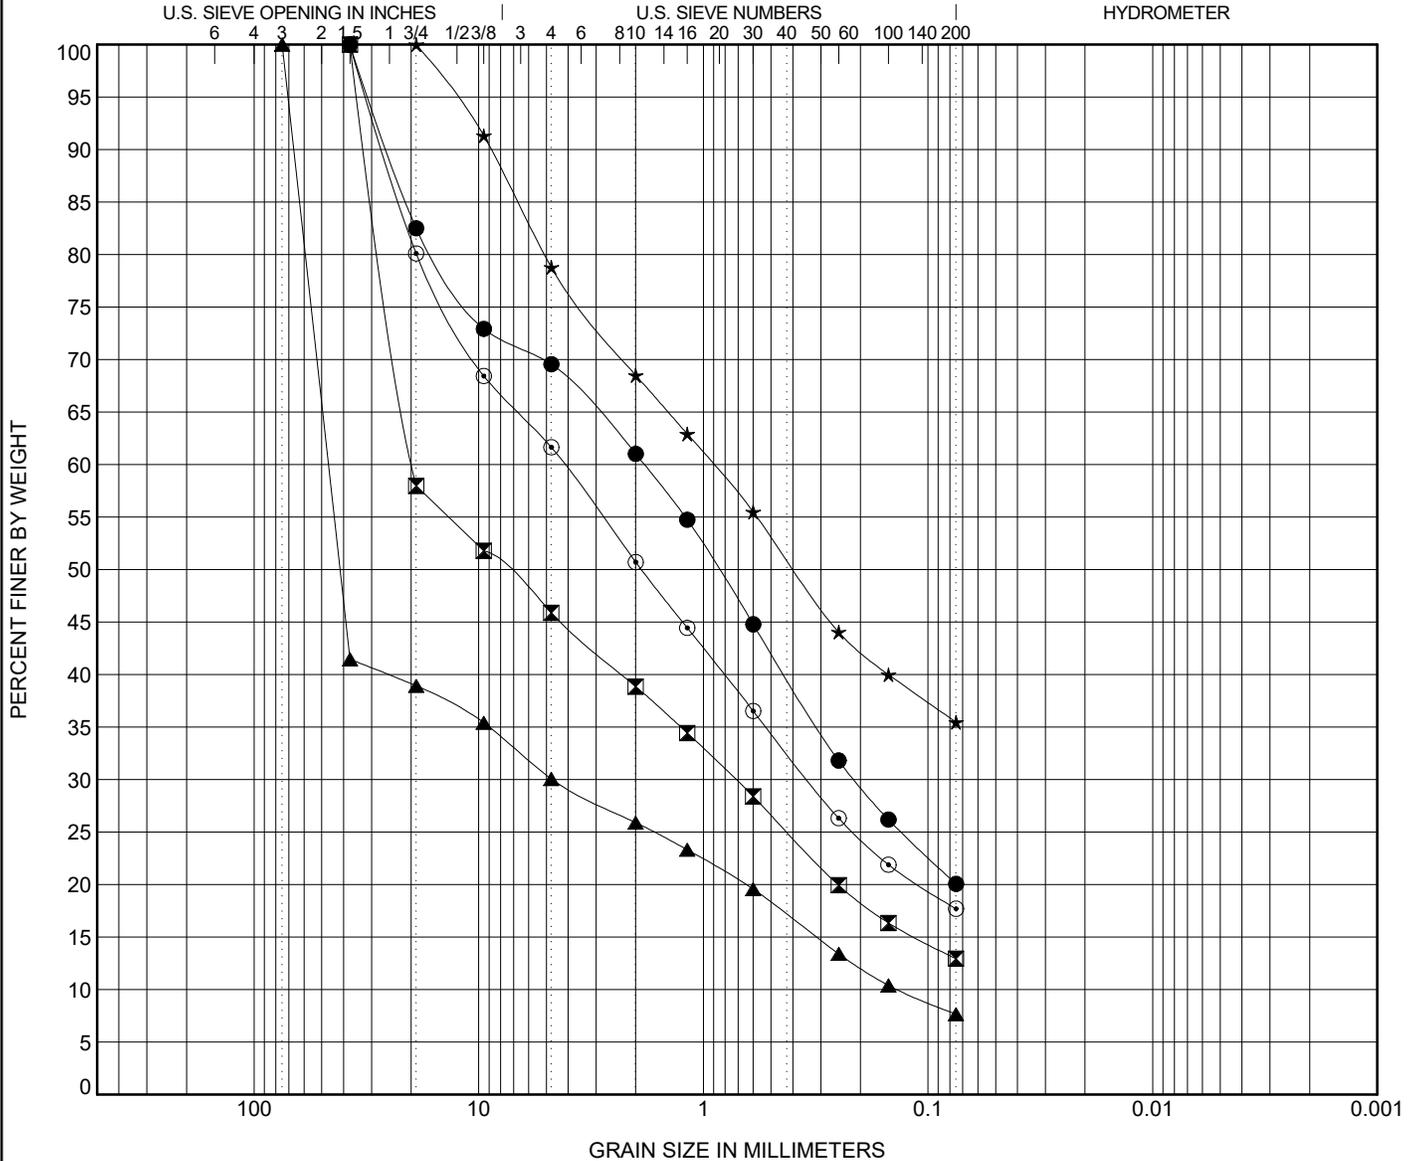
COBBLES	GRAVEL		SAND			SILT OR CLAY
	coarse	fine	coarse	medium	fine

Specimen Identification	Classification							Cc	Cu
● TP-01 4.00ft.	USDA: Brown Very Gravelly Coarse Sandy Loam. USCS: SM with Gravel.								
■ TP-02 9.00ft.	USDA: Gray Extremely Gravelly Coarse Sandy Loam. USCS: GM with Sand.								
▲ TP-03 11.00ft.	USDA: Gray Extremely Gravelly Sandy Loam. USCS: GP-GM with Sand.							3.48	343.88
★ TP-06 3.50ft.	USDA: Brown Gravelly Loam. USCS: SM with Gravel.								
○ TP-07 9.00ft.	USDA: Brown Very Gravelly Coarse Sandy Loam. USCS: SM with Gravel.								
Specimen Identification	D100	D60	D30	D10	LL	PL	PI	%Silt	%Clay
● TP-01 4.0ft.	37.5	1.836	0.212					20.1	
■ TP-02 9.0ft.	37.5	19.63	0.719					12.9	
▲ TP-03 11.0ft.	75	46.707	4.696	0.136				7.7	
★ TP-06 3.5ft.	19	0.905						35.5	
○ TP-07 9.0ft.	37.5	4.172	0.343					17.7

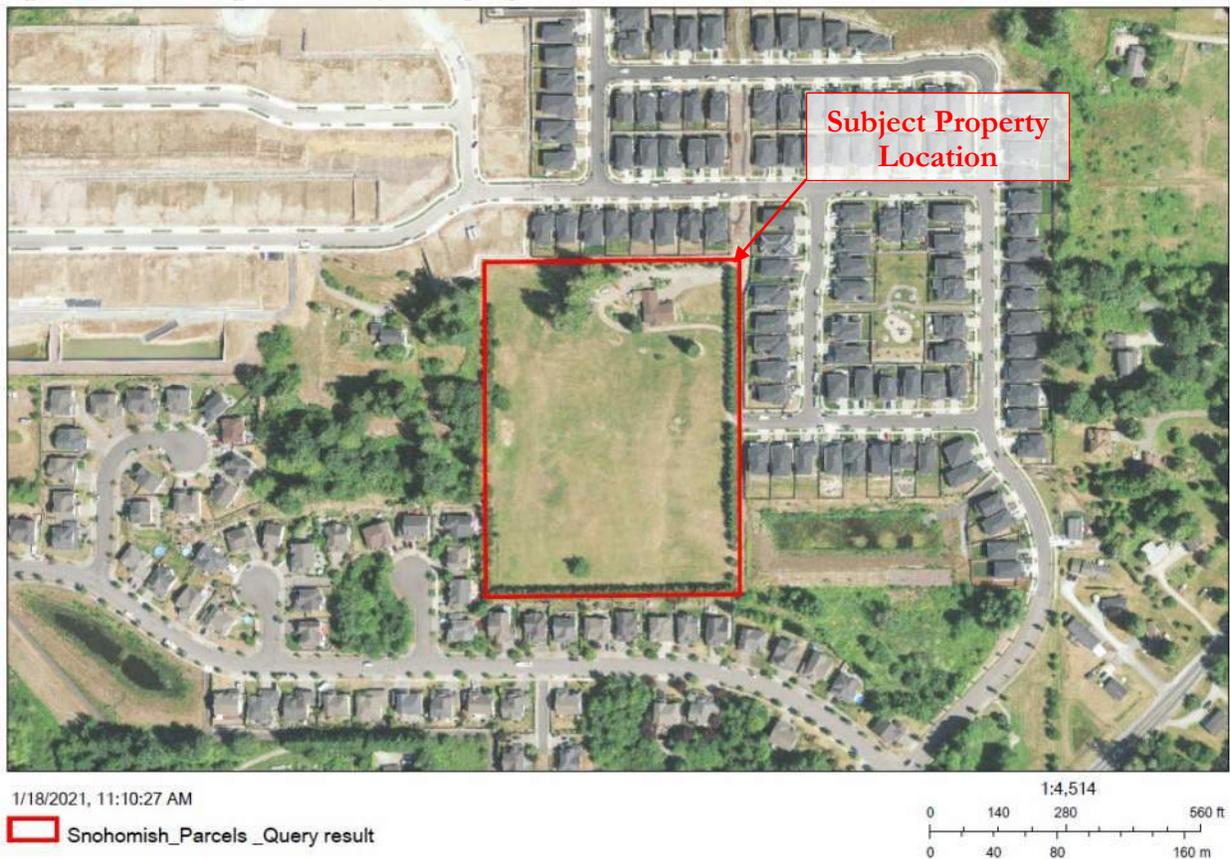
Figure 2. Aerial Image of the Subject Property.

The 8.35-acre subject property is located in a residential setting in the City of Monroe (Figure 2). The subject property is surrounded by residential plats or single-family residences. Topography onsite slopes moderately to the south with elevations ranging from approximately 330 feet above mean sea level (amsl) on the northeast portion of the subject property to approximately 260 feet amsl on the southeast portion of the subject property. A Snohomish County contours map is provided in Appendix B1. The subject property is located within Water Resource Inventory Area (WRIA) 7 – Snohomish.

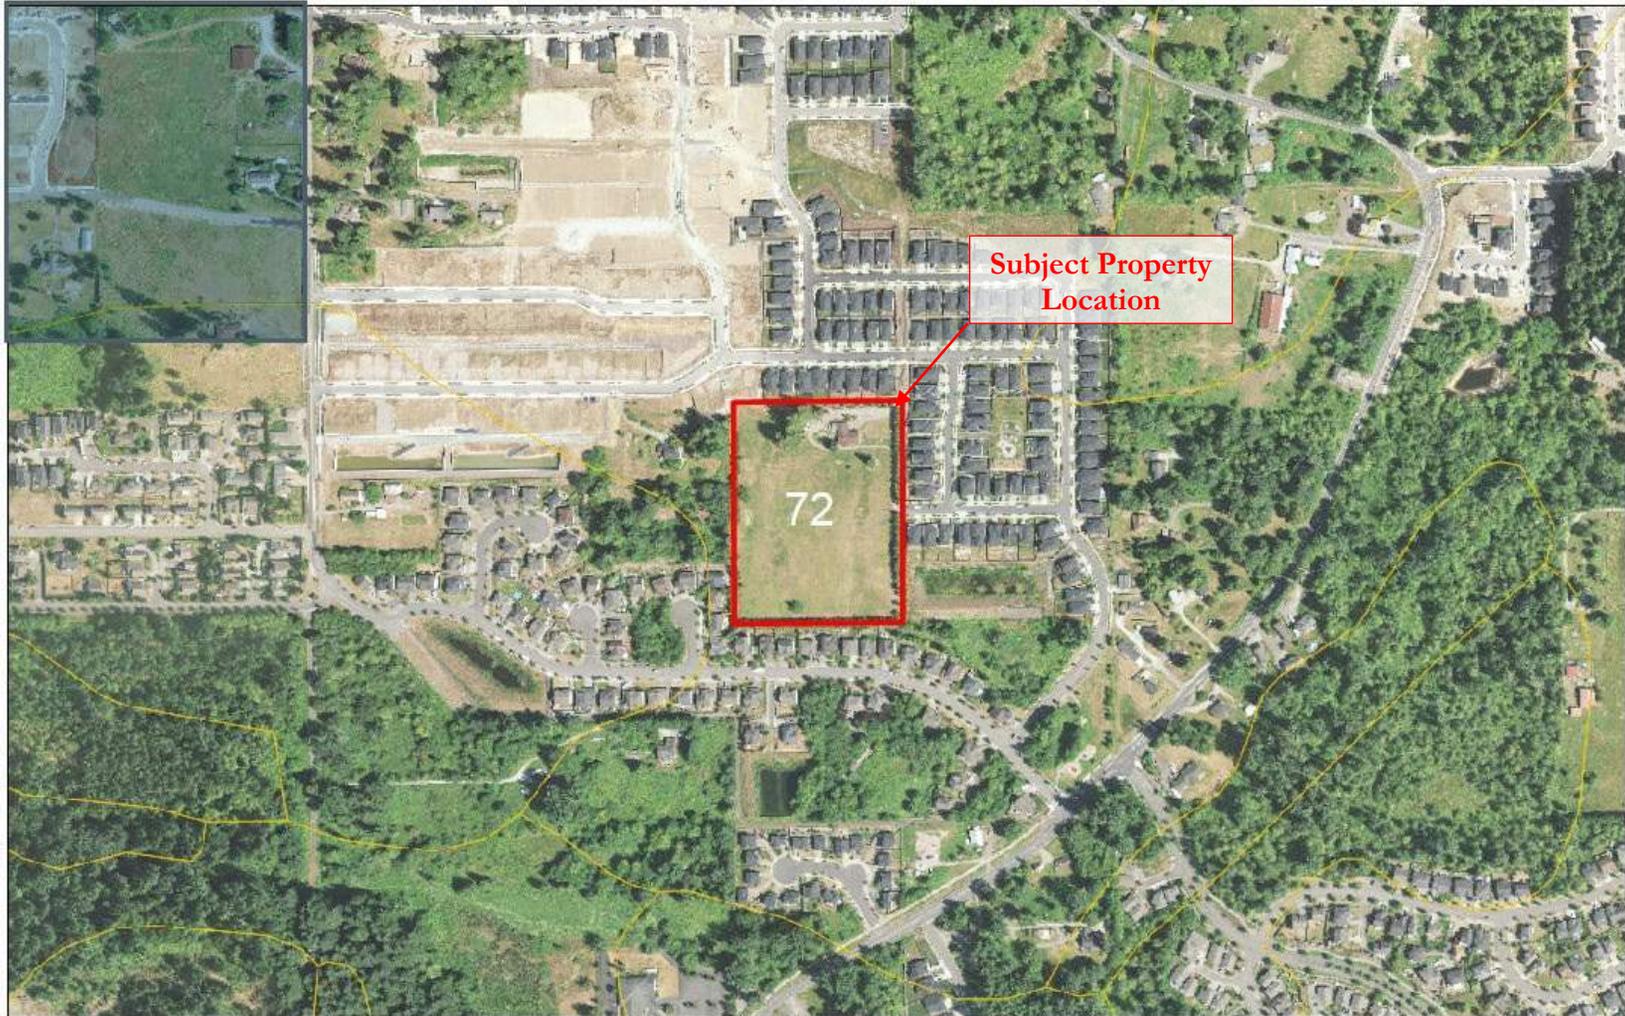
Appendix B2 — NRCS Soil Survey Map

The NRCS Soil Survey of Snohomish County, Washington identifies one soil series on the subject property: Tokul gravelly medial loam, 0 to 8 percent slopes (72). A soil map is provided in Appendix B2. Below is a detailed description of the soil profile.
