2021 MONROE TRANSPORTATION BENEFIT DISTRICT ANNUAL REPORT

MAY 24, 2022

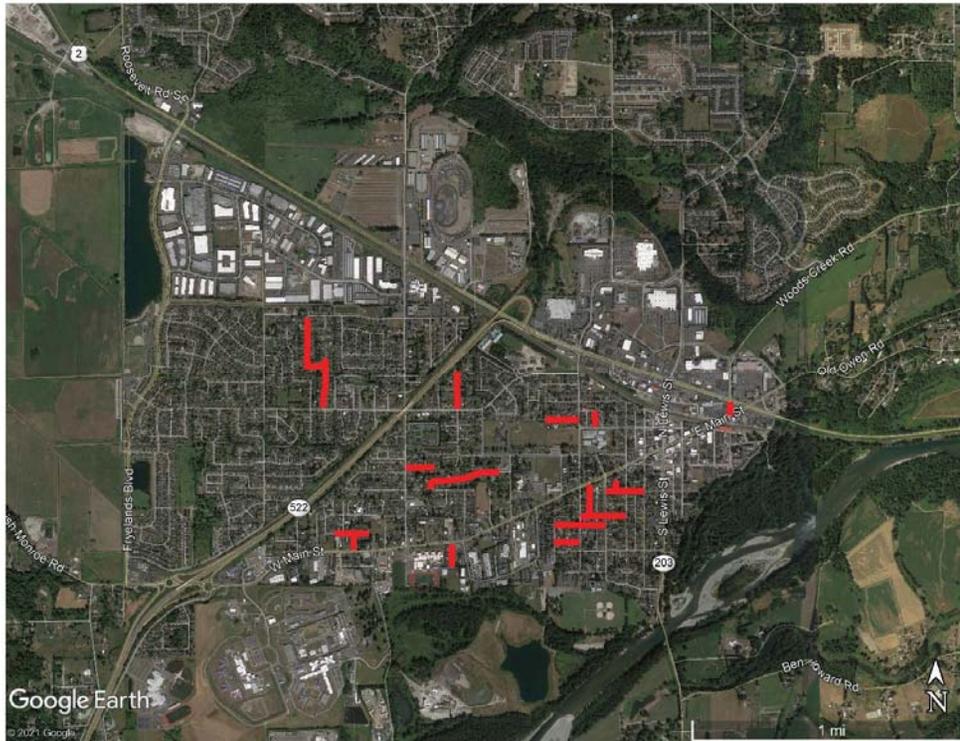
2021 TBD OVERVIEW MAP

30 CURB RAMPS UPGRADED

STREET	PAVING AREA (SQURE FEET)	PAVING LENGTH (CENTERLINE MILES)
ACADEMYWAY	10,616	0.09
176 TH AVE & 161 ST ST	19,700	0.17
157 TH PL	11,209	0.10
PARK LN	29,646	0.26
173 RD AVE & 174 TH AVE & 152 ND ST	47,318	0.41
182 ND AVE	12,026	0.22
W MAPLE ST	14,215	0.12
N ANN ST	6,301	0.05
MCDOUGALL ST & FOYE LN	20,330	0.18
MORRIS ST	13,506	0.12
MONROE ST	10,764	0.09
ROBERTS ST	21,254	0.18
ORR ST	7,234	0.06
PIKE ST	11,932	0.10
TOTAL	236,051	2.15

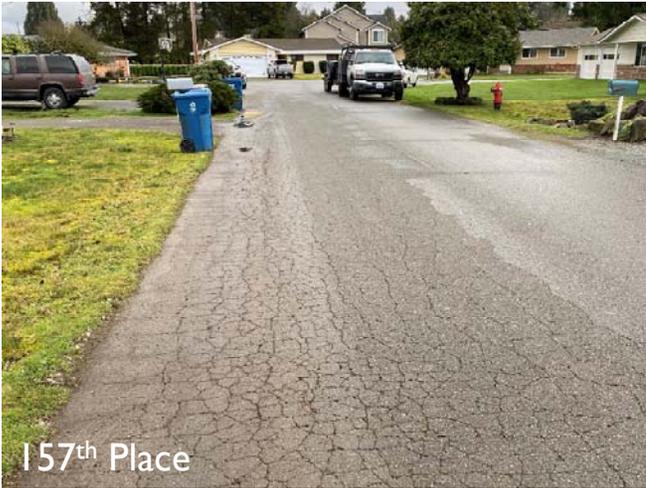
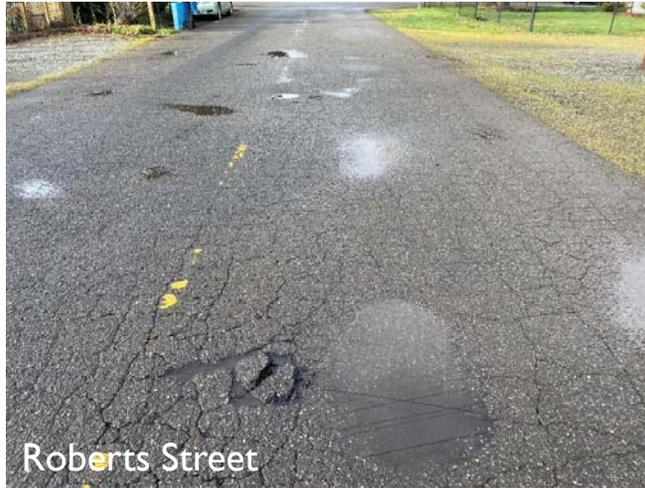
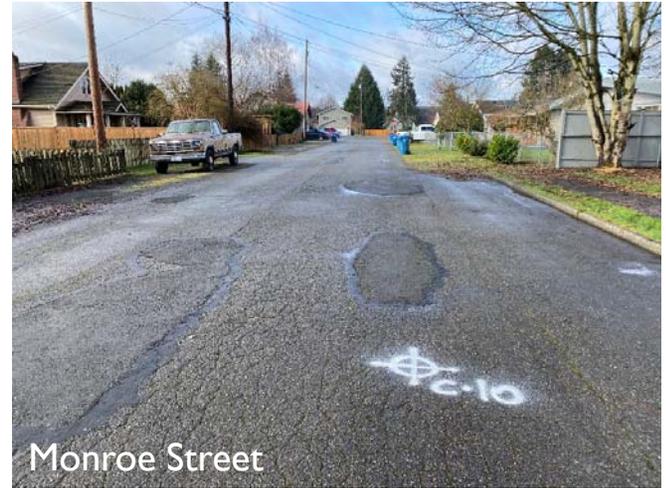
EXISTING PAVEMENT CONDITIONS

EXCAVATION COMPANY: HVA Geosciences Inc.
 EXCAVATING EQUIPMENT: 6-inch Diameter Core Barrel
 STREET: 157th Pl., SB, 8' from E edge of pavement

LOCATION: See Figure 23
 DATE COMPLETED: 2/19/21
 LOGGED BY: S. Perdue

DEPTH (feet)	SYMBOL	USDC SOIL CLASS	DESCRIPTION	SAMPLE TYPE SAMPLE NUMBER MOISTURE (%) CONTENTS (%) OTHER TESTS
0	SP		3.5-inches HD Mix Asphalt	
0.5	SM		2 lifts, 1.5" x 1.5" Control on high severity alligator cracking. Cracked through full depth of pavement. Lifts are unbound. (HMA)	
1.0	SM		Dense, brown, gravelly SAND with sil. moist. (FLL)	
1.5	ML		Silt, olive brown, sandy SILT, moist. (ALLIUM)

PAVEMENT CORE PHOTO

Corehole was terminated at 2.5-feet below ground surface.
 No groundwater seepage was observed during the exploration.

EXCAVATION COMPANY: HVA Geosciences Inc.
 EXCAVATING EQUIPMENT: 6-inch Diameter Core Barrel
 STREET: Roberts St., WB, 4.5' from N edge of pavement

LOCATION: See Figure 25
 DATE COMPLETED: 2/12/21
 LOGGED BY: S. Perdue

DEPTH (feet)	SYMBOL	USDC SOIL CLASS	DESCRIPTION	SAMPLE TYPE SAMPLE NUMBER MOISTURE (%) CONTENTS (%) OTHER TESTS
0	SP		3.5-inches HD Mix Asphalt	
0.5	SM		2 lifts, 1" x 1.5" Control on high severity alligator cracking. Cracked through full depth of pavement. Lifts are unbound. (HMA)	
1.0	SM		Medium dense, brown, silty SAND with gravel, moist. (ALLIUM)	
1.5	SP		Medium dense to dense, olive gray, poorly graded SAND, moist.

Corehole was terminated at 2.25-feet below ground surface.
 No groundwater seepage was observed during the exploration.

EXCAVATION COMPANY: HVA Geosciences Inc.
 EXCAVATING EQUIPMENT: 6-inch Diameter Core Barrel
 STREET: Monroe St., SB, 10.5' from curb

LOCATION: See Figure 27
 DATE COMPLETED: 2/12/21
 LOGGED BY: S. Perdue

DEPTH (feet)	SYMBOL	USDC SOIL CLASS	DESCRIPTION	SAMPLE TYPE SAMPLE NUMBER MOISTURE (%) CONTENTS (%) OTHER TESTS
0	SP		2.5-inches HD Mix Asphalt	
0.5	SM		2 lifts, 1" x 1.5" Control on high severity alligator cracking. Cracked through full depth of pavement. Lifts are unbound. (HMA)	
1.0	SM		Dense, gray, silty, gravelly SAND, moist. (FLL)	
1.5	SM		Medium dense, brown, silty SAND with scattered organics, moist. (ALLIUM)

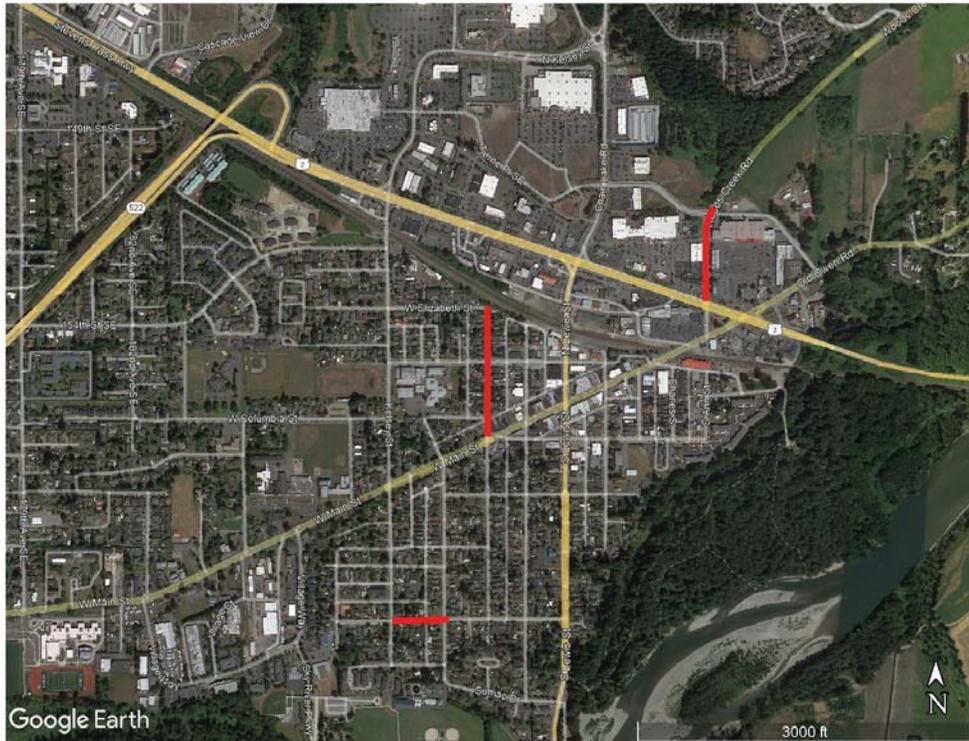
2022 TBD OVERVIEW MAP

34 CURB RAMPS TO UPGRADE

STREET	PAVING AREA (SQURE FEET)	PAVING LENGTH (CENTERLINE MILES)
WOODS CREEK RD OVERLAY	46,620	0.16
MADISON ST COMBINED SEWER SEPERATION	62,337	0.22
POWELL ST RECONSTRUCTION	22,141	0.10
TOTAL	131,098	0.48

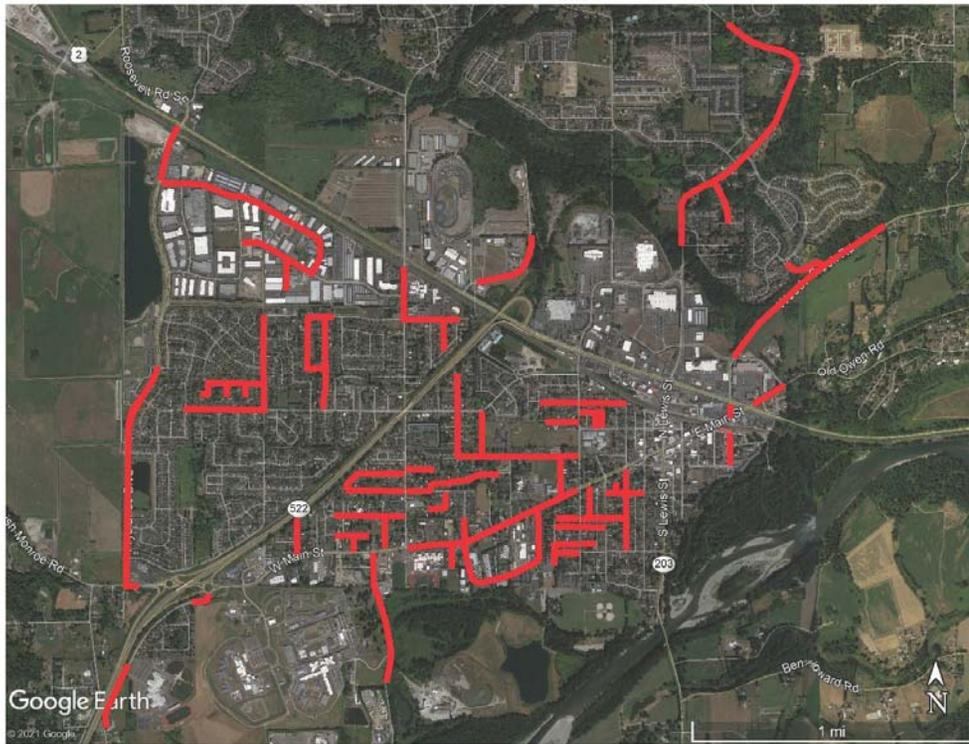
2016 - 2021 TBD OVERVIEW MAP

YEAR	PAVING AREA (SQUARE FEET)	PAVING LENGTH (CENTERLINE MILES)	CURB RAMPS UPGRADED
2016	262,854	1.15	5
2017	442,485	4.39	46
2018	335,533	1.72	44
2019	390,370	2.43	41
2020	409,249	2.49	33
2021	236,051	2.15	30
TOTAL	2,076,542	14.33	199
