Monroe Police Department

Facility Assessment

June 26, 2024

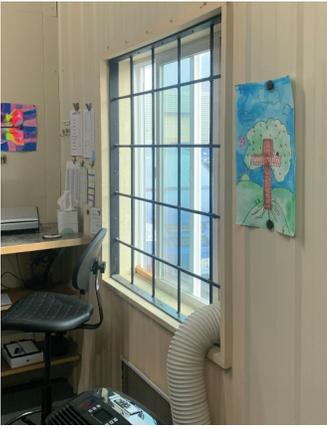
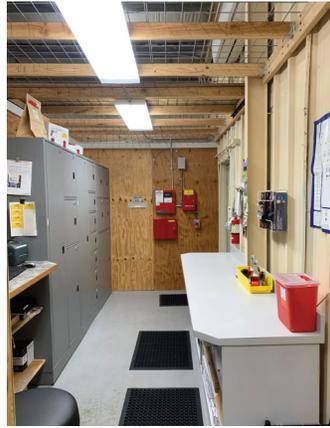
1. EVIDENCE STORAGE

- Security improvements needed at doors and windows.
- Unfinished HVAC venting at storage. Temperature control issues.
- Water damage at evidence storage ceiling. Water infiltration at garage doors. Rusting at exterior finishes.
- Stairs to mezzanine not ADA compliant.

- Temperature control issues are prevalent throughout this space due to failing insulation and air | water infiltration from overhead doors and rodent damage. Evidence area lacks running water needed for hygiene and safety purposes when handling incoming evidence. Drying racks and biohazard storage require power.
- Stairs to storage loft are not in code compliance. This loft is undersized and cannot accommodate for future growth, materials in this area need to be stored for 99 years. Booking and storage buildings are exposed plywood, roof structure is exposed.

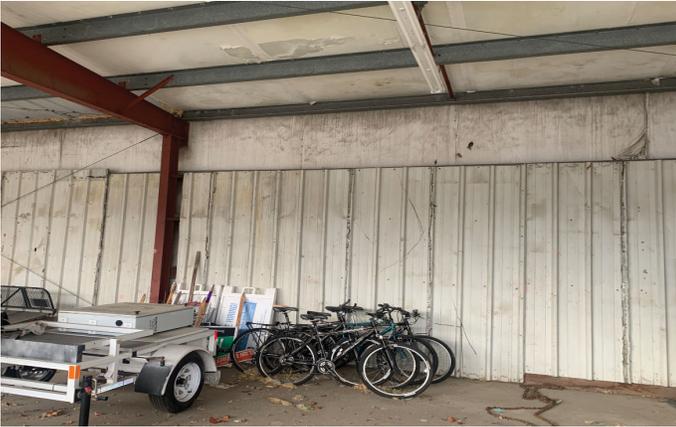
2. GARAGE AND MAT ROOM

- Damage to insulation and all exposed finishes due to weather exposure, deposits from birds and rodents. Space is non-conditioned and open to exterior elements.
- Limited gym space, officers use facilities at nearby fire station. Existing MAT Room lacks storage space and proper clearances for utilities.

- No doors at garage leaving space completely open to the elements. Damage to insulation and all exposed finishes due to weather exposure, deposits from birds and rodents and gunfire. This space is used for storage for ATVs, bicycles and motorcycles in addition to materials for target practice. Water infiltration occurs at garage door opening.

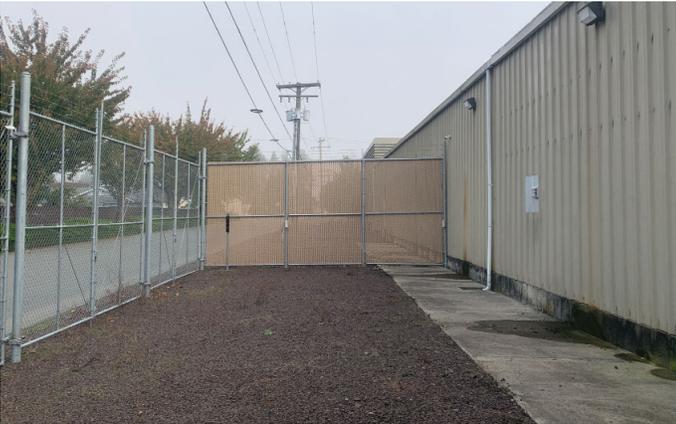
3. SECURE PARKING AND IMPOUND LOT

- Impound has more vehicle spaces than needed and lacks overhead rain protection. Water pools from adjacent building to concrete pad.
- Tow trucks bringing impounded vehicles to the police station block the emergency access drive meant for police and fire vehicles.

- Gutters from the surrounding evidence room drain off the stem wall into this lot and pool at the concrete pad leaving rust and algae deposits.

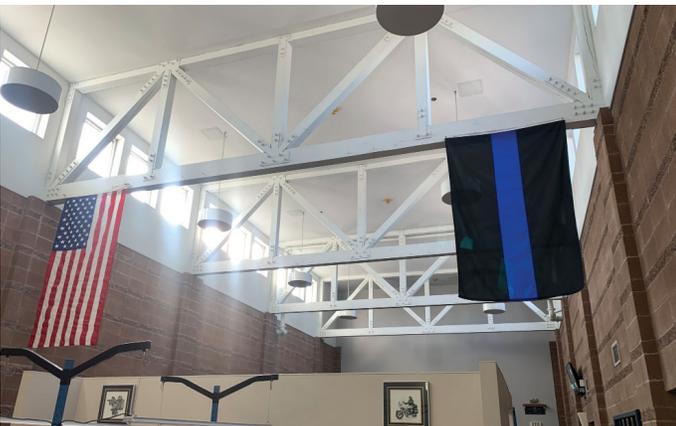
4. OFFICE AREAS

- Clerestory windows cause harsh glares on computer screens at open office area. Temperature control and lighting are issues for occupants.
- The open briefing area is sized insufficiently and lacks privacy.
- Windows at Chief and Deputy offices are adjacent to public space and have no ballistics protection. Chief's office has multiple doors and acts as a pass-through for other offices.

- Noise transfer issues throughout open offices and adjacent areas, mainly the interview room and conference room.
- Lack of privacy both visual and audio for confidential information due to open office layout and public circulation. Windows from enclosed office spaces look into open office area are shielded by blinds for privacy.
- Clerestory windows cause lighting and heat transfer issues. Battery powered shades previously installed are difficult to maintain at the specified height and are no longer operational. Overhead task lighting used to compensate for lighting inefficiencies.
- Steel gate installed near copy area is not in use. Copy area does not have secured file storage for confidential documents.

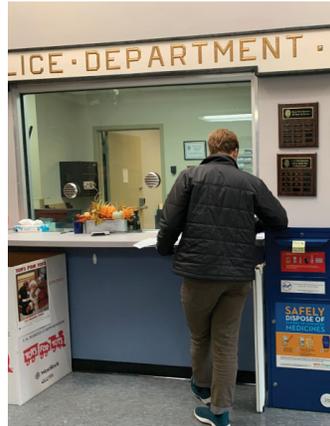
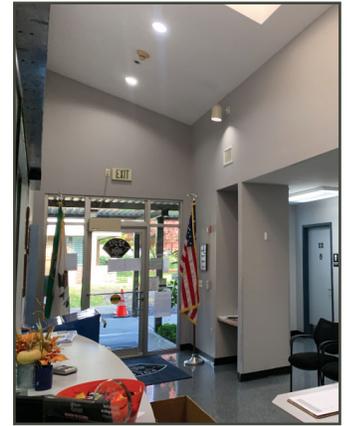
5. LOBBY | LOCKERS AND RESTROOMS

- Countertops and work stations in lobby not ADA compliant. Lack of adequate turning radius in lobby at sign-in vestibule.
- Existing showers are not ADA compliant. Non-used shower stalls are utilized for storage.
- The facility lacks an emergency vestibule for crisis situations.

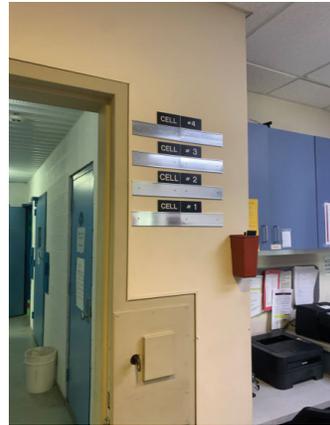
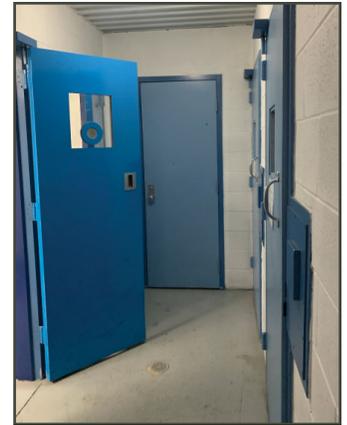
6. INTAKE AND HOLDING

- Inactive holding cells are utilized for storage.
- City employees and detainees use same fingerprint equipment in intake area within the secured space.
- Weapon maintenance is accessed off of the intake room.

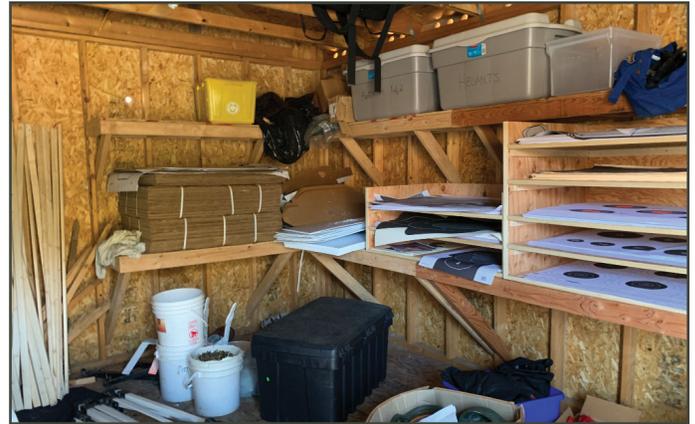
8. GENERAL DEFICIENCIES

- Numerous acoustical ceiling tiles are missing | damaged throughout the facility. Multiple locations of worn or missing carpet tile throughout the facility.
- Lack of privacy both visual and audio for confidential information due to open office layout, lack of public spaces and public circulation.
- Insufficient spacing for on-duty cars and emergency response egress.

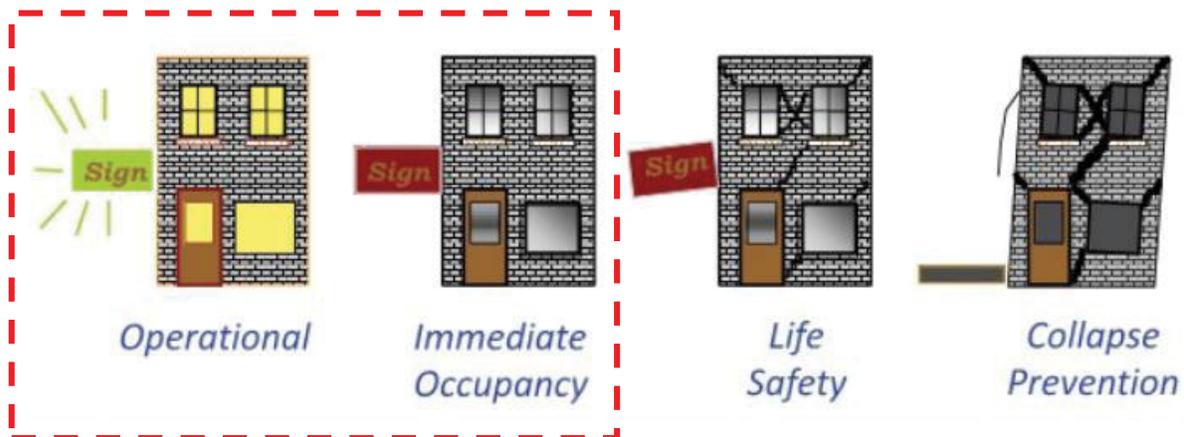
Figure 1: Building Performance Levels

Within ASCE 41-17, there are four Building Performance Levels: Collapse Prevention (CP), Life Safety (LS), Immediate Occupancy (IO), and Operational. Most buildings are categorized as and designed for LS Performance Levels. The LS performance level is meant to ensure the safety of building occupants; however, buildings with this performance level will likely experience significant damage that may or may not be repaired or occupied after the earthquake. For critical facilities that need to retain full function immediately post-earthquake to provide emergency response to the community, such as a police station, the building is evaluated to the higher standard of Operational. It should be noted that for structural evaluation, the Operational and Immediate Occupancy criteria are the same. The difference in the two levels is that the support systems and equipment are operational; see Figure 1. Figure 2 includes a summary of each performance level and the anticipated damage for a building designed to each performance level.

For our evaluation, we have used the Basic Performance Objective for Existing Buildings (BPOE) for Risk Category IV structures. For this performance objective, the building is evaluated to the Life Safety (LS) structural performance level for the BSE-2E seismic hazard and to the Immediate Occupancy (IO) structural performance level for the BSE-1E seismic hazard.
