# Monroe 30

## *Preliminary Drainage Report*

June 2025

Job No: 24-0072

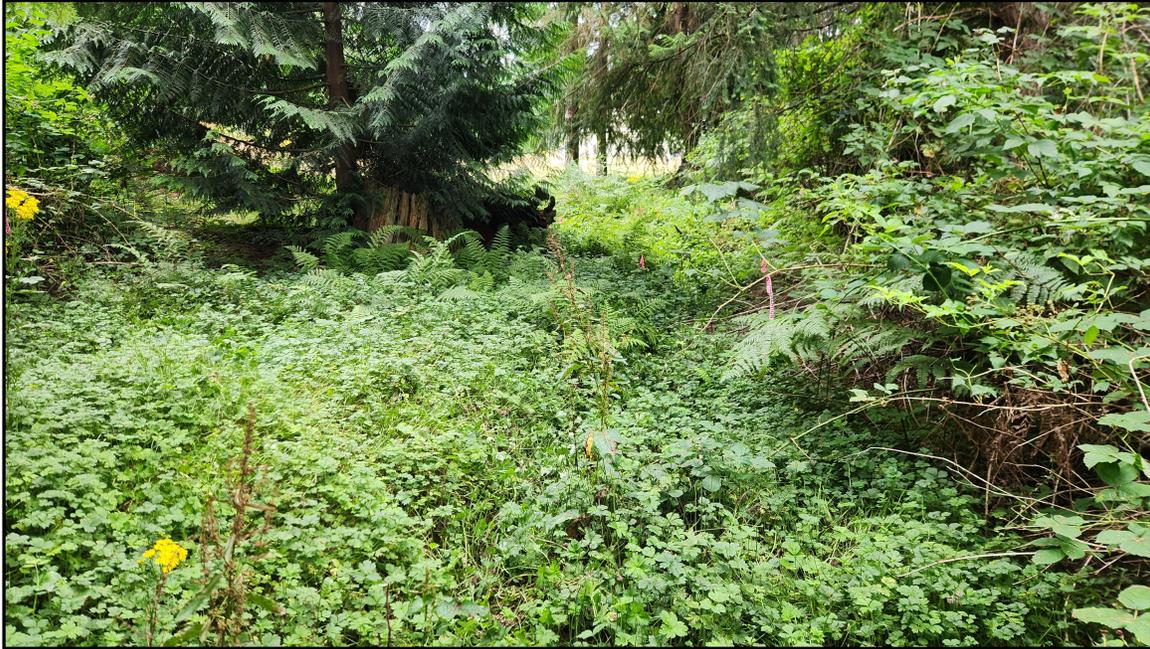
**Figure 2** - Looking east through Wetland A.

Wetland A is a small wetland associated with Stream A located in the western portion of the site, entirely within parcel 01038000099900. The outer edge of the wetland is forested with a dense, shrubby understory. The interior of the wetland is dominated by emergent plants. Species observed within Wetland A include western red cedar (*Thuja plicata*; FAC), Himalayan blackberry (*Rubus armeniacus*; FAC), salmonberry (*Rubus spectabilis*; FAC), vine maple (*Acer circinatum*; FAC), youth-on-age (*Tolmiea menziesii*; FAC), and creeping buttercup (*Ranunculus repens*; FAC). Dominant vegetation within Wetland A is rated as facultative (FAC) and therefore the plant community within the wetland is considered hydrophytic.

The top four inches of soil within Wetland A is typically very dark grayish brown (10YR 3/2) sandy loam. Between four and sixteen inches below the soil surface, soils are generally very dark brown (10YR 2/2) sandy loam with dark yellowish brown (10YR 3/6) redoximorphic concentrations present in the matrix. These soils meet the criteria for the hydric soil indicator Redox Dark Surface (F6). Soils within Wetland A were dry at the time of the August 2023 site investigation; however, conditions meeting the criteria for the secondary hydrologic indicators Drainage Patterns (B10) and Geomorphic Position (D2) were observed.

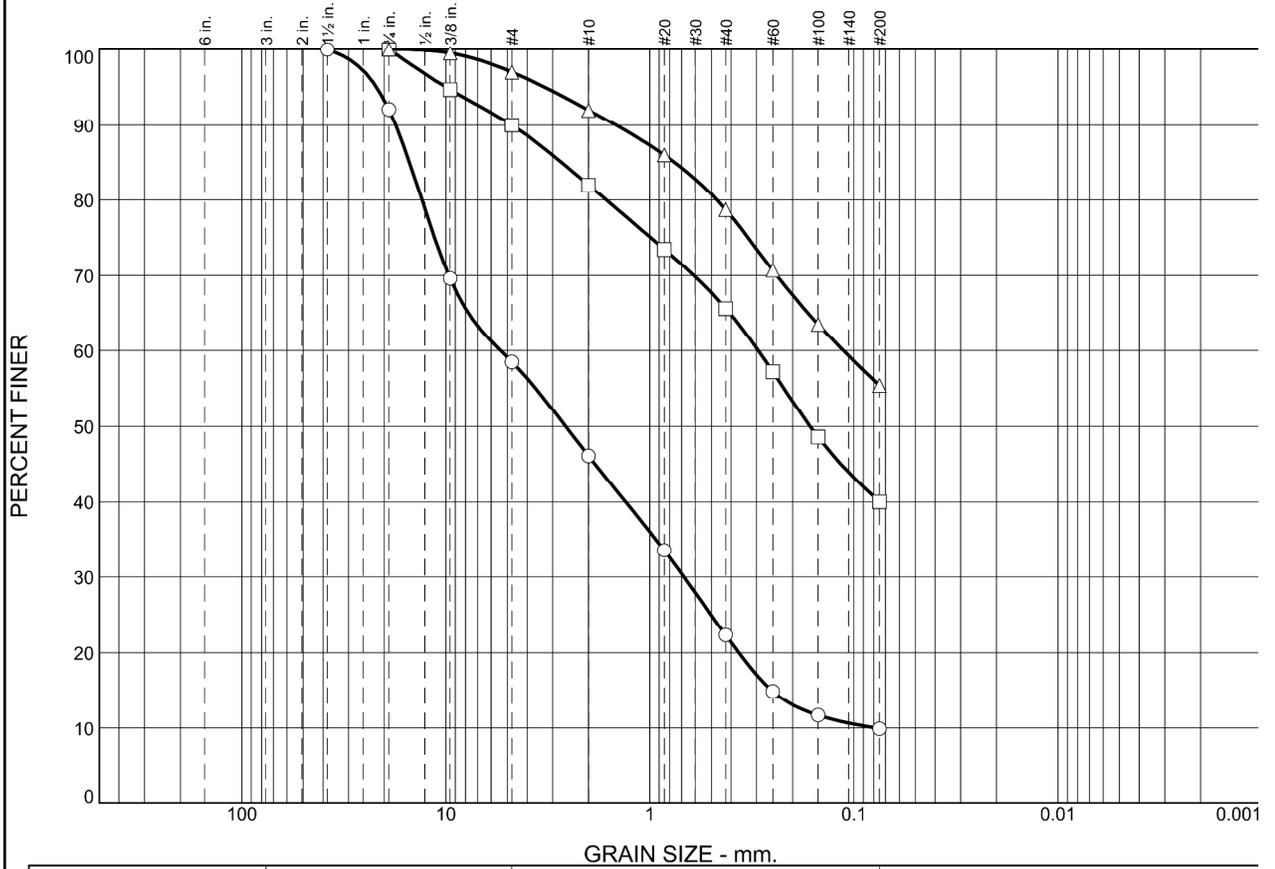
# Particle Size Distribution Report

% +3"	% Gravel		% Sand			% Fines			
		Coarse	Fine	Coarse	Medium	Fine	Silt	Clay		
○	0.0	7.9	33.6	12.4	23.8	12.4		9.9		
□	0.0	0.0	10.0	8.0	16.4	25.6		40.0		
△	0.0	0.0	3.0	5.0	13.3	23.3		55.4		
⊗	LL	PL	D85	D60	D50	D30	D15	D10	C <sub>c</sub>	C <sub>u</sub>
○			15.0791	5.4020	2.5891	0.6816	0.2525	0.0788	1.09	68.59
□			2.7079	0.2949	0.1641					
△			0.7563	0.1127

Material Description	USCS	AASHTO
○ Silty SAND with gravel	SM	
□ Silty SAND with gravel	SM	
△ Sandy SILT	ML

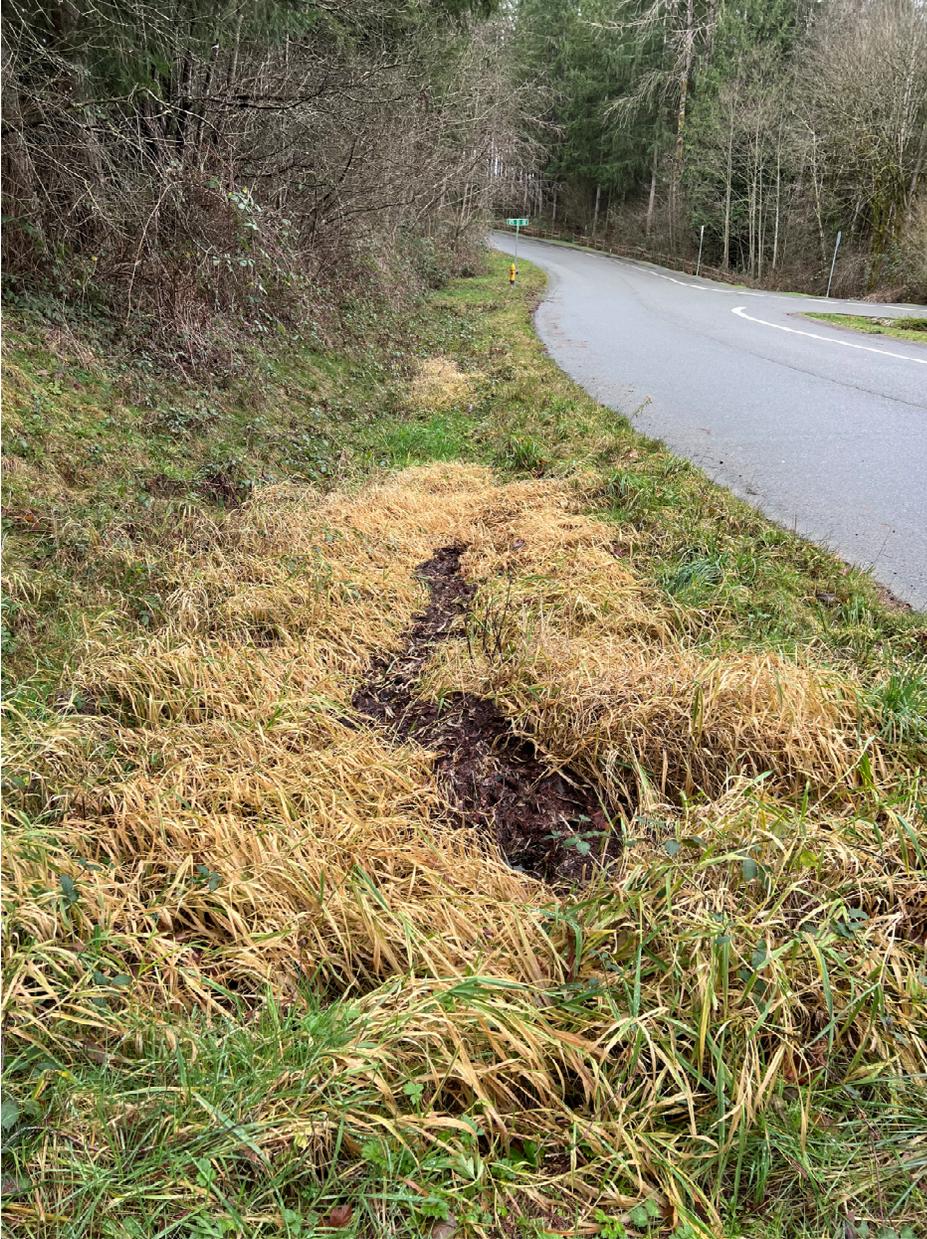
**Image 1: Flow path 1 travels into existing stormwater structure and then travels south down 175<sup>th</sup> Ave SE**

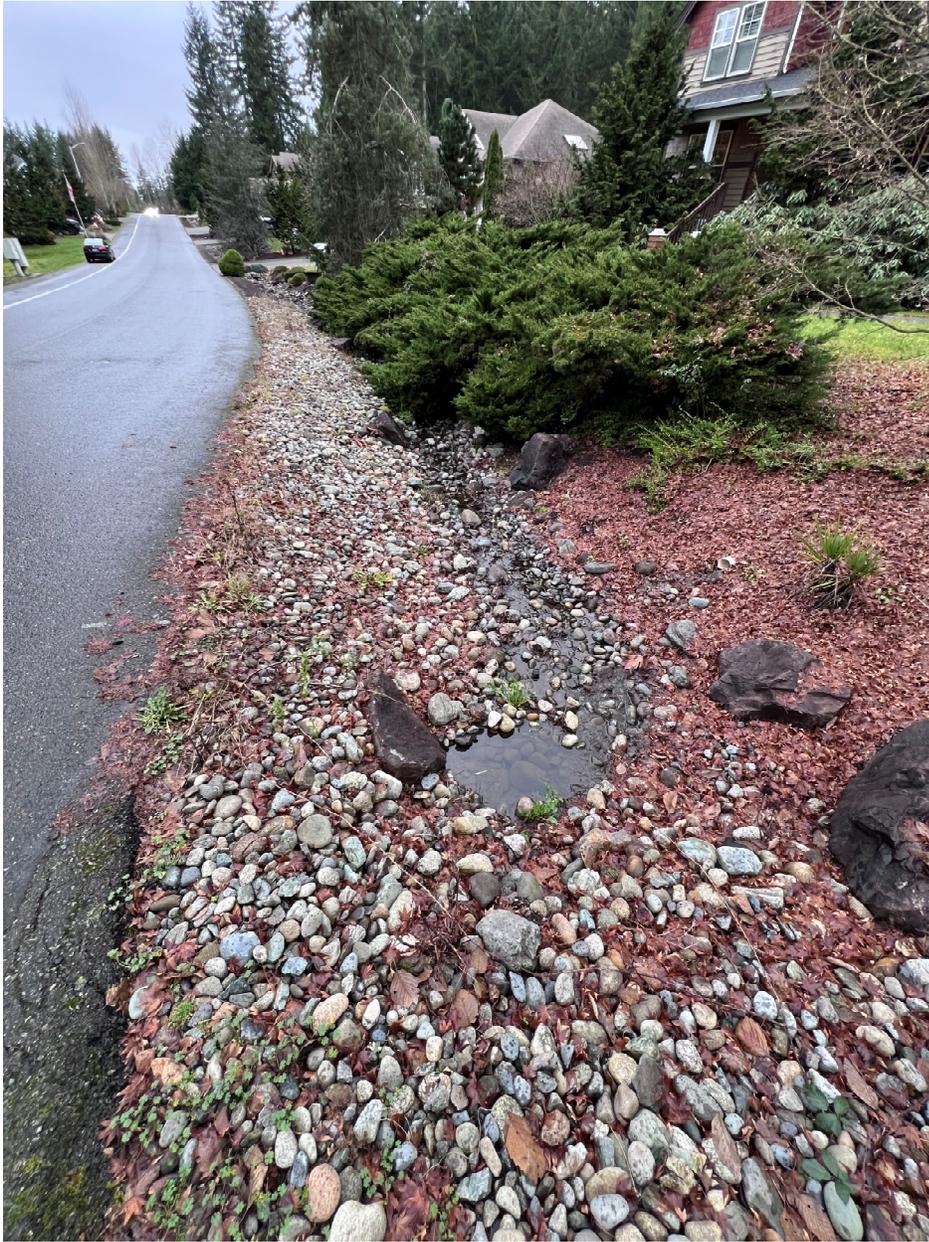
**Image 2: Flow path 1 travels west in existing stormwater structure**

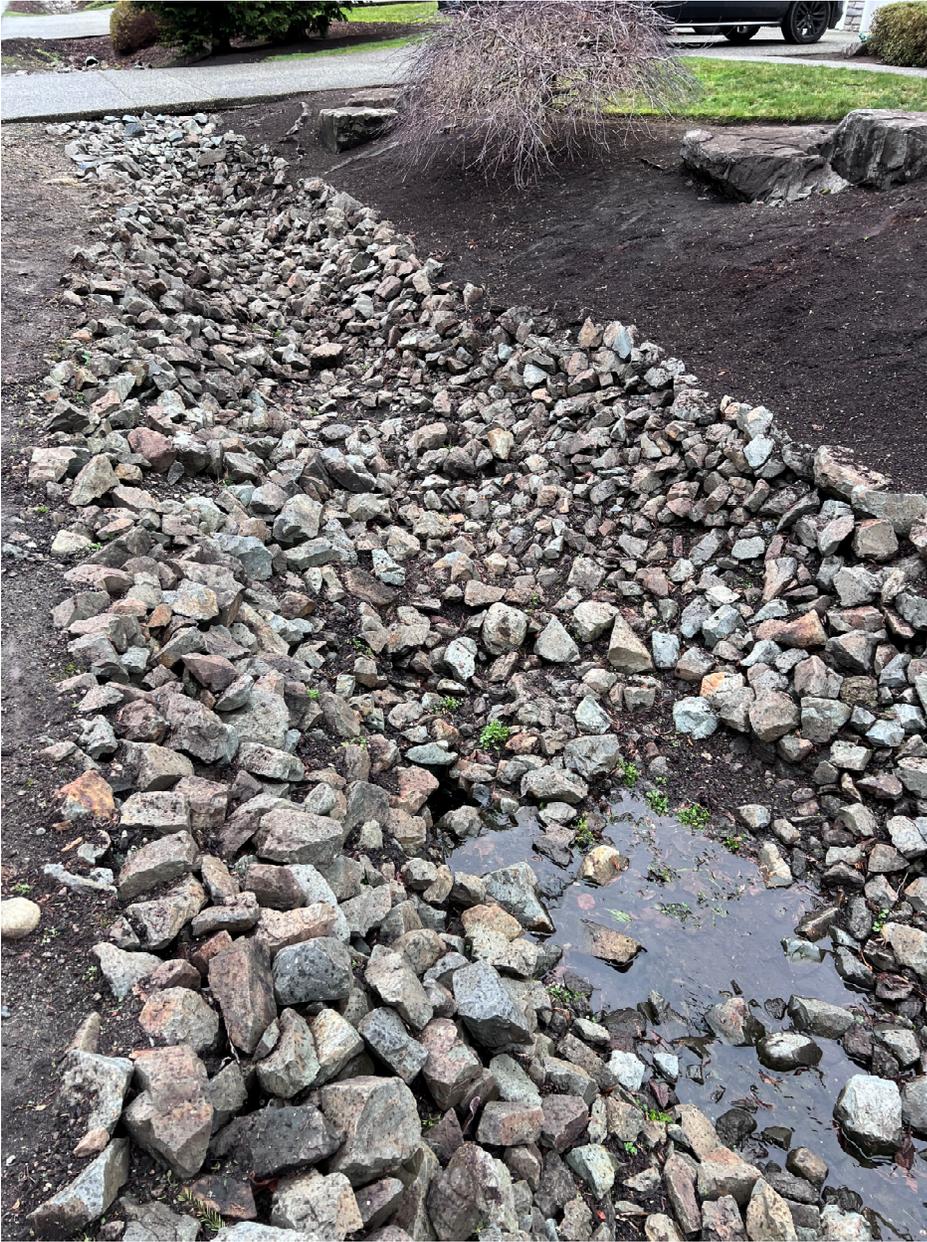
**Image 3: Water then turns south under 125<sup>th</sup> St SE and outfalls into drainage stream**

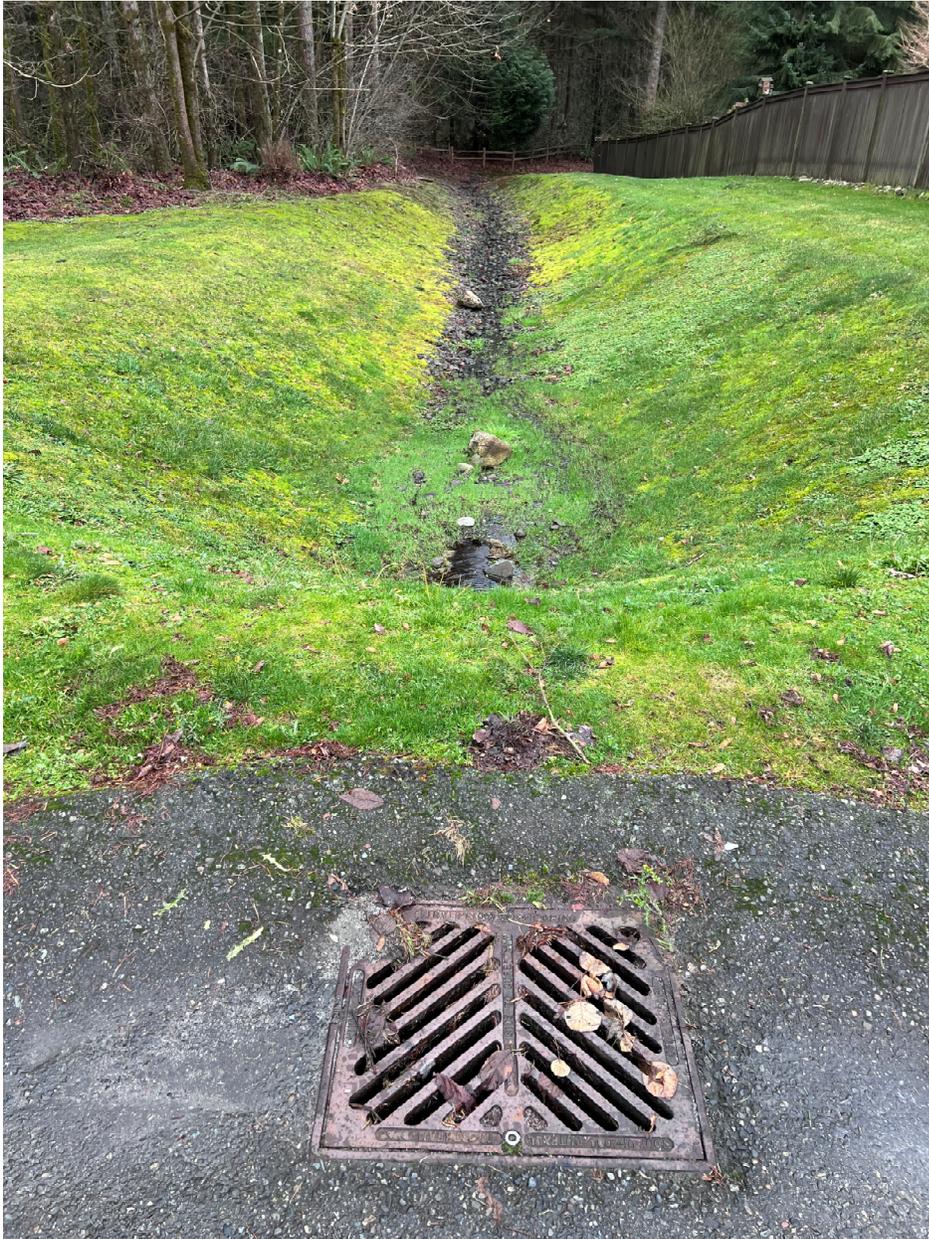
**Image 4: Existing drainage stream**

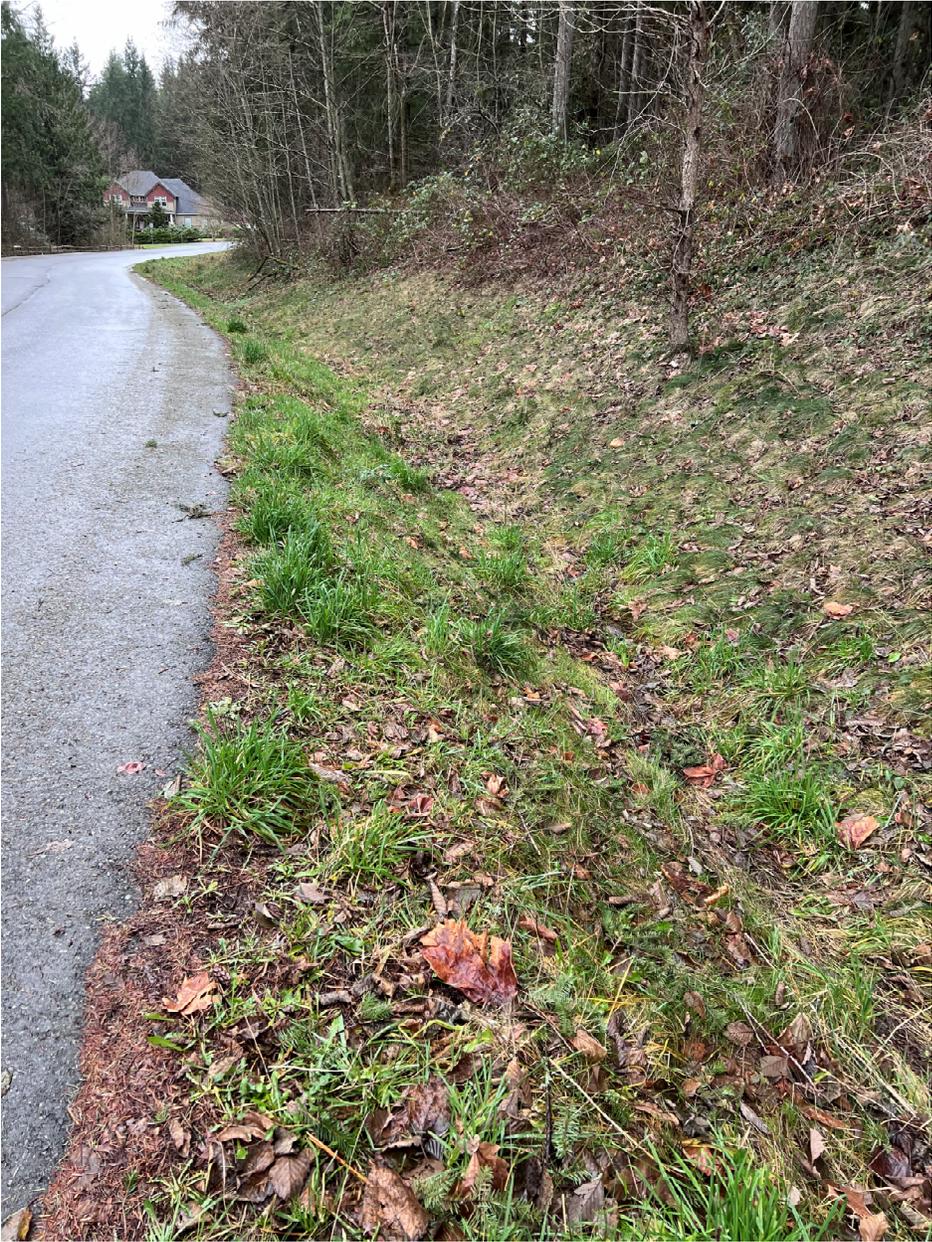
**Image 5: Flow path 2 will discharge into the existing drainage system that travels north on 175th**

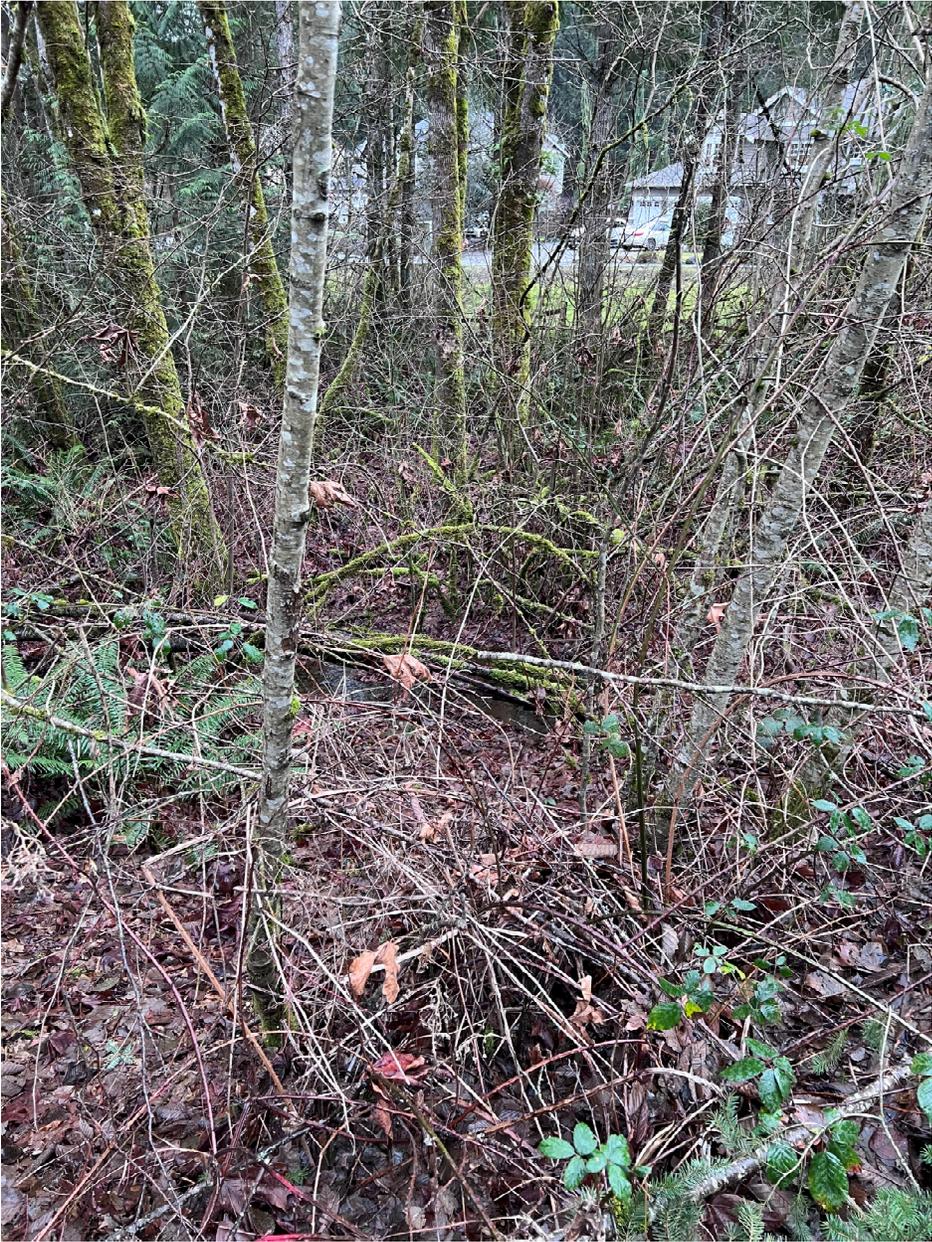
Image 6: Water outfalls in wetlands

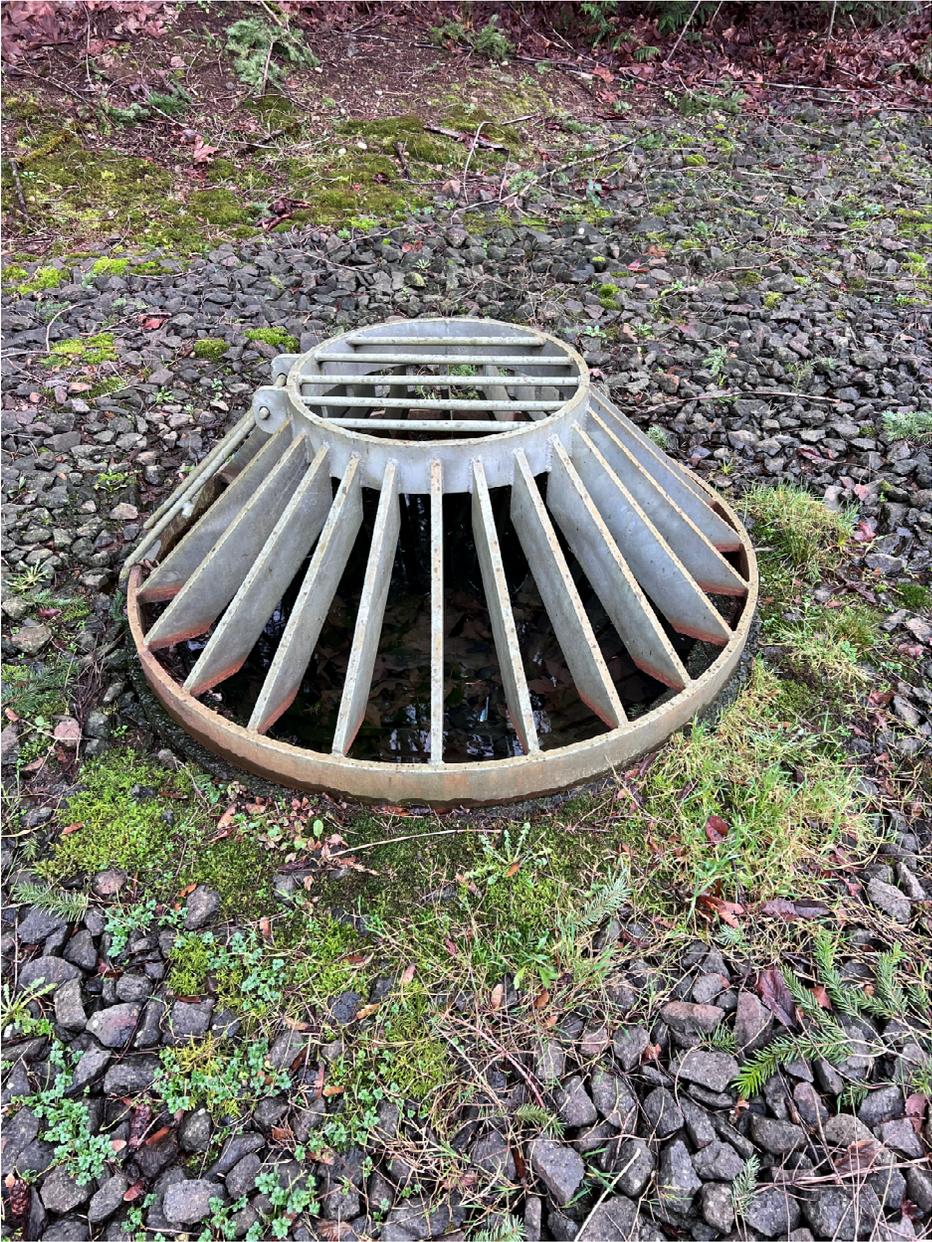
**Image 7: bubbler outfalls into existing drainage ditch where flow paths converge**

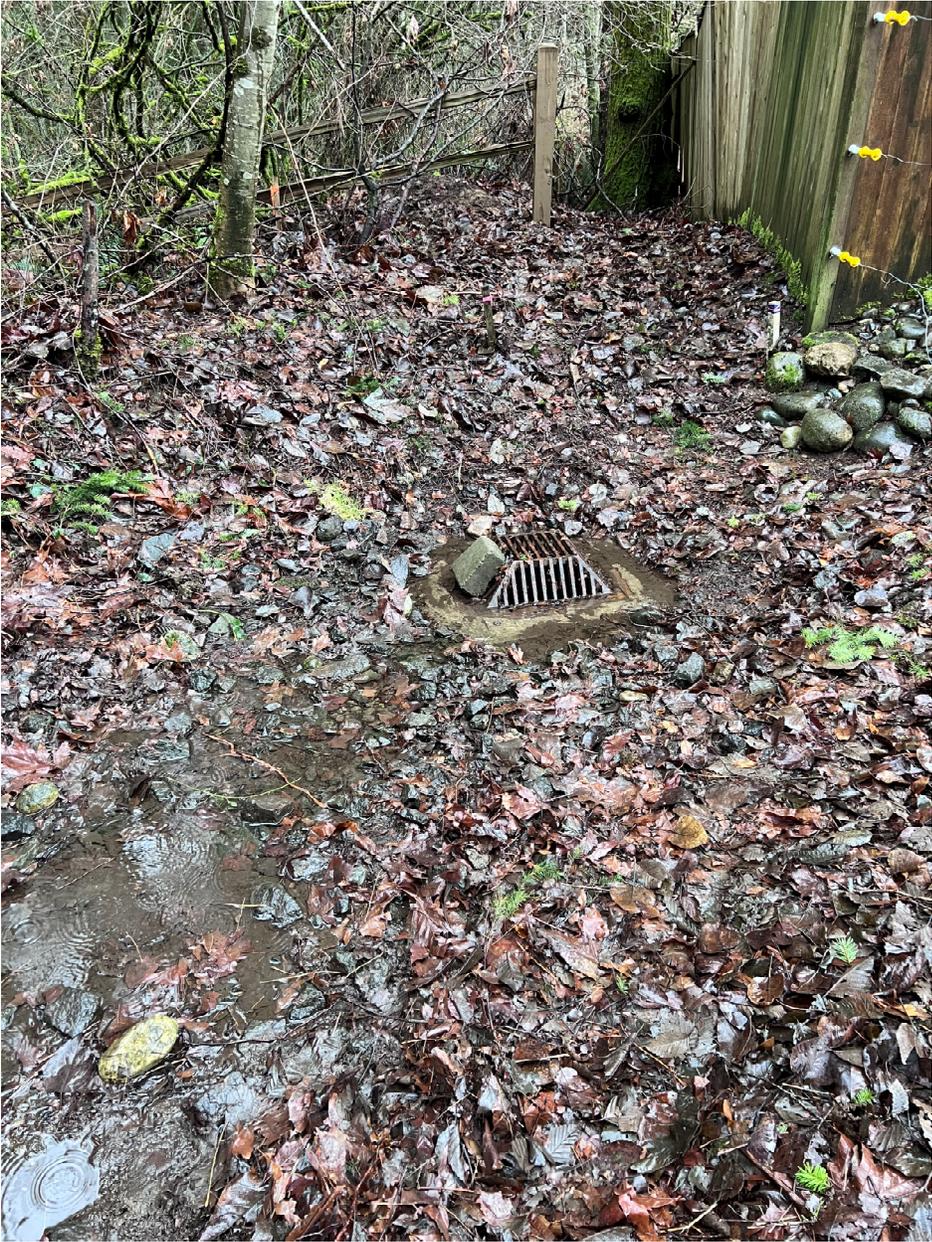
Image 8: Wetland drainage trench funnels into catch basin here

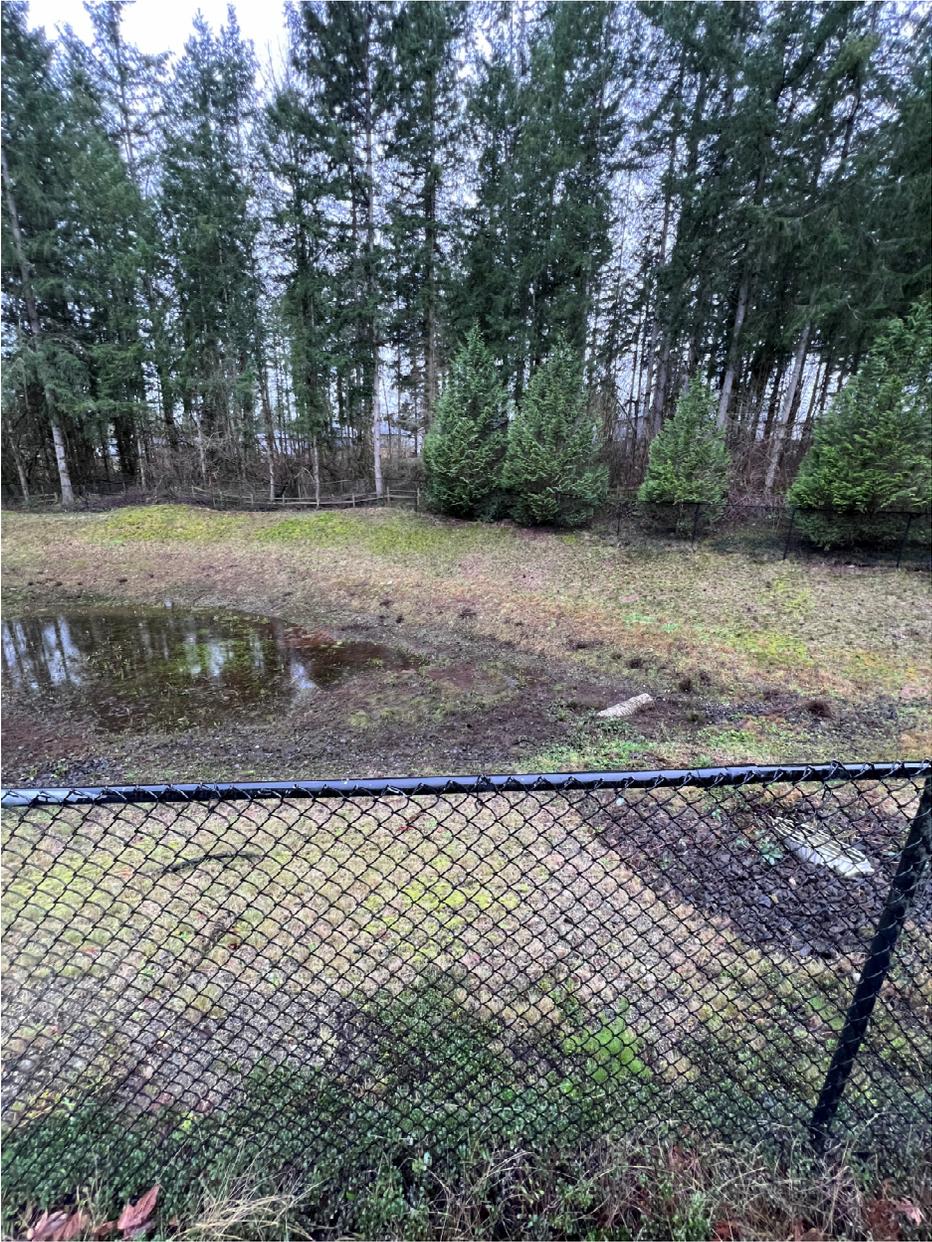
Image 9: water flows to detention pond and outfalls south

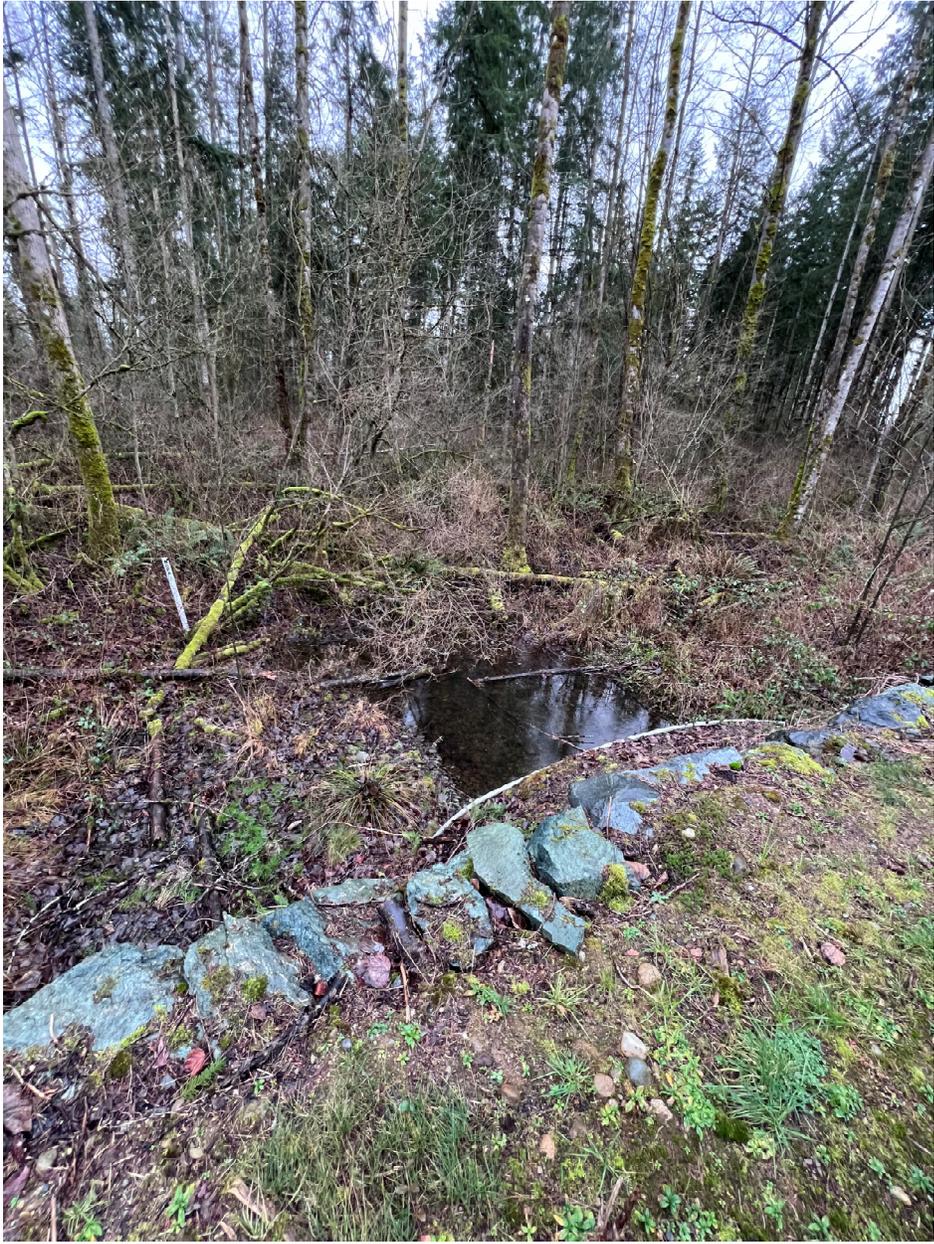
**Image 10: Water outfalls south across 129<sup>th</sup> St SE past the ¼ mile boundary**

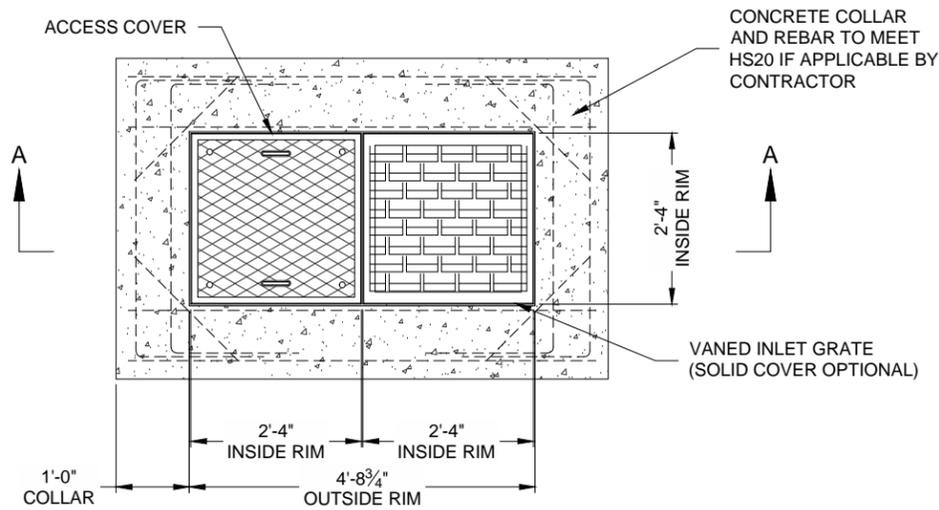
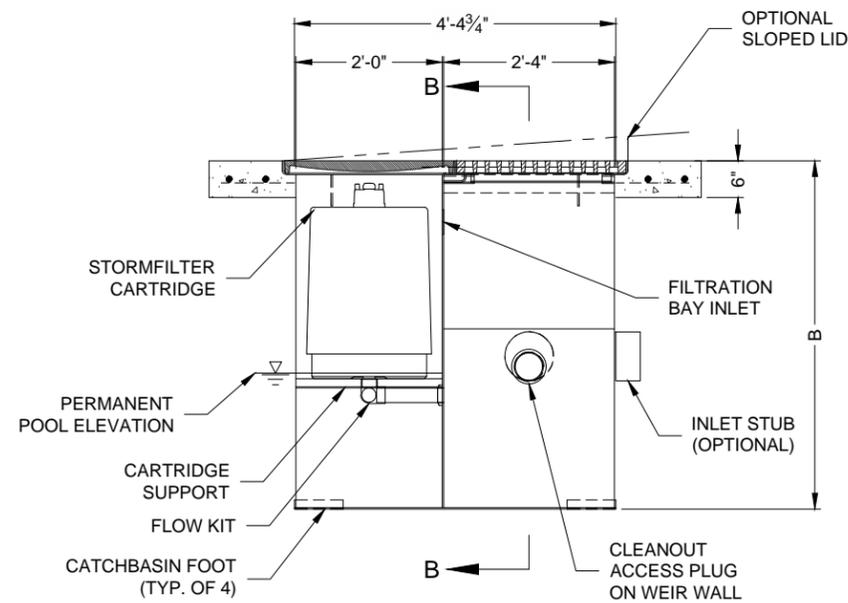
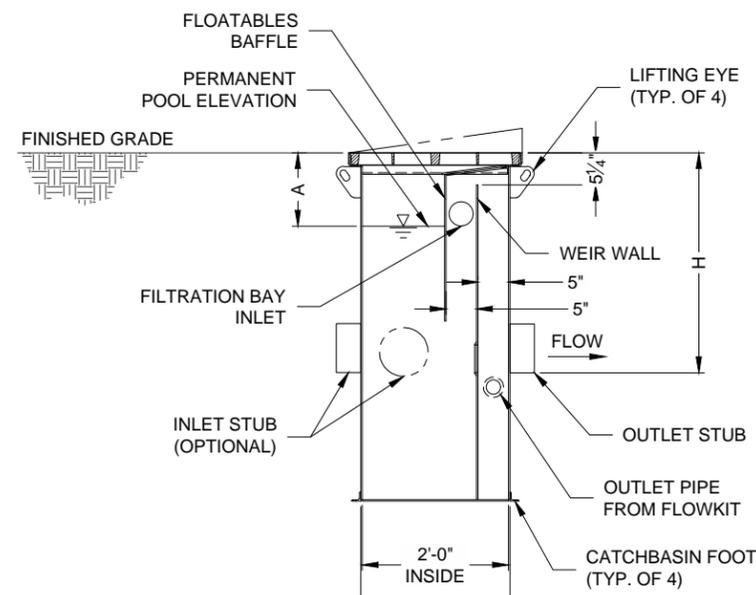
### 1-CARTRIDGE CATCHBASIN STORMFILTER DATA

**PLAN VIEW**

**SECTION A-A**

**SECTION B-B**

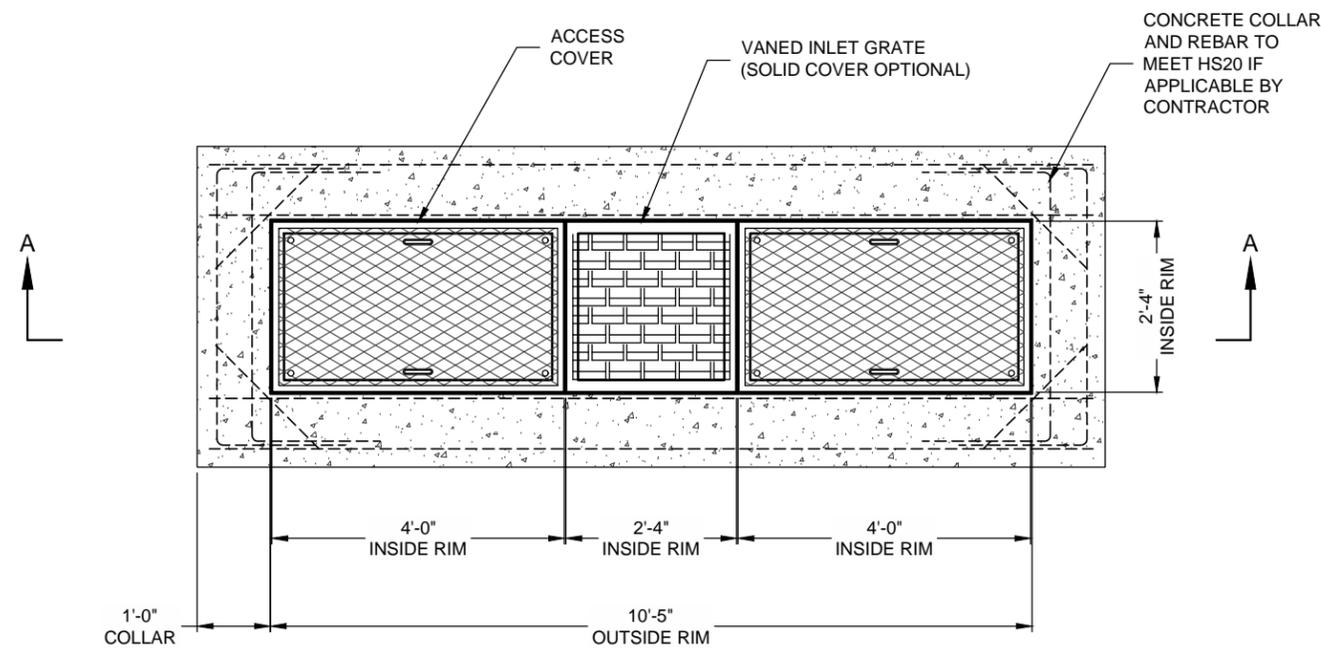
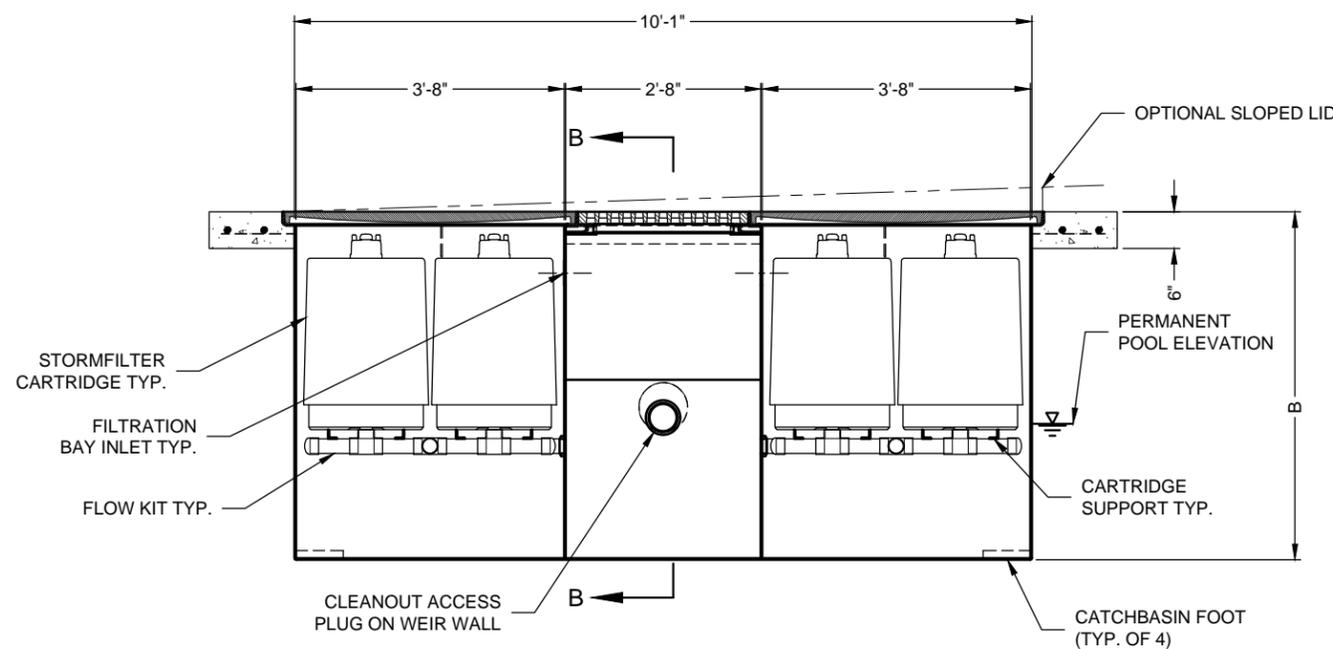
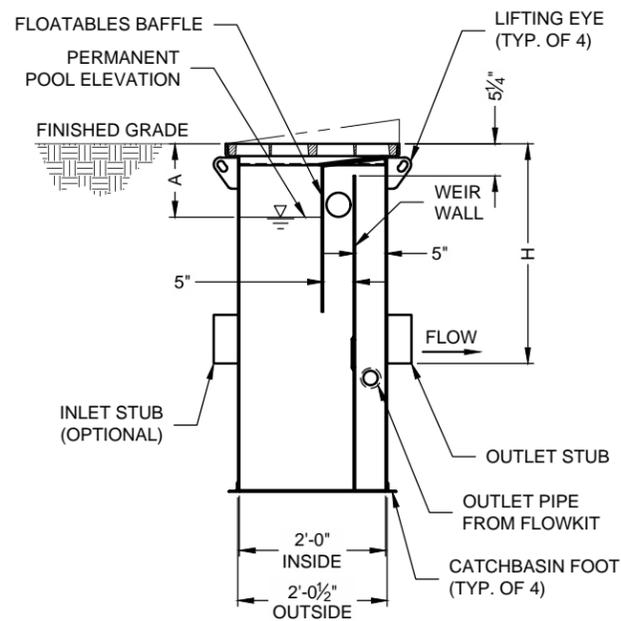
**4-CARTRIDGE CATCHBASIN  
STORMFILTER DATA**

**PLAN VIEW**  
27" CARTRIDGES

**SECTION A-A**

STORMFILTER STEEL CATCHBASIN DESIGN NOTES									
STORMFILTER TREATMENT CAPACITY IS A FUNCTION OF THE CARTRIDGE SELECTION AND THE NUMBER OF CARTRIDGES. 4 CARTRIDGE CATCHBASIN HAS A MAXIMUM OF FOUR CARTRIDGES. SYSTEM IS SHOWN WITH A 27" CARTRIDGE, AND IS ALSO AVAILABLE WITH AN 18" CARTRIDGE. STORMFILTER CATCHBASIN CONFIGURATIONS ARE AVAILABLE WITH A DRY INLET BAY FOR VECTOR CONTROL. PEAK HYDRAULIC CAPACITY PER TABLE BELOW. IF THE SITE CONDITIONS EXCEED PEAK HYDRAULIC CAPACITY, AN UPSTREAM BYPASS STRUCTURE IS REQUIRED.									
CARTRIDGE SELECTION									
CARTRIDGE HEIGHT	27"			18"			18" DEEP		
RECOMMENDED HYDRAULIC DROP (H)	3.05'			2.3'			3.3'		
SPECIFIC FLOW RATE (gpm/sf)	2 gpm/sf	1.67* gpm/sf	1 gpm/sf	2 gpm/sf	1.67* gpm/sf	1 gpm/sf	2 gpm/sf	1.67* gpm/sf	1 gpm/sf
CARTRIDGE FLOW RATE (gpm)	22.5	18.79	11.25	15	12.53	7.5	15	12.53	7.5
PEAK HYDRAULIC CAPACITY	1.0			1.0			2.25		
INLET PERMANENT POOL LEVEL (A)	1'-0"			1'-0"			2'-0"

**SECTION C-C**

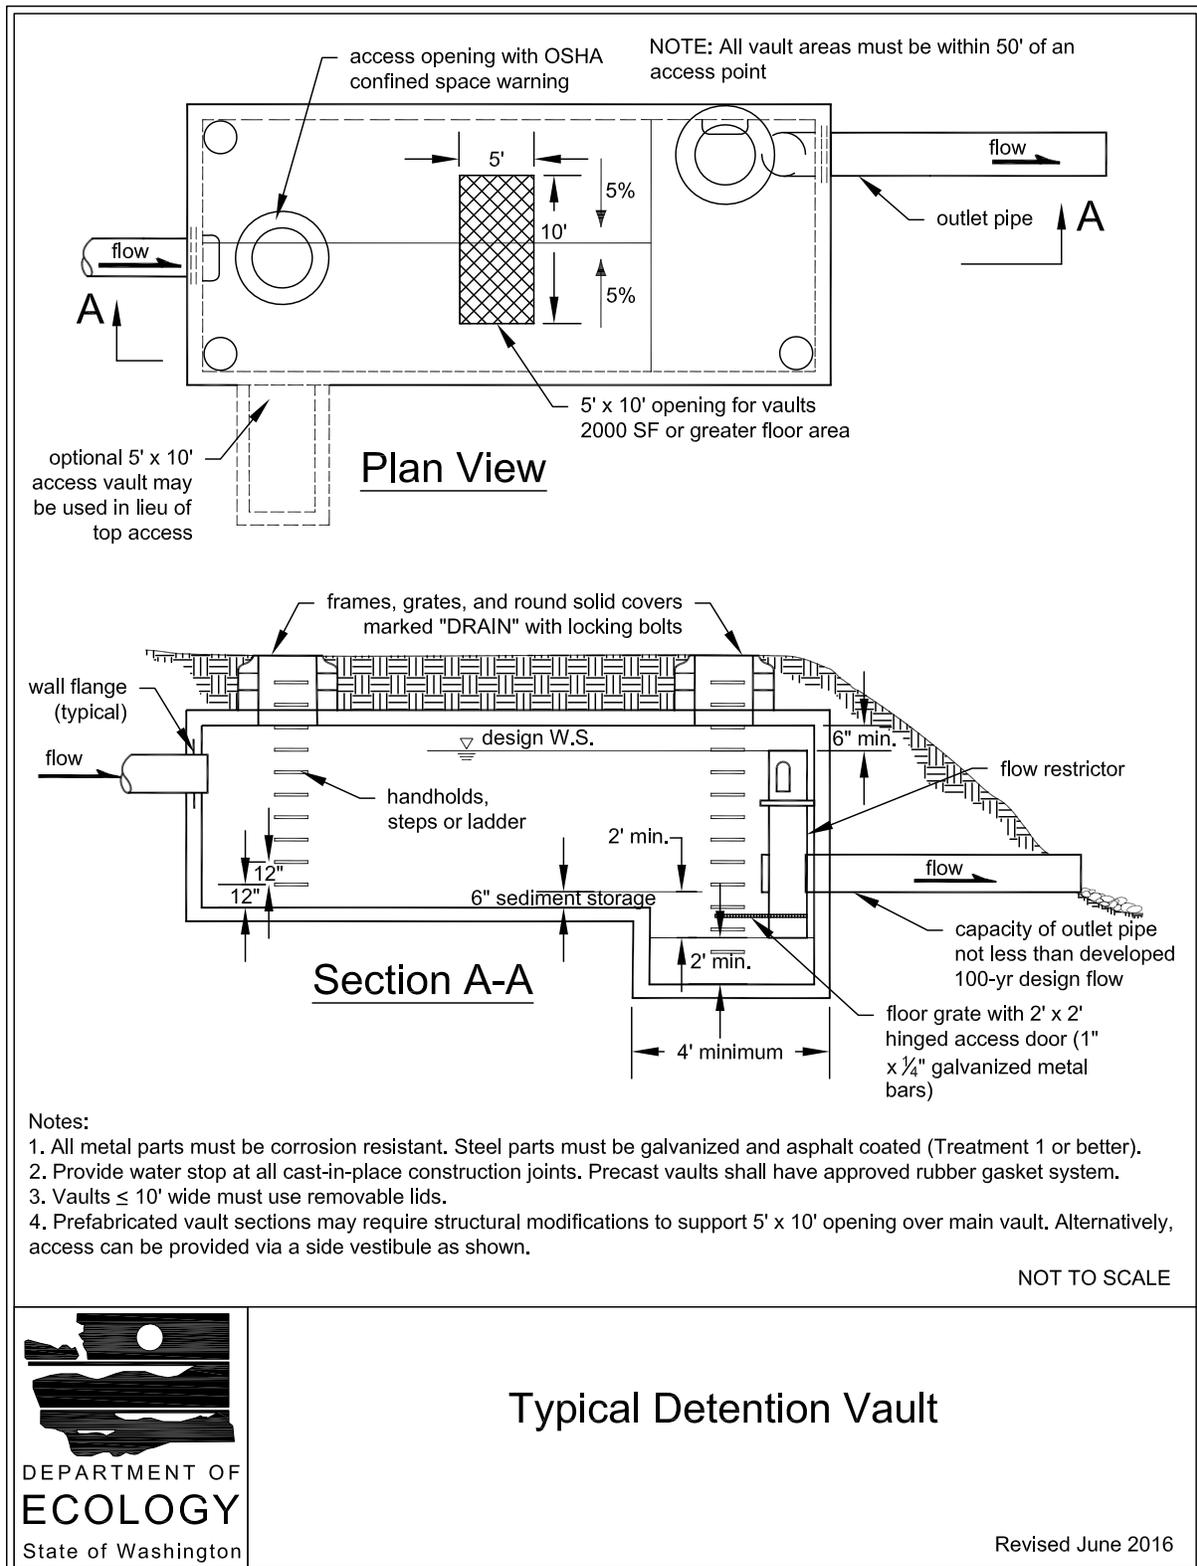
**Figure V-13.16: Typical Detention Vault**

Design volumes and outflows for detention vaults vary, and are typically designed to meet the performance standards as required in [I-3.4.5 MR5: On-Site Stormwater Management](#), [I-3.4.7 MR7: Flow Control](#), and/or [I-3.4.8 MR8: Wetlands Protection](#) and the hydrologic analysis and design methods in [III-2 Modeling Your BMPs](#). Design guidelines for control structures are given in [V-13.2 Control Structure Design](#).
