STORMWATER MANAGEMENT REPORT

MEAN BEAN COFFEE STAND

134 South Ferry Avenue
Monroe, WA 98272

CSP Engineering PFN 24-014
City PFN _____

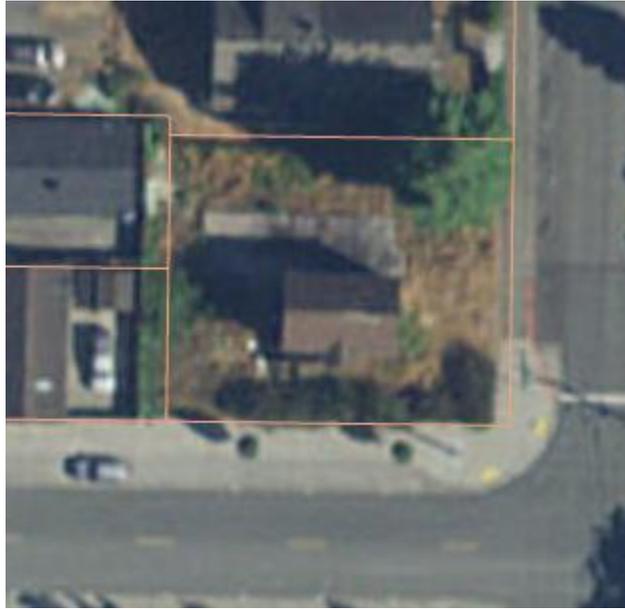
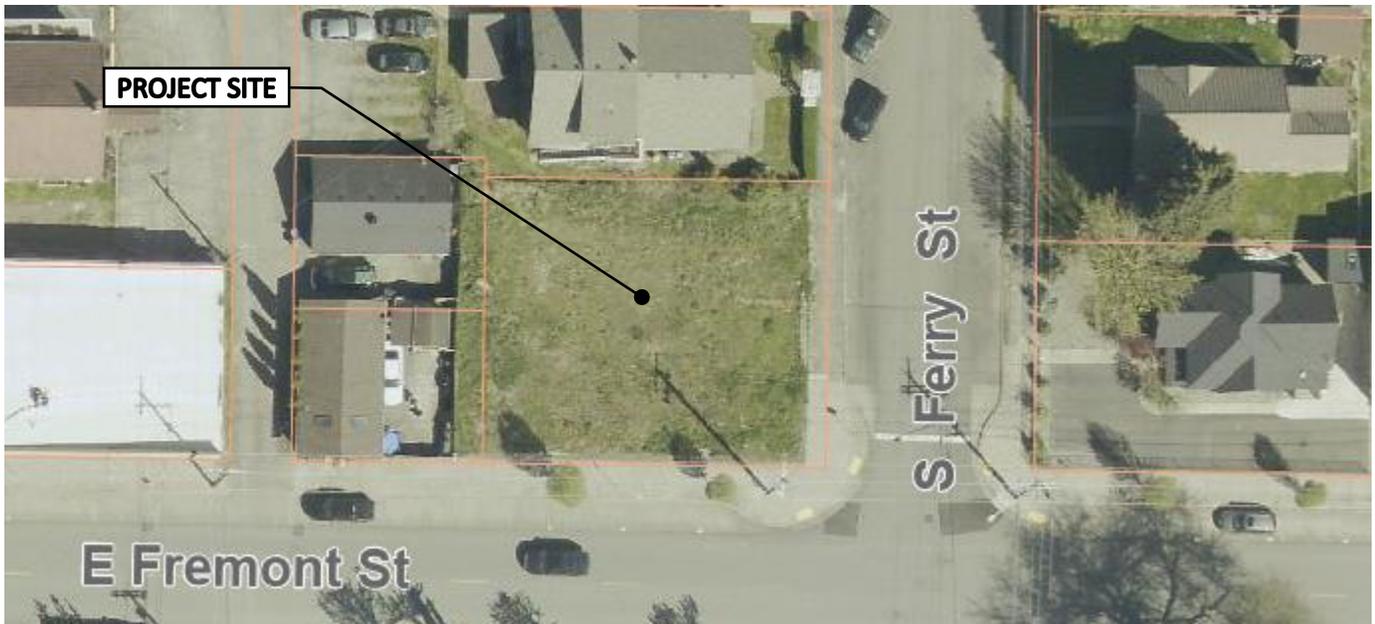
Existing Conditions Maps

The subject Site Parcel is situated on a relatively flat parcel within an urban residential neighborhood and is currently undeveloped. Previous site coverage consisted of a single-family residential home. Current site coverage currently consists of scrub grasses. No stormwater facilities, BMPs, or surface water features are known to exist on the Site. Site topography is flat. Developed parcels exist north and west of the Project Site. The Geotech report identifies 2 to 3 feet of topsoil and old fill materials overlying recessional outwash (gravelly sand and sandy gravel). No ground water was observed to a maximum depth of 9 feet below existing grade.

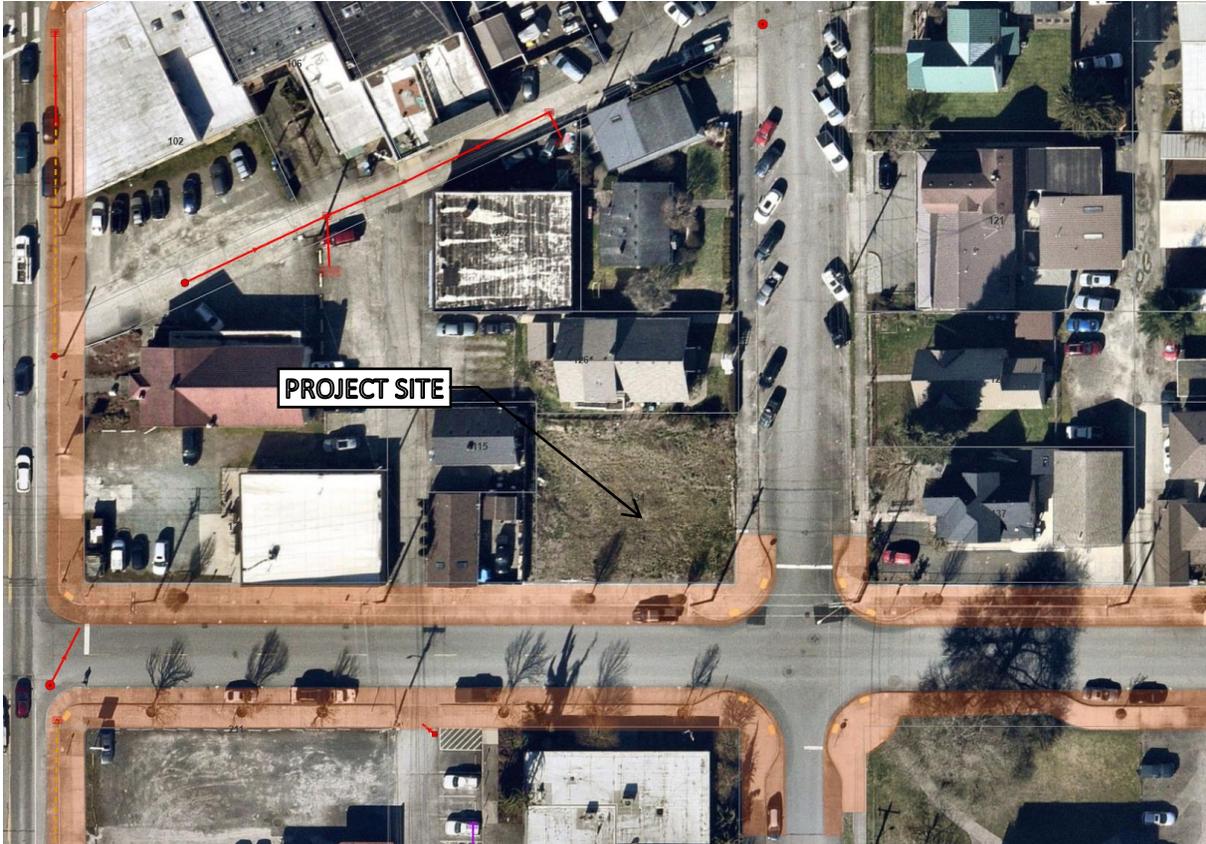
Basin Map

Due to the flat topography and granular soil types on and in the vicinity of the project site no stormwater enters the site parcel and the incorporation of onsite infiltration for proposed impervious surfaces results in no runoff leaving the developed site.

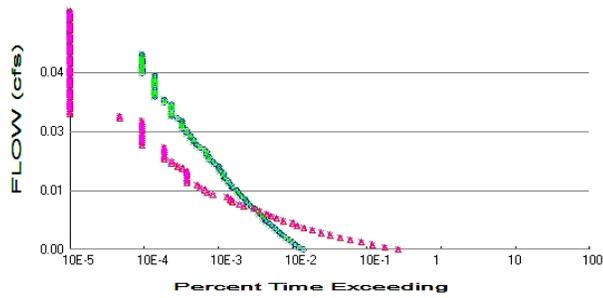
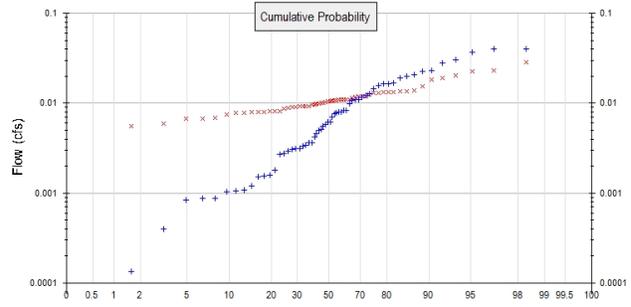
POC 1

+ Predeveloped x Mitigated

The Duration Matching **Failed**

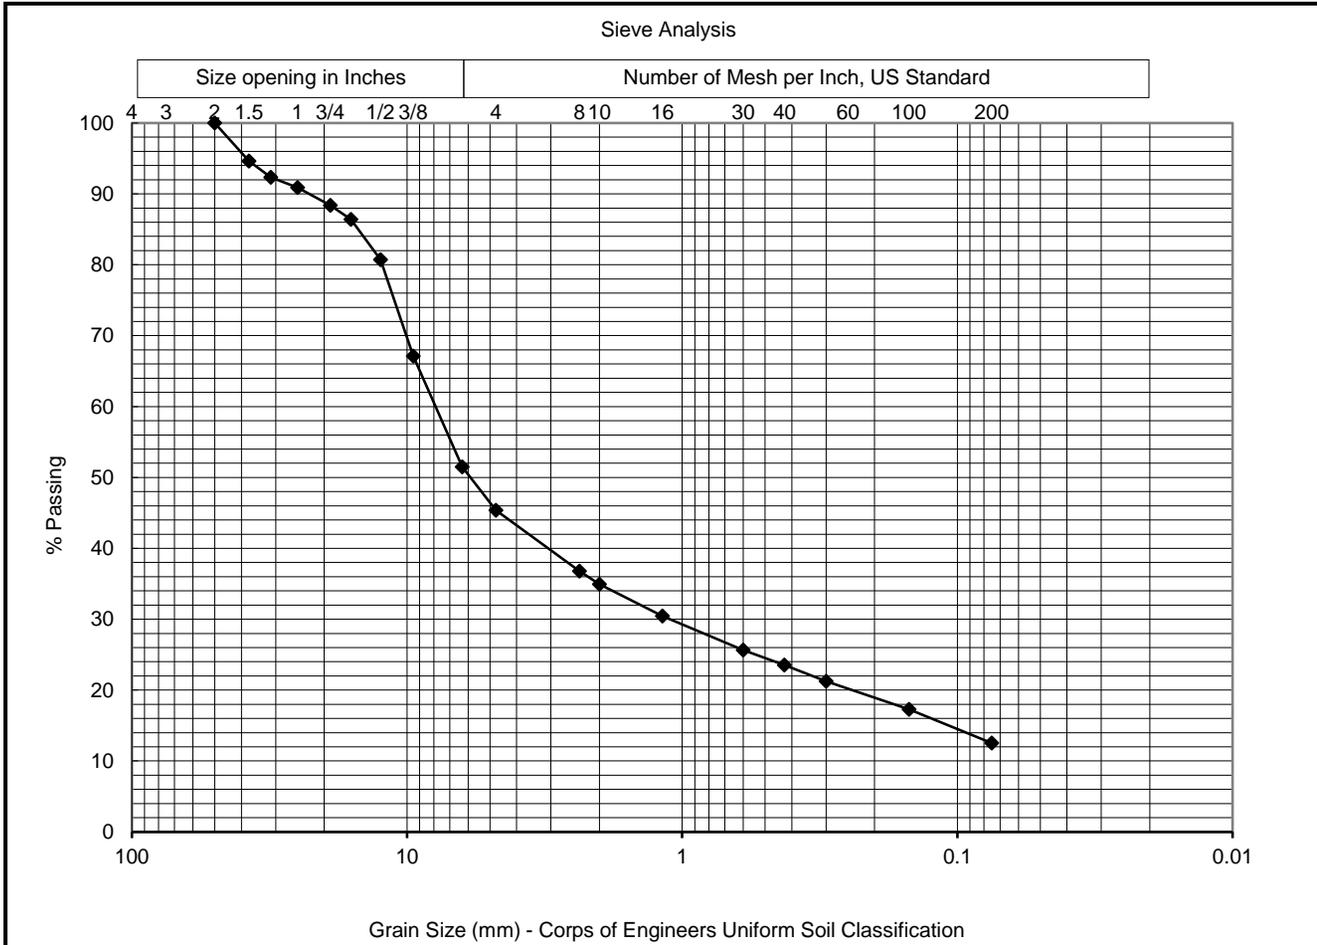
Sieve Analysis			
ASTM C136 / C117			
Sieve Size	% Passing	Specs *	
		min	max
2.00"	100		
1.50"	95		
1.25"	92		
1.0"	91		
3/4"	88		
5/8"	86		
1/2"	81		
3/8"	67		
1/4"	51		
#4	45		
#8	37		
#10	35		
#16	30		
#30	26		
#40	24		
#50	21		
#100	17		
#200	12.5

Material: Reddish brown silty gravel with sand
 Source: EP-1 @ 1.5' - fill
 Project: Monroe Coffee Stand
 Project #: M7251140 (25-001)
 Date Rec'd: 2/20/2025

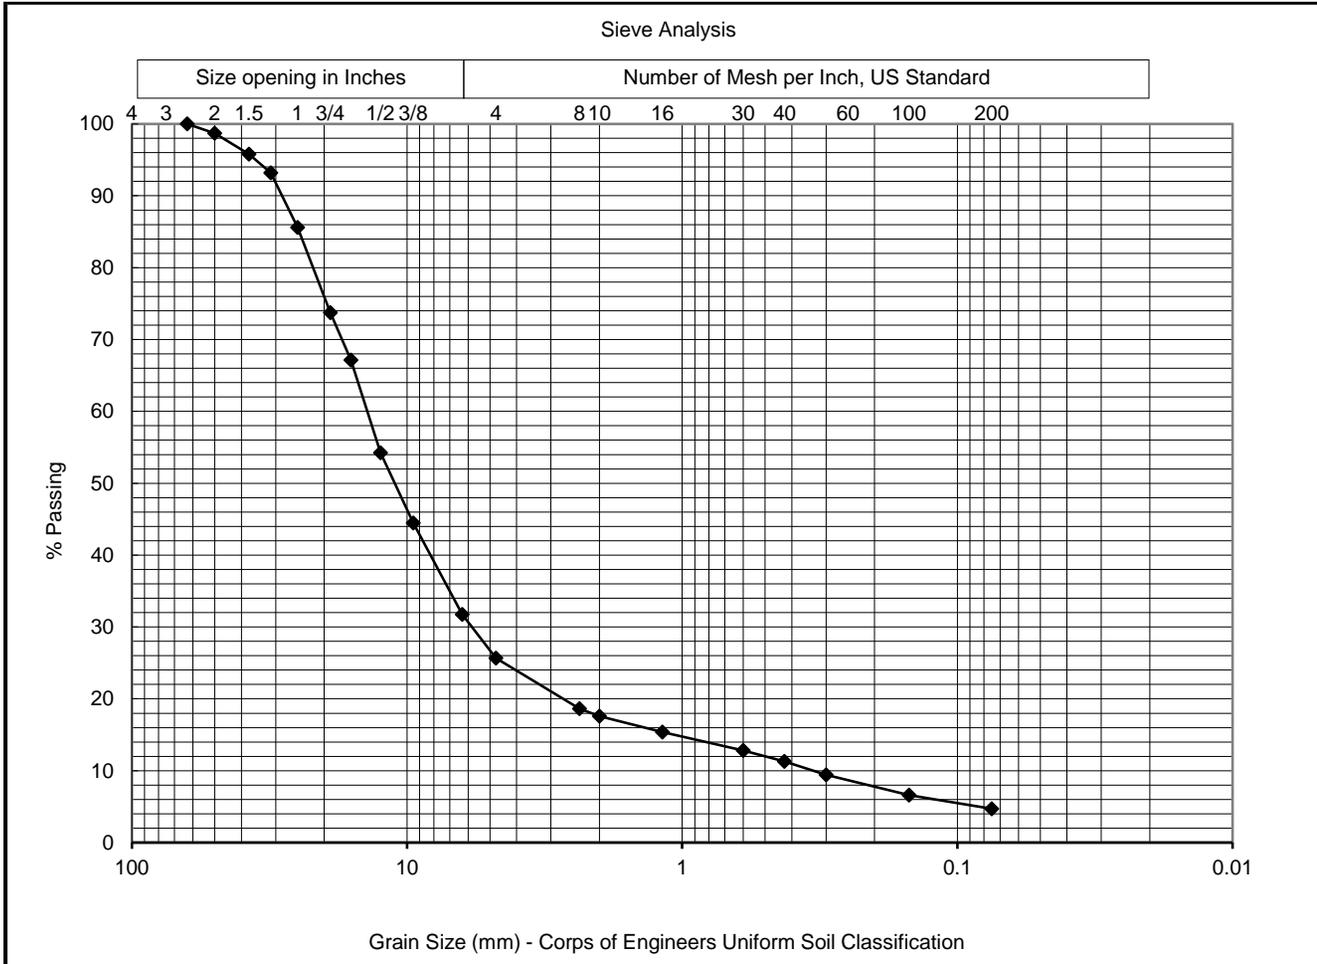
Sieve Analysis			
ASTM C136 / C117			
Sieve Size	% Passing	Specs *	
		min	max
2.50"	100		
2.00"	99		
1.50"	96		
1.25"	93		
1.0"	86		
3/4"	74		
5/8"	67		
1/2"	54		
3/8"	44		
1/4"	32		
#4	26		
#8	19		
#10	18		
#16	15		
#30	13		
#40	11		
#50	9		
#100	7		
#200	4.7		
Material: Brown gravel with sand			
Source: EP-2 @ 4.0' - Native			
Project: Monroe Coffee Stand			
Project #: M7251140 (25-001)			
Date Rec'd: 2/2/025

Sample Number	Depth (ft)	Classification
650		Poorly graded gravel with sand, GP

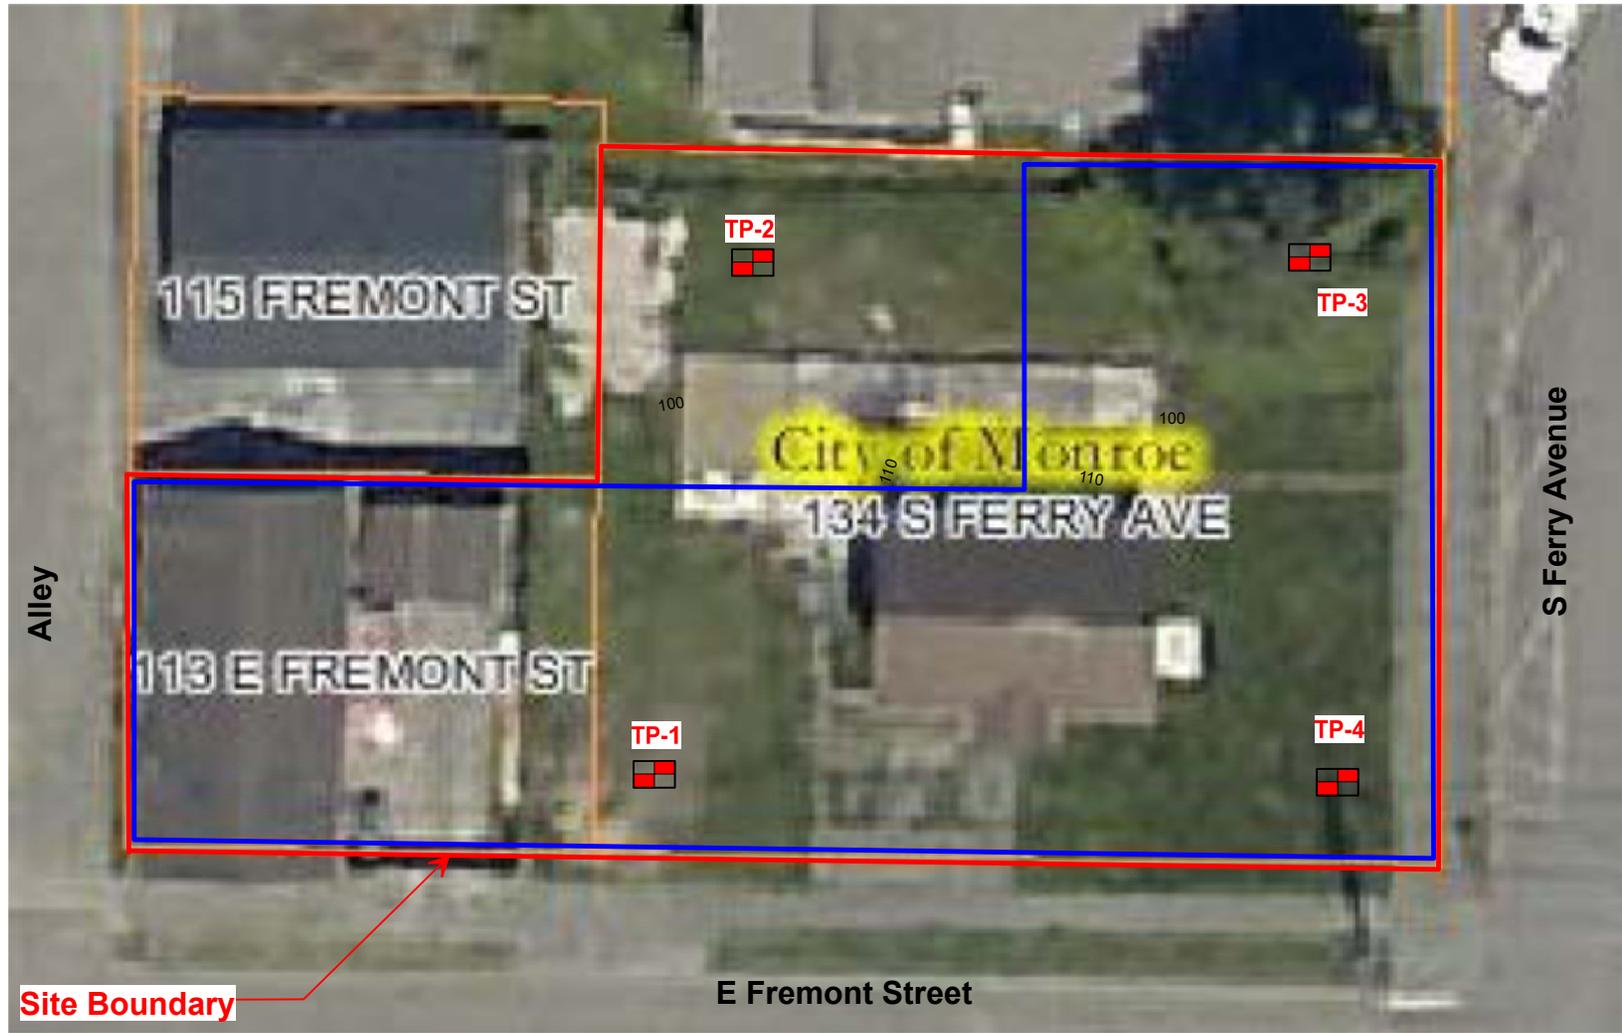
Note: Basemap modified from Snohomish County Parcel Map.

For this soil infiltration rate study an additional two exploration pits were excavated on the site (see attached Figure 1, Site and Exploration Plan). Our pits also encountered 2 to 3 feet of topsoil and old fill materials overlying recessional outwash (gravelly sand and sandy gravel). No ground water was observed to a maximum depth of 9 feet below existing grade.

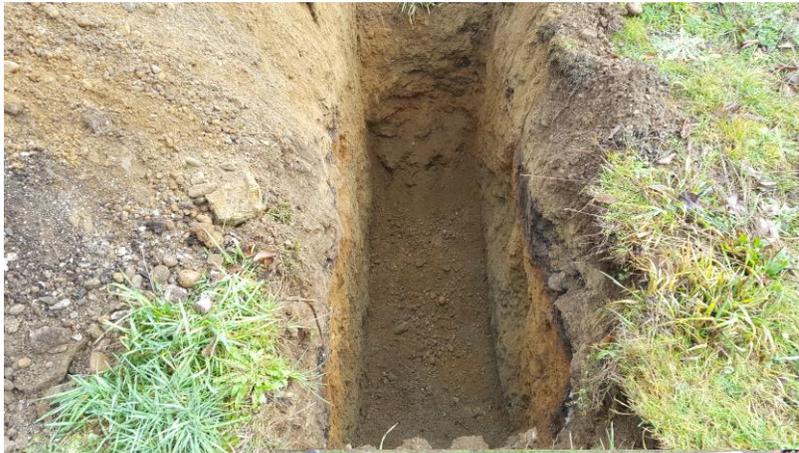
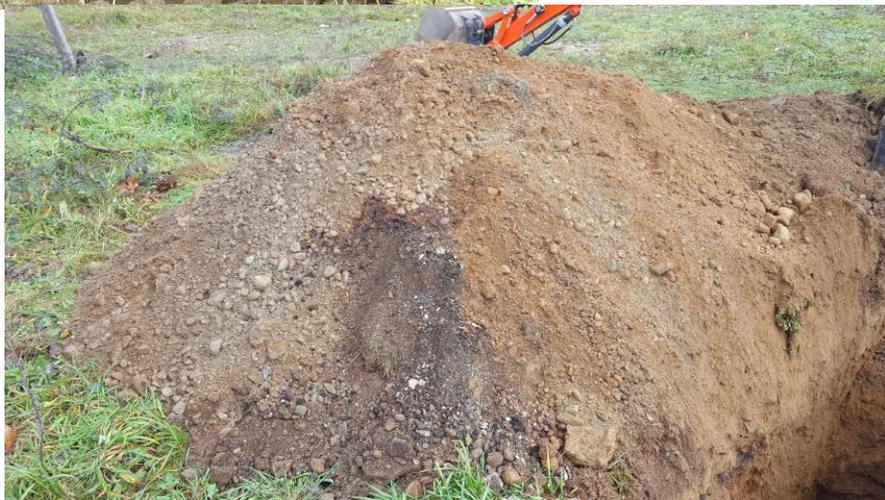
Ground Surface Conditions: Short Grass

Depth (ft)	Material Description
0 – 0.3	Loose, gray-brown, crushed ROCKS, little silt, damp to moist
0.3 – 3	Loose, brown, silty SAND, trace to some gravel, organics and trace charcoal, moist (Fill)
3 – 7	Medium dense, gray, gravelly coarse SAND, occasional cobbles, moist (Recessional Outwash)
	Test Pit terminated approximately 7 feet below ground surface. No caving and groundwater seepage observed during excavation.

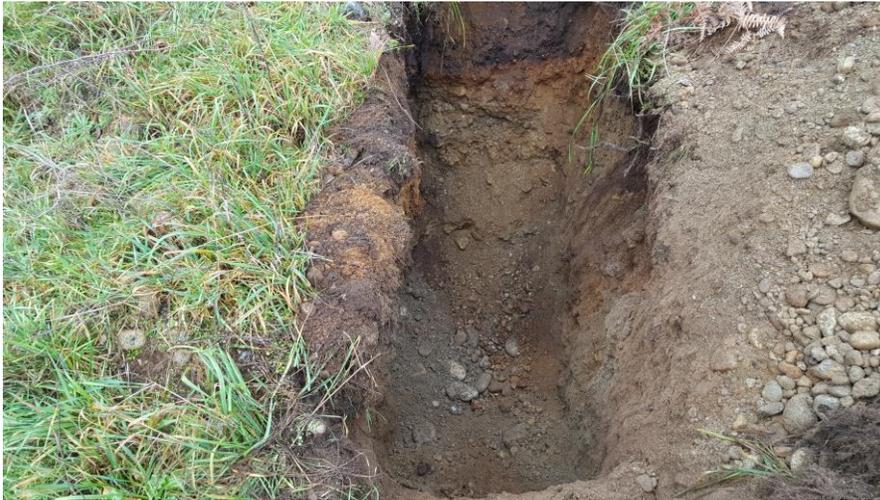
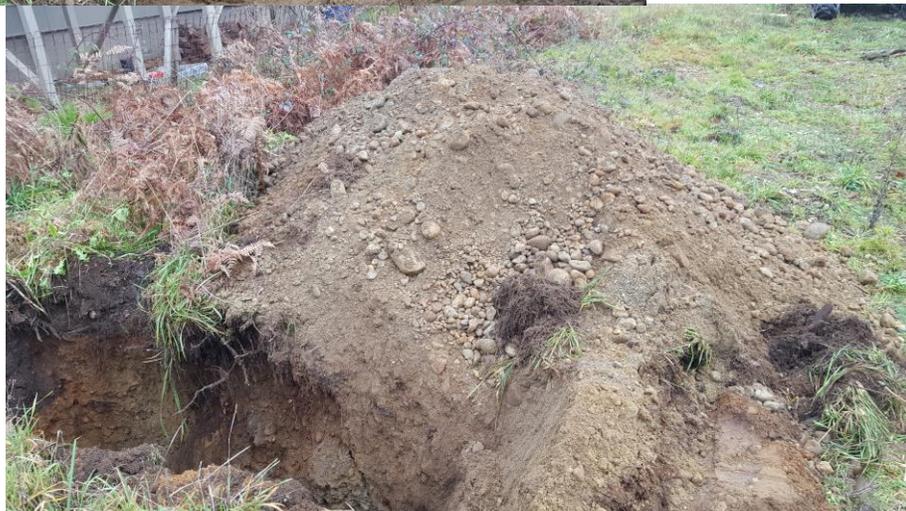
Test Pit TP-2

Ground Surface Conditions: Tall Grass

Depth (ft)	Material Description
0 – 2½	Loose, dark brown-brown, silty fine SAND, some roots and organics, trace gravel, moist (Fill)
2½ – 6½	Medium dense, gray, sandy GRAVEL/gravelly coarse SAND, some cobbles, occasional boulders (Recessional Outwash)
	Test Pit terminated approximately 6½ feet below ground surface. No caving and groundwater seepage observed during excavation.

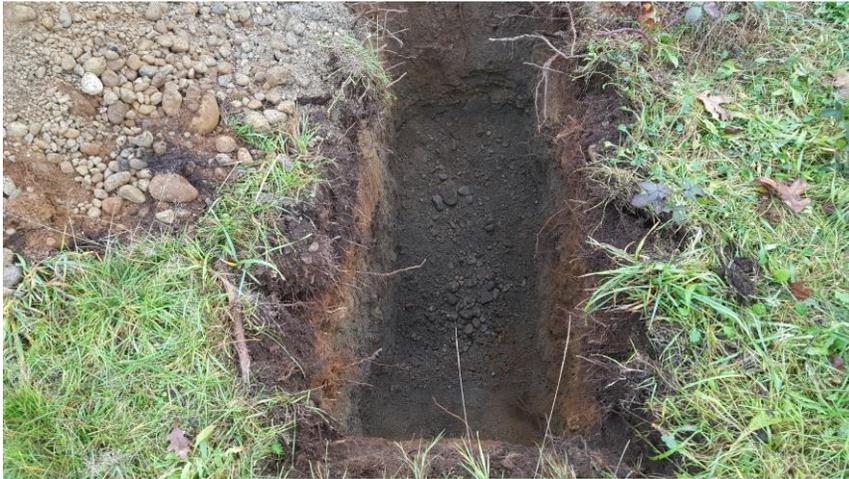
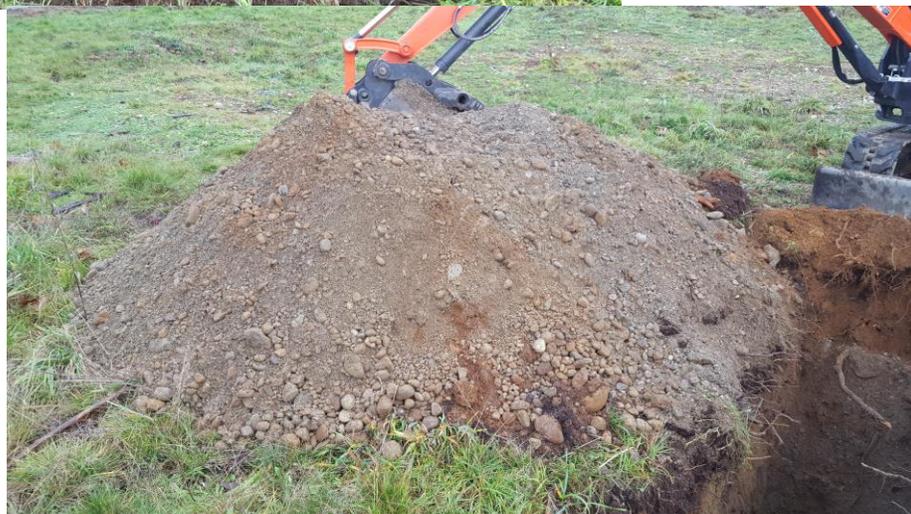
Test Pit TP-3

Ground Surface Conditions: Short Grass

Depth (ft)	Material Description
0 – 2½	Loose, brown, silty fine SAND, some roots and organics, trace gravel, moist (Fill)
2½ – 6½	Medium dense, gray, sandy GRAVEL/gravelly coarse SAND, occasional to some cobbles (Recessional Outwash)
	Test Pit terminated approximately 6½ feet below ground surface. No caving and groundwater seepage observed during excavation.

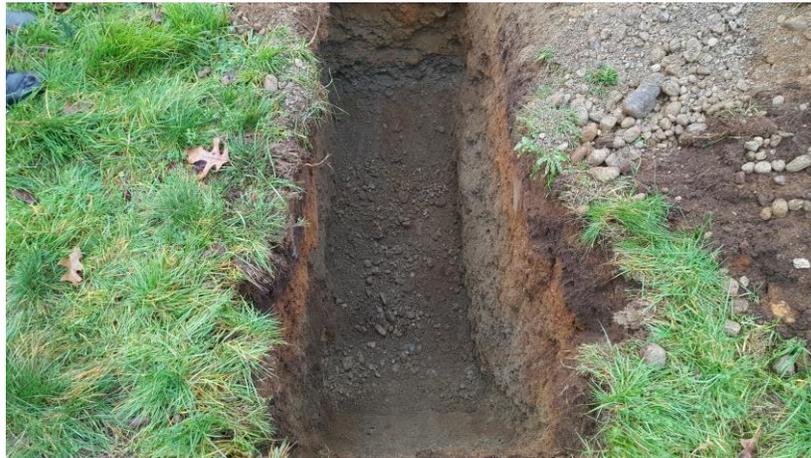
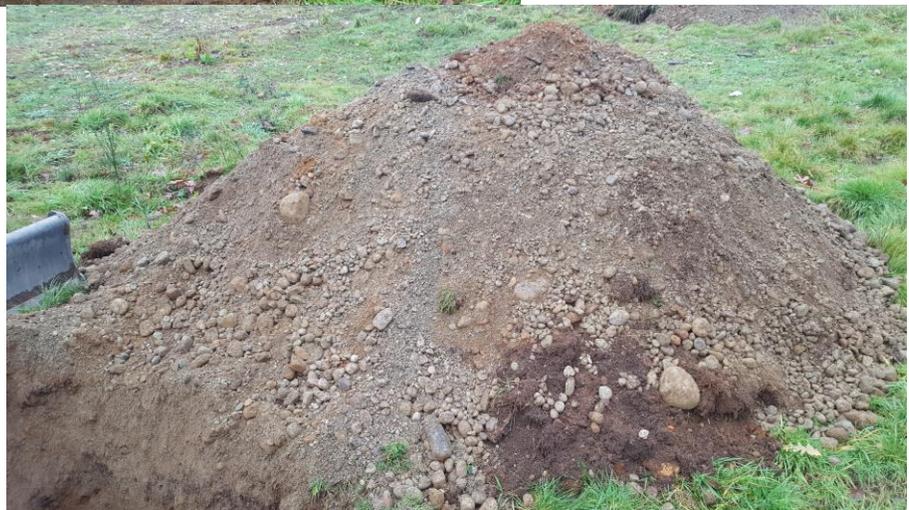
Test Pit TP-4

Ground Surface Conditions: Short Grass

Depth (ft)	Material Description
0 – 2	Loose, brown-dark brown, silty fine SAND, some roots and organics, trace gravel, moist (Fill)
2 – 7	Medium dense, gray, sandy GRAVEL/gravelly coarse SAND, occasional cobbles (Recessional Outwash)
	Test Pit terminated approximately 7 feet below ground surface. No caving and groundwater seepage observed during excavation.

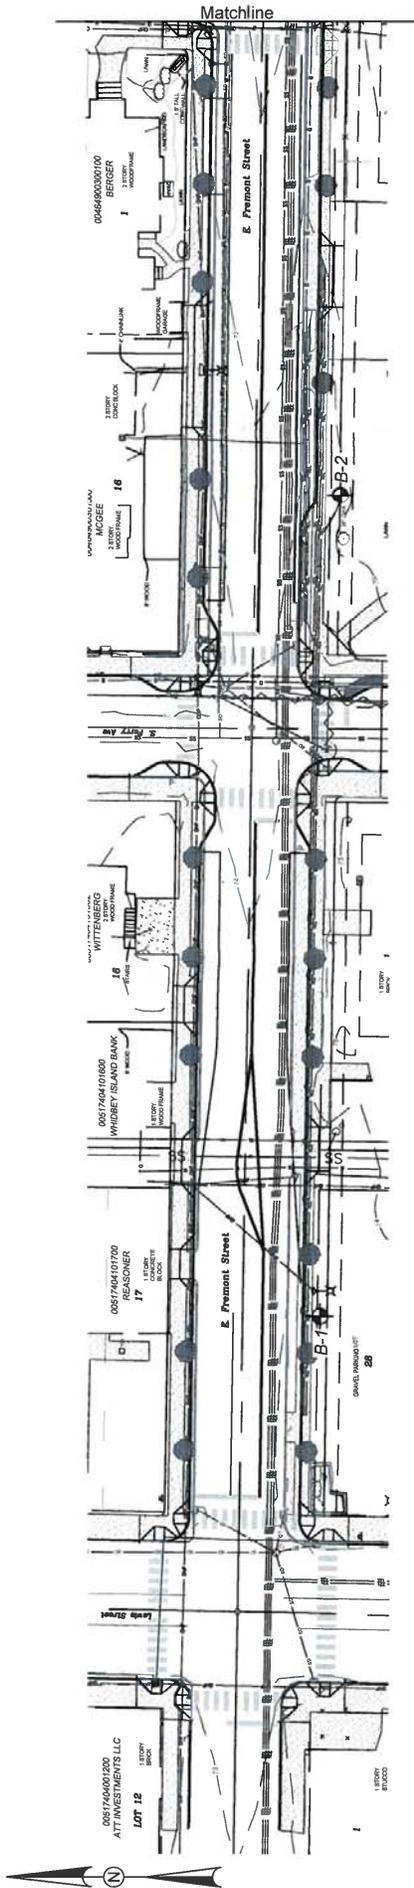
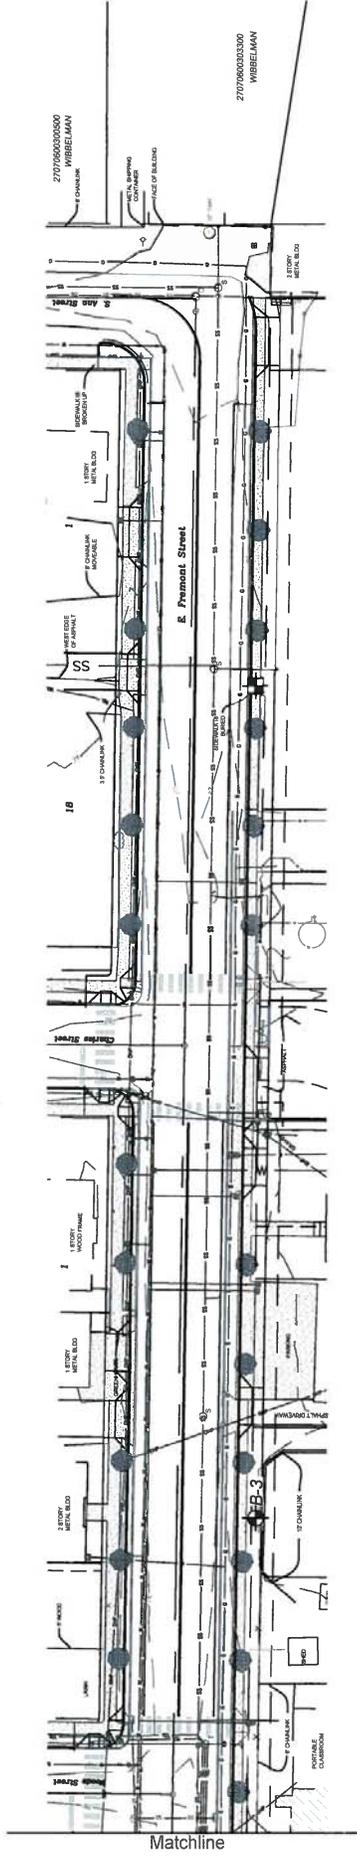
- Legend**
- B-1 Boring Number and Approximate Location
 - B-2 Test Pit by Others (RH2)

The previous test borings along Fremont Street between South Lewis Street and South Charles Street (B-1 through B-3) by Kleinfelder in 2013 are located as close as approximately 200 feet southwest of the subject site. The existing borings generally encountered approximately 1 to 2 feet of fill overlying recessional outwash deposit consisting of medium dense to very dense, sand and silty sand with gravel, and gravel with sand and cobble extending to the maximum depth drilled at about 16 to 41½ feet below the surface. The groundwater table in the previous boring B-1 was observed at about 28½ below the surface. The boring location plans and summary test boring logs for the previous exploration are included in Appendix B for reference.
