# Altmann Oliver Associates, LLC

Environmental  
Planning &  
Landscape  
Architecture

**SUBJECT: Critical Areas Study for Reasonable Use Exception (RUE)  
Sayah Cabins on Parcel 00777800000300  
Monroe, WA (Revised)**

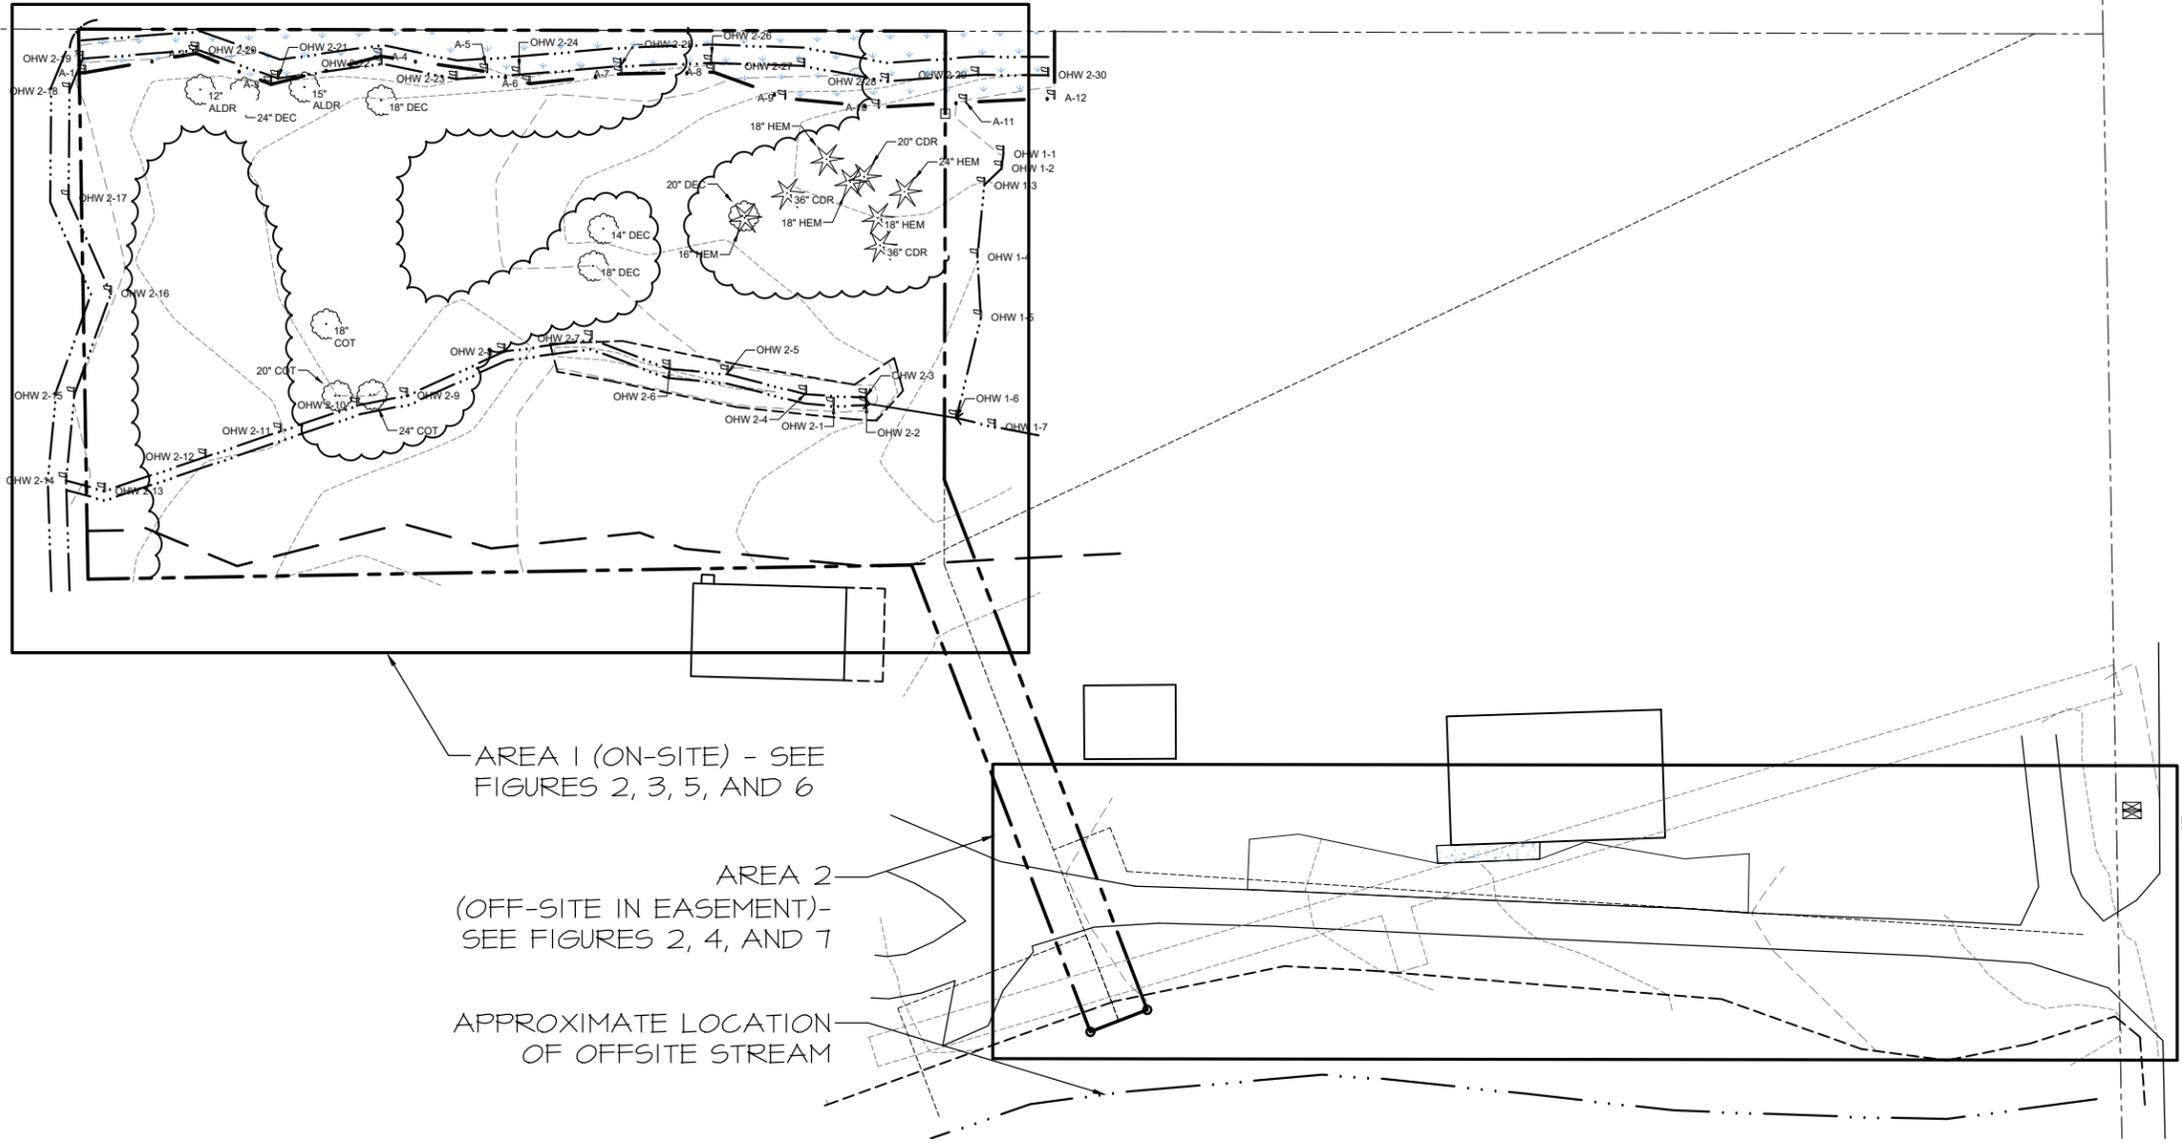
FIGURE 1: SITE OVERVIEW PLAN  
SAYAH PROPERTY  
13626 179TH AVE. SE  
MONROE, WA 98272  
PARCEL 0071800000300

AREA 1 (ON-SITE) - SEE FIGURES 2, 3, 5, AND 6

AREA 2 (OFF-SITE IN EASEMENT)- SEE FIGURES 2, 4, AND 7

**SITE OVERVIEW PLAN**  
SCALE - 1:60

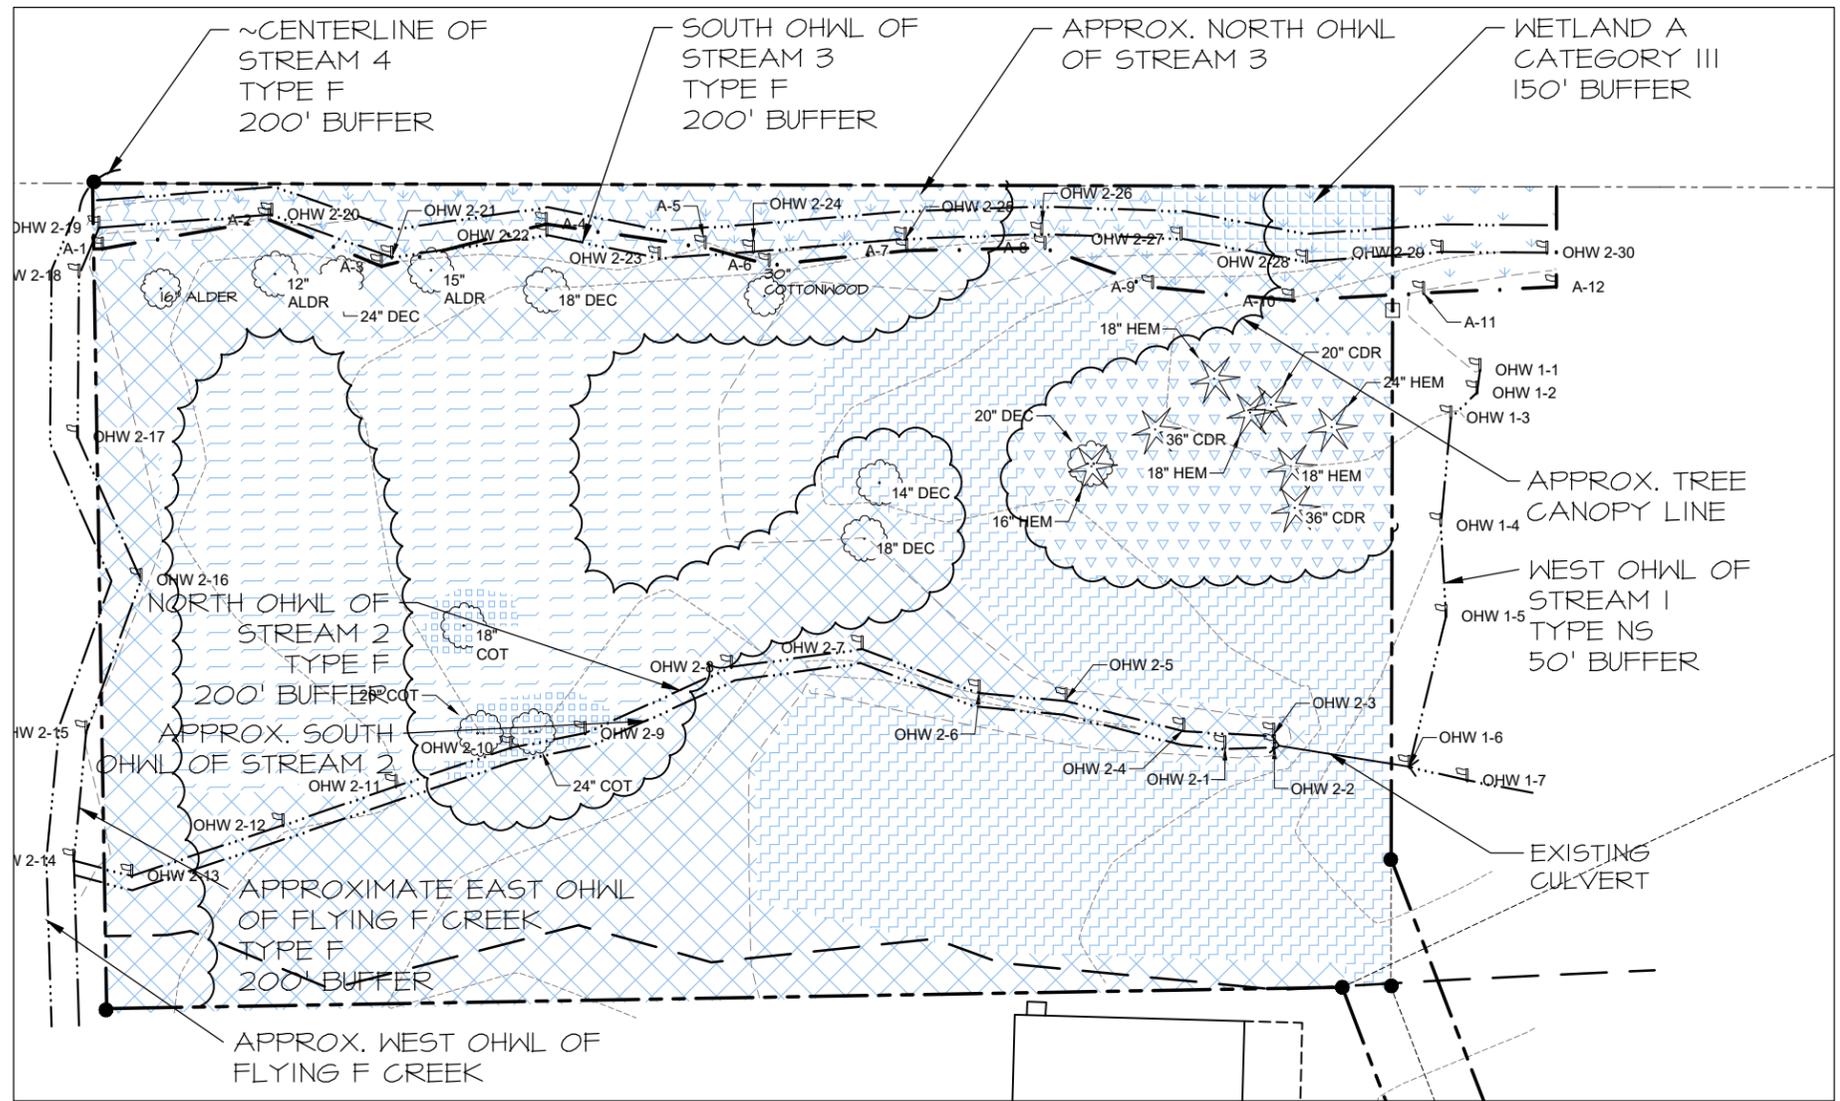
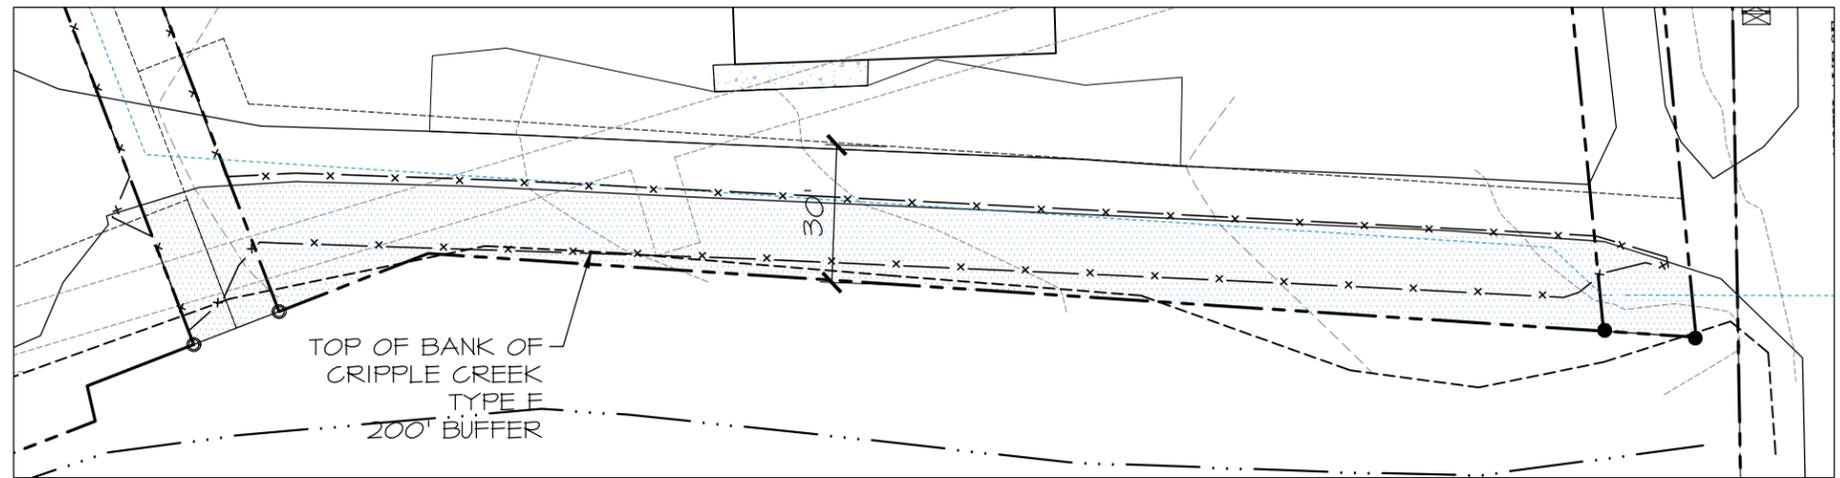
FIGURE 2: CRITICAL AREAS + EXISTING VEGETATION  
 SAYAH PROPERTY  
 13626 179TH AVE. SE  
 MONROE, WA 98272  
 PARCEL 0077800000300

**CRITICAL AREAS & EXISTING VEGETATION MAP - AREA 1**

**CRITICAL AREAS & EXISTING VEGETATION MAP - AREA 2**

- 100% RED ALDER & BLACK COTTONWOOD, 70% SWORD FERN, VINE MAPLE & SALAL, 30% HIMALAYAN BLACKBERRY & REED CANARY GRASS
- 100% HIMALAYAN BLACKBERRY & STINGING NETTLE
- 100% NATIVE CANOPY, 10% HIMALAYAN BLACKBERRY, 90% OPEN W/ DEBRIS
- 100% HIMALAYAN BLACKBERRY, STINGING NETTLE, REED CANARY GRASS & THISTLE
- 100% REED CANARY GRASS & STINGING NETTLE
- 100% NATIVE CANOPY, 100% SALMONBERRY, SWORD FERN, RED ELDERBERRY, WILLOW & SPIREA
- 100% NATIVE CANOPY, 50% SALMONBERRY, SWORD FERN, LADY FERN & RED ELDERBERRY, 50% HIMALAYAN BLACKBERRY
- 90% OPEN MOWED LAWN, 10% HIMALAYAN BLACKBERRY

One wetland (Wetland A), and five stream segments (Stream Segments 1, 2, 3, 4, and Flying F Creek) were identified and delineated on and directly adjacent to the site. Another Stream (Cripple Creek) was identified off-site to the south of the property.

All 6 stream channels were generally well defined and likely historically dredged. All flow from the on-site streams eventually merges with Flying F Creek in the northwest corner of the site and continues off-site to the west. Flow from Cripple Creek flows east to west entirely off-site. No salmonids or fish and wildlife conservation areas are mapped within any of the on-site streams associated with the site; however, Cripple Creek is shown off-site to the south containing salmonids on the WA Department of Fish and Wildlife's Priority Habitats and Species (PHS) database, WDFW Salmonscape, and WA Department of Natural Resources' Forest Practices mapping.

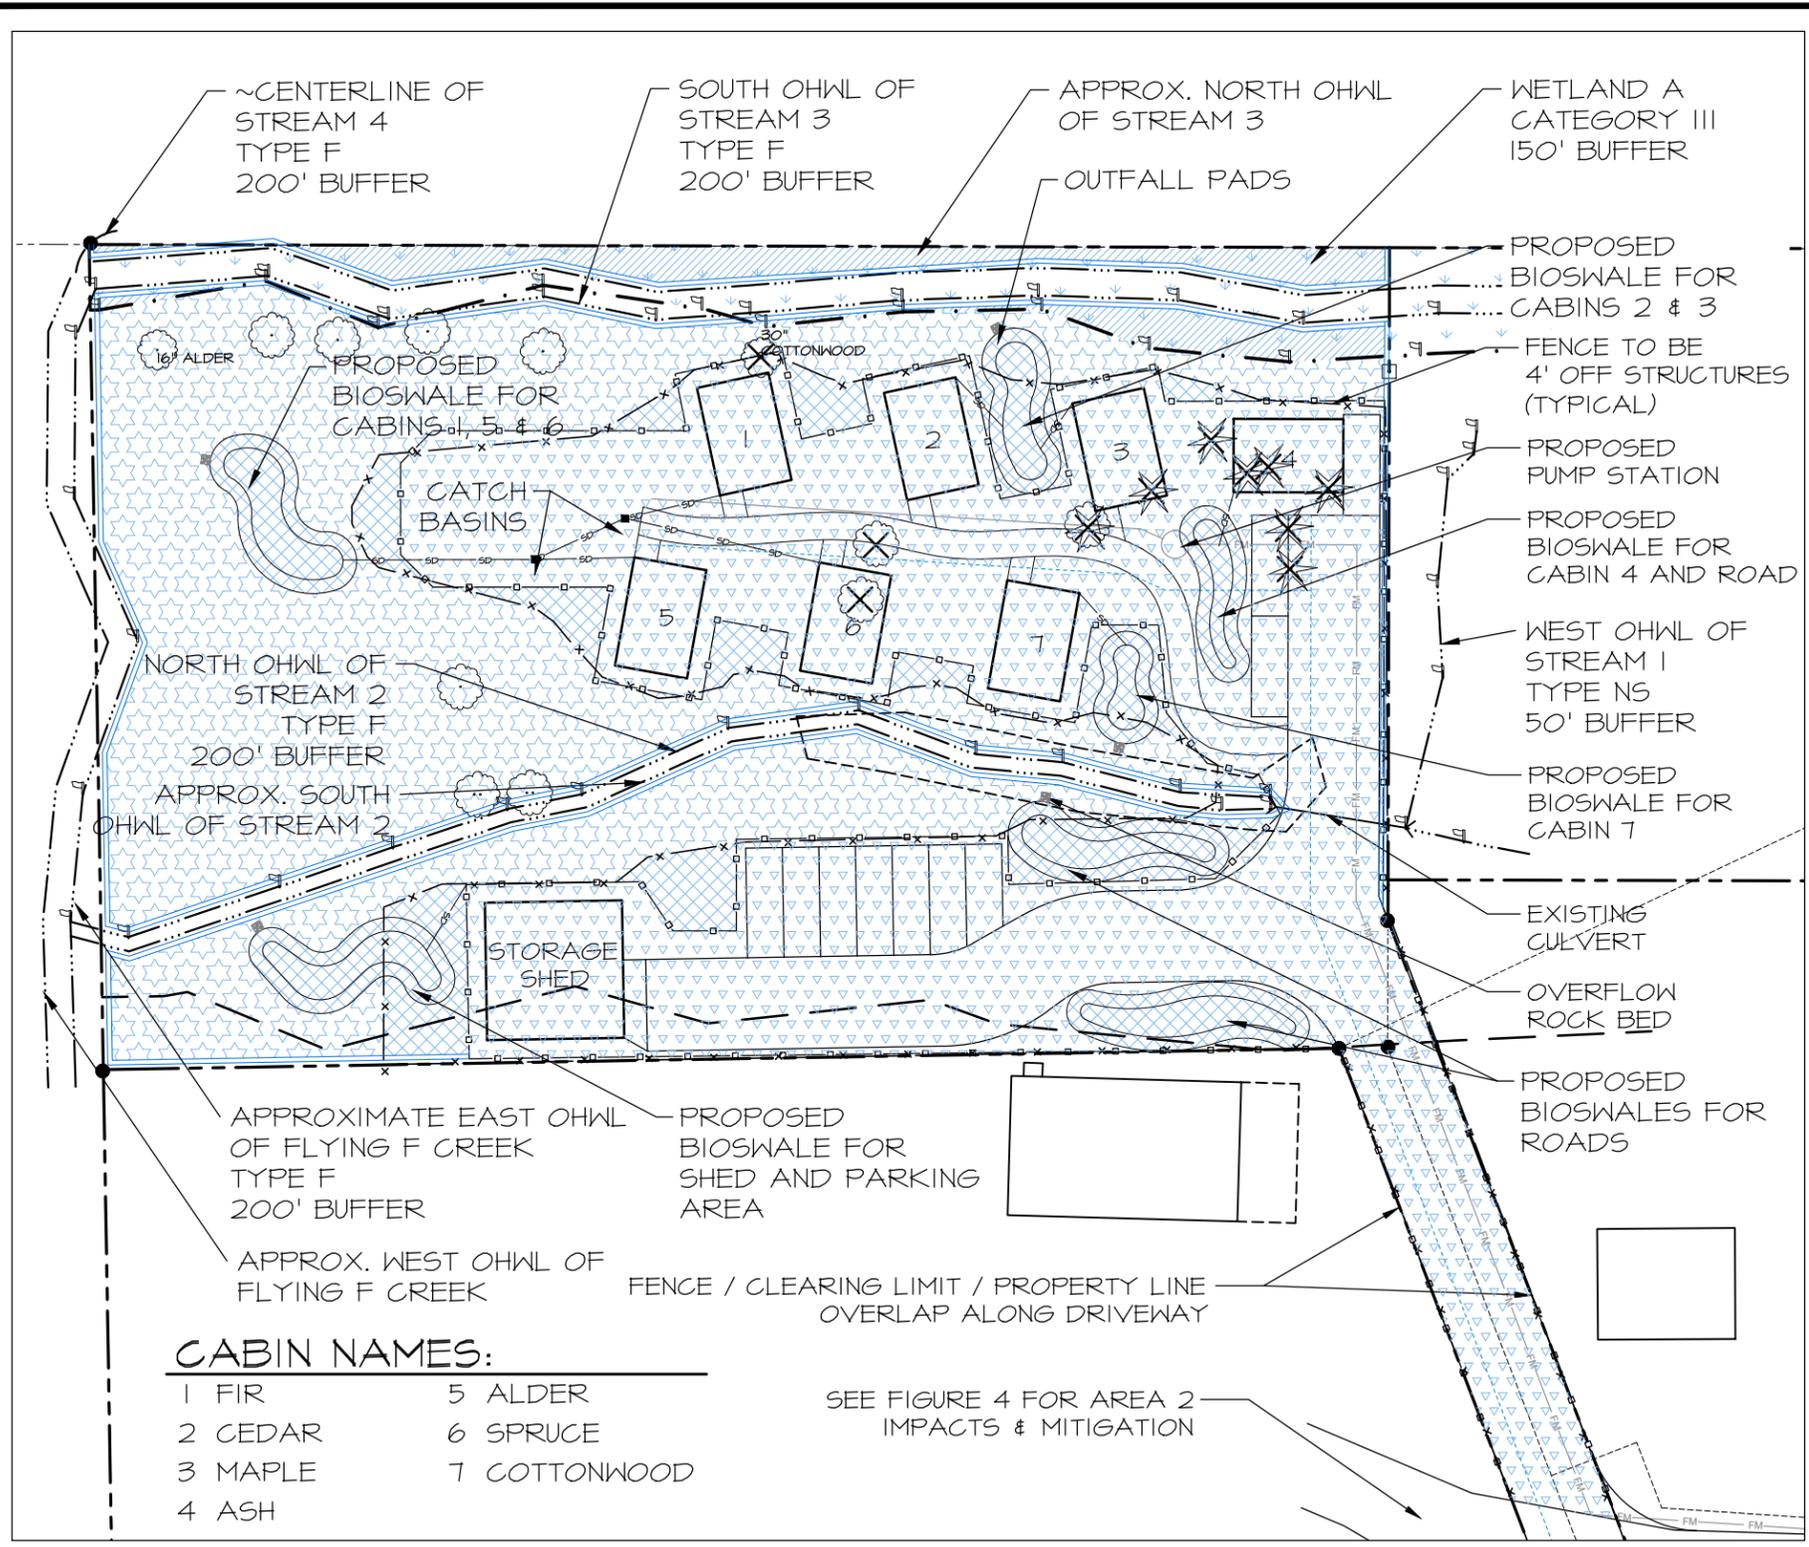
FIGURE 3: IMPACTS & MITIGATION - AREA 1  
 SAYAH PROPERTY  
 13626 179TH AVE. SE  
 MONROE, WA 98272  
 PARCEL 00717800000300

PERMANENT ON-SITE BUFFER IMPACT - AREA 1	22,478 SF
	PERMANENT OFF-SITE BUFFER IMPACT - AREA 2	2,598 SF
	TEMPORARY ON-SITE BUFFER IMPACT - AREA 1	5,840 SF
<b>TOTAL IMPACT: 30,916 SF</b>

ON-SITE BUFFER ENHANCEMENT AREA - AREA 1	16,645 SF
	ON-SITE WETLAND ENHANCEMENT AREA - AREA 1	1,847 SF
	OFF-SITE BUFFER ENHANCEMENT AREA - AREA 2	3,777 SF
	ON-SITE BUFFER RESTORATION - AREA 1	5,840 SF
<b>TOTAL MITIGATION: 28,109 SF</b>

**IMPACTS & MITIGATION MAP - AREA 1**

The proposed project consists of the construction of seven small cabins with associated paths, storage shed, parking, and off-site roadway expansion (**Plan Set Figures 3 and 4**). This equates to 22,478 sf of permanent on-site buffer impact for the cabins, storage shed, paths, and parking; 2,598 sf of permanent off-site buffer impact for the road expansion (25,076 total), and 5,816 sf of temporary on-site buffer impact for the bioswales which will be fully restored following construction.

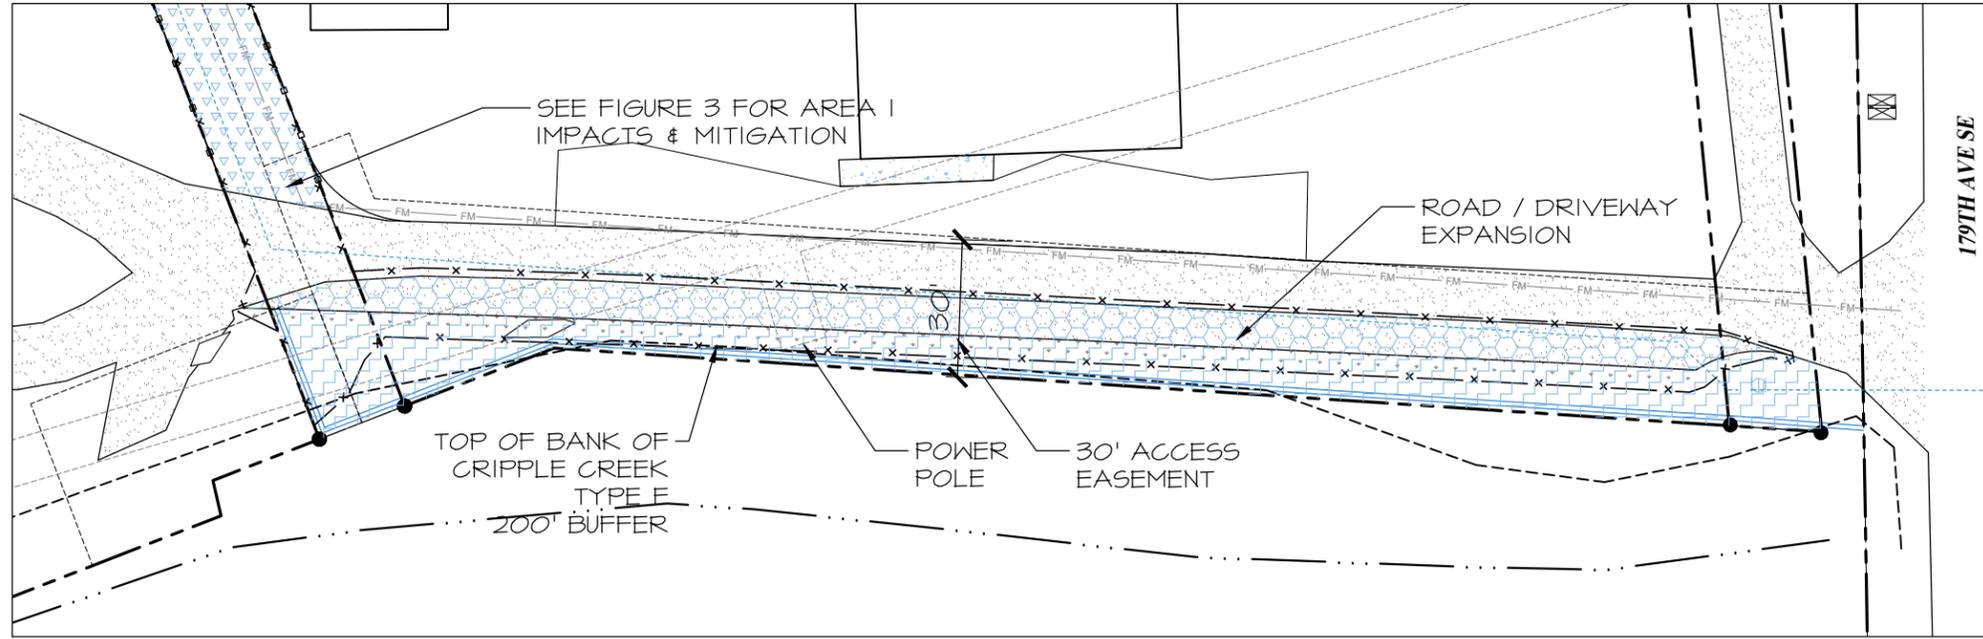
**IMPACTS & MITIGATION MAP - AREA 2**

PERMANENT ON-SITE BUFFER IMPACT - AREA 1	22,478 SF
	PERMANENT OFF-SITE BUFFER IMPACT - AREA 2	2,598 SF
	TEMPORARY ON-SITE BUFFER IMPACT - AREA 1	5,840 SF
<b>TOTAL IMPACT:</b>		<b>30,916 SF</b>

ON-SITE BUFFER ENHANCEMENT AREA - AREA 1	16,645 SF
	ON-SITE WETLAND ENHANCEMENT AREA - AREA 1	1,847 SF
	OFF-SITE BUFFER ENHANCEMENT AREA - AREA 2	3,777 SF
	ON-SITE BUFFER RESTORATION - AREA 1	5,840 SF
<b>TOTAL MITIGATION:</b>		<b>28,109 SF</b>

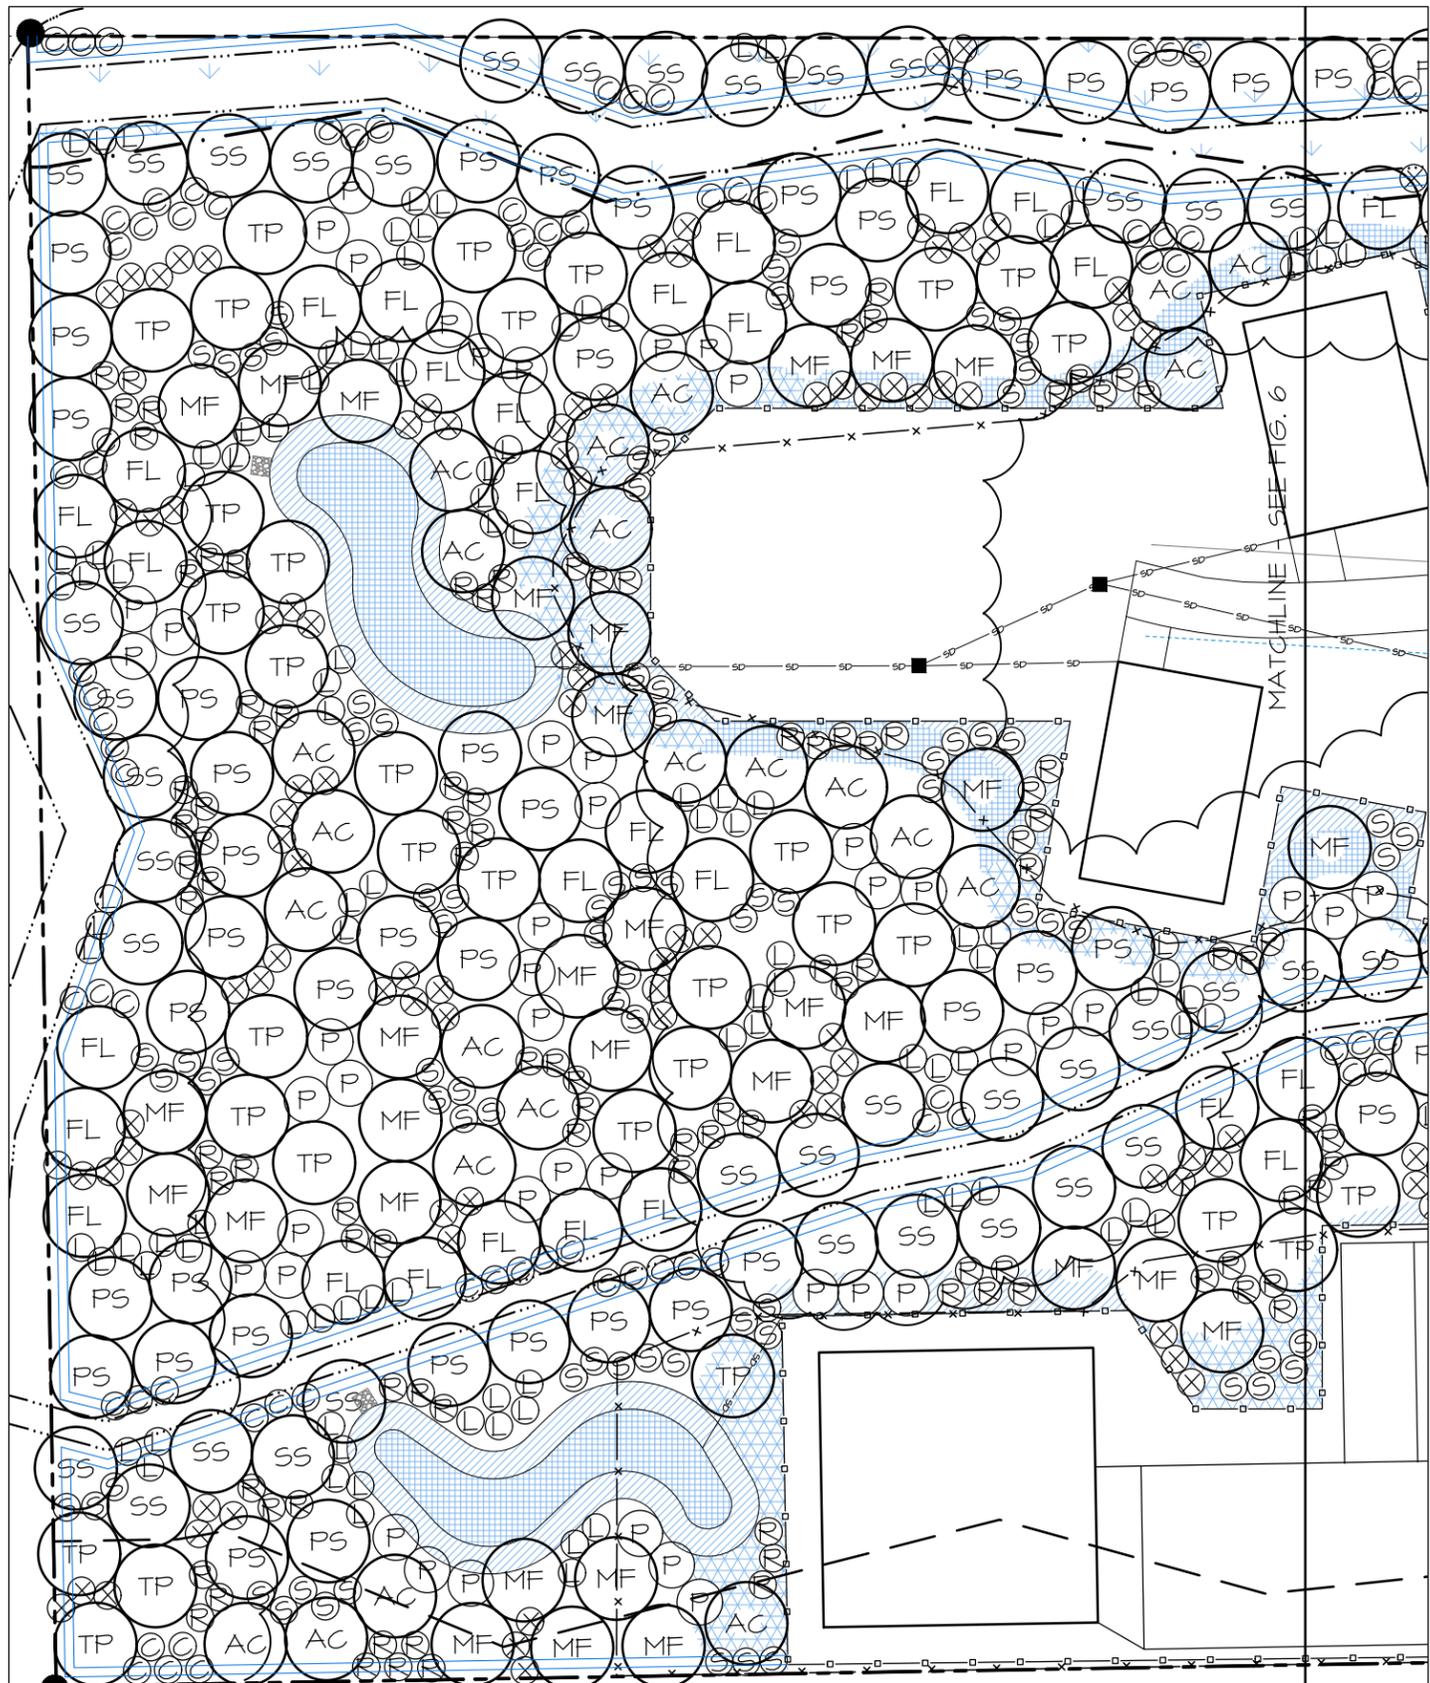
**PLANTING PLAN - AREA I - WEST SECTION**  
 SCALE - 1:20

KEY	SCIENTIFIC NAME	COMMON NAME	QTY
XXXXXX	ATHYRIUM FILIX-FEMINA	LADY FERN	600
XXXX	CAREX OBNUPTA	SLOUGH SEDGE	500
XXXX	IRIS TENAX	OREGON IRIS	600

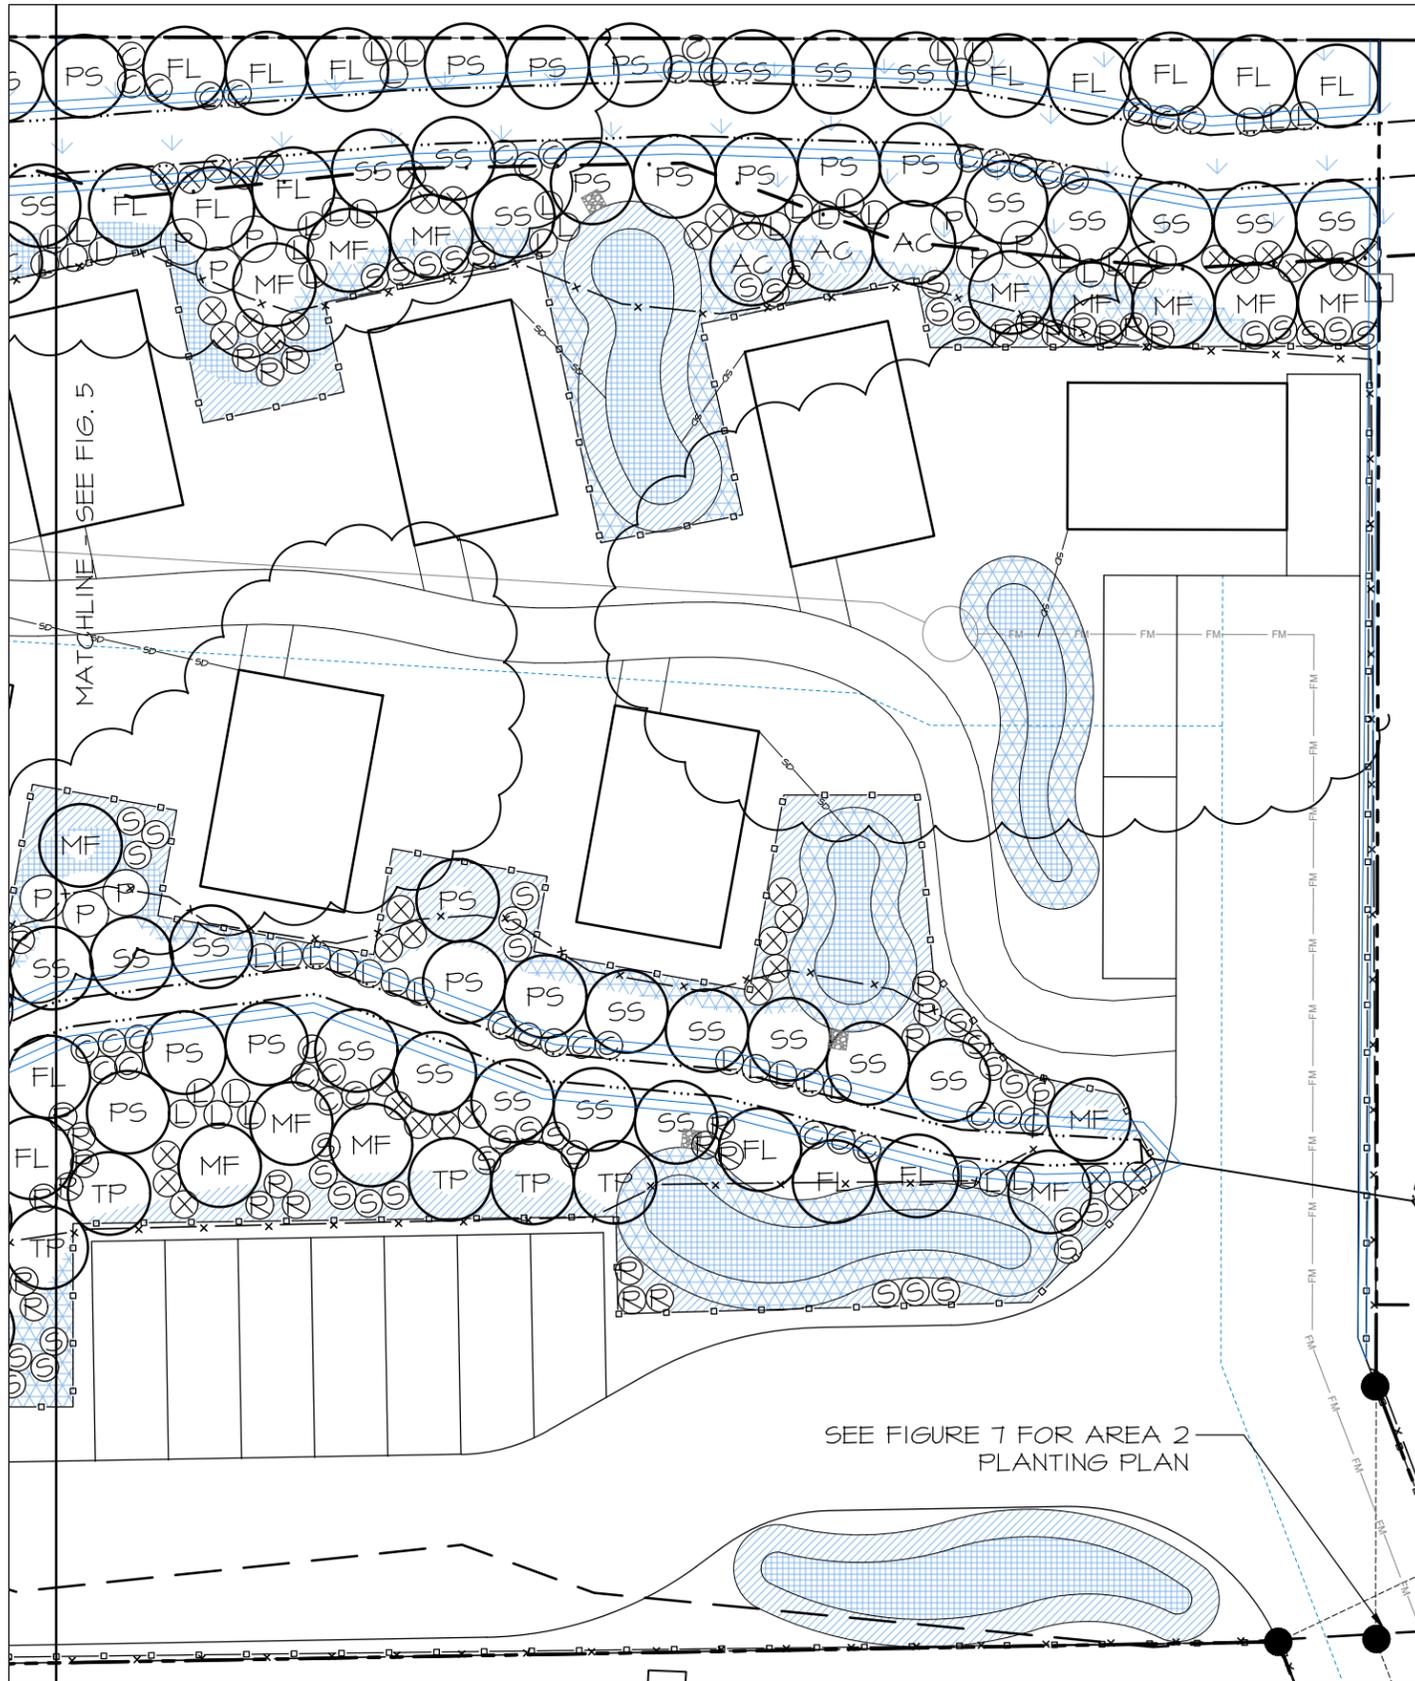
**PLANTING PLAN - AREA I - EAST SECTION**  
SCALE - 1:20

KEY	SCIENTIFIC NAME	COMMON NAME	QTY
[Symbol]	ATHYRIUM FILIX- FEMINA	LADY FERN	600
[Symbol]	CAREX OBNUPTA	SLOUGH SEDGE	500
[Symbol]	IRIS TENAX	OREGON IRIS	600

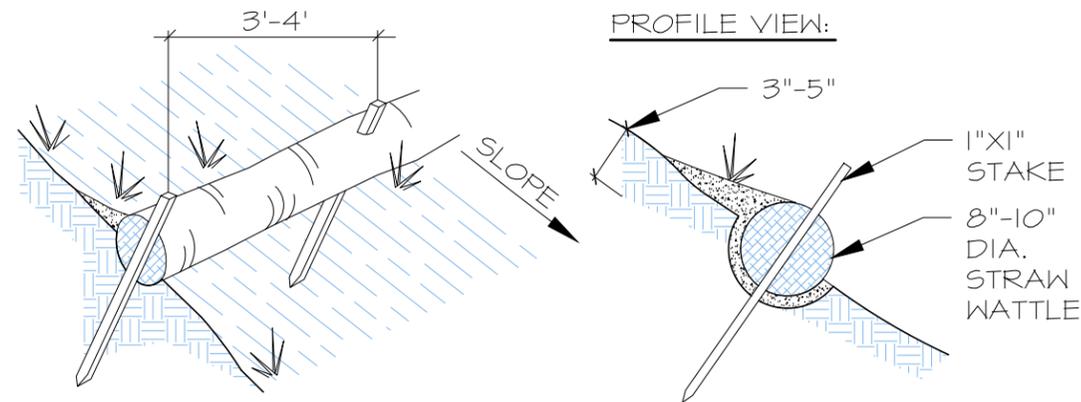
- STRAW ROLLS MUST BE PLACED ALONG SLOPE CONTOURS.
- STRAW ROLL INSTALLATION REQUIRES THE PLACEMENT AND SECURE STAKING OF THE ROLL IN A TRENCH, 3" X 5" DEEP DUG ON CONTOUR.
- RUNOFF MUST NOT BE ALLOWED TO RUN UNDER OR AROUND ROLL.

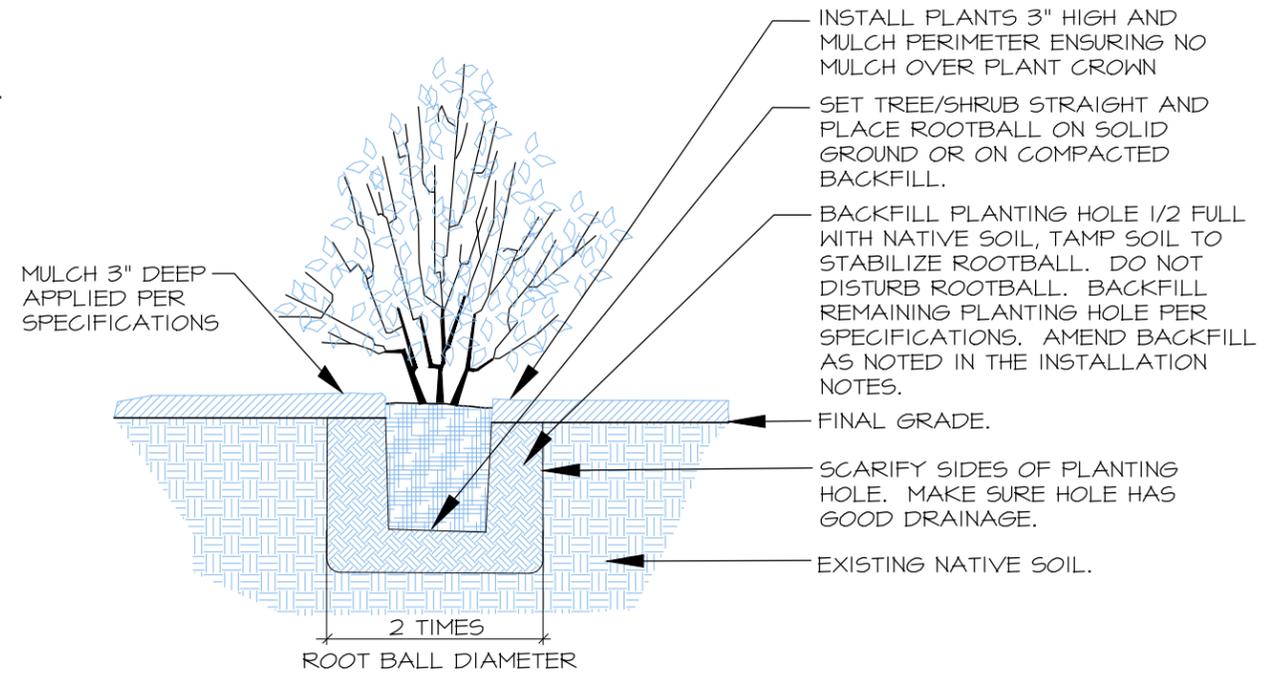
**1 CONTAINER TREE/SHRUB PLANTING (TYP.)**  
SCALE: NTS

9. FOR PLANTING, MULCH SHALL BE PULLED AWAY TO INSTALL PLANTS, THEN REPLACED AFTER PLANTING. PLANTS SHALL BE INSTALLED 3" HIGH AND SURFACED REMULCHED TO A DEPTH OF 3". DO NOT PLACE MULCH ON PLANT CROWNS.
