CRITICAL AREAS REPORT

TROMBLEY HILL
TRANSMISSION MAIN REPLACEMENT PROJECT
MONROE, WASHINGTON

August 4, 2025
Revision 1: February 18, 2026

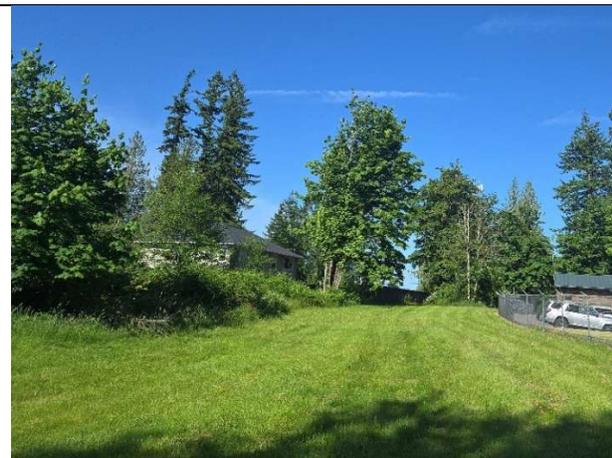
Photo 1. Northernmost portion of the corridor looking southwest. Photo taken on 06/10/2025.

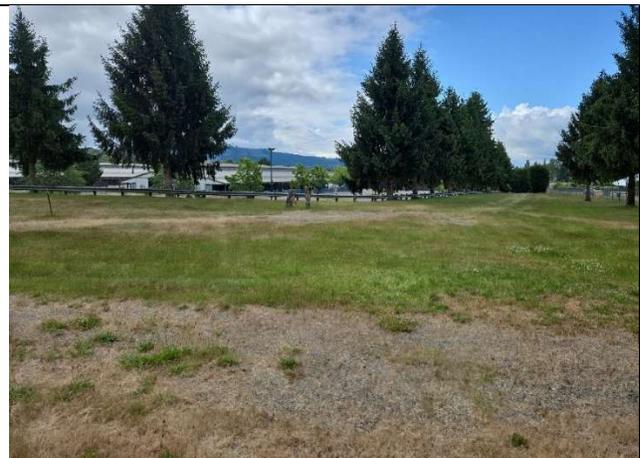
Photo 2. Southern portion used as fairgrounds overflow parking. Looking south along 179th Ave SE. Photo taken on 06/18/2025.

The onsite stream buffer (**Appendix A/Figure 8**) is largely used as overflow parking for the Evergreen Equestrian Park (**Photo 6**). The open area consists of gravel fill and mowed grass species adapted to disturbed environments such as white clover (*Trifolium repens*), common dandelion (*Taraxacum officinale*), lesser trefoil (*Trifolium dubium*), and ribwort plantain (*Plantago lanceolata*). Landscaped Norway spruce (*Picea abies*) is planted along the perimeter of the lot. This area serves as a physical buffer in terms of proximity, but it lacks ecological functions typically associated with effective stream buffers. Vegetation and soil disturbance from anthropogenic activities prevent the establishment of native vegetation, resulting in limited plant diversity and structural complexity. This simplified vegetative cover offers minimal habitat for wildlife. Additionally, shallow root systems and compacted soils reduce infiltration and fail to protect the stream from pollutants, erosion, or hydrologic fluctuations. As such, this type of buffer contributes little to the protection or enhancement of stream functions.

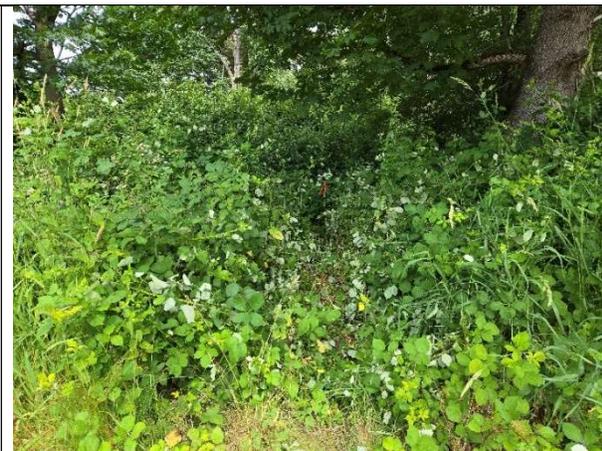
The streambank is dominated by Himalayan blackberry (*Rubus armeniacus*), with Orchard grass (*Dactylis glomerata*), velvet grass (*Holcus lanatus*), meadow fescue (*Festuca arundinacea*), reed canary grass (*Phalaris arundinacea*), and broad-leaved dock (*Rumex obtusifolius*). Tree cover along the streambank consists of common hazel (*Corylus avellana*), Douglas fir (*Pseudotsuga menziesii*), and big leaf maple (*Acer macrophyllum*) (**Photo 3**). Within the stream, the channel is largely confined with Himalayan blackberry and reed canary grass (**Photo 4**).

Photo 3. Vegetation along streambank looking north. Photo taken on 06/18/2025.

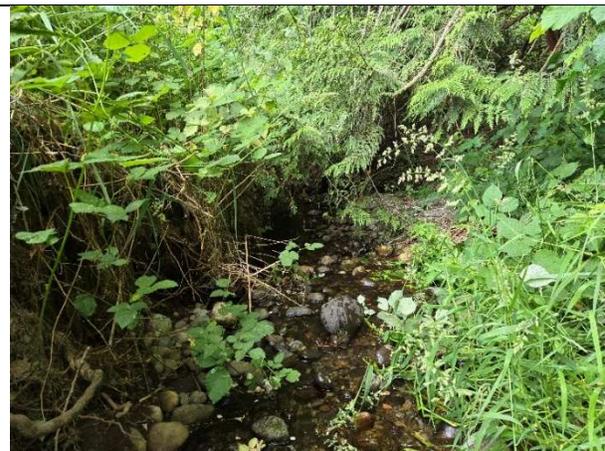
Photo 4. Within stream channel looking west. Photo taken on 06/18/2025.

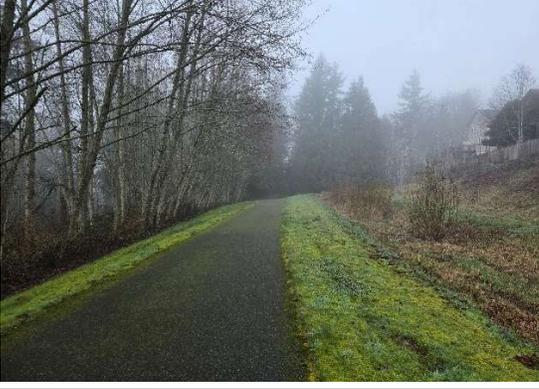
Observation Point (OB-X)	Summary	Photo
<p>OBS-1 (Upland)</p>	<p>Within wetland area mapped by the Snohomish County PDS Map Portal, consists of an asphalt pedestrian walking path. The paved path is flanked by a stormwater swale to the northeast and red alder (<i>Alnus rubra</i>), Himalayan blackberry (<i>Rubus armeniacus</i>), and sword fern (<i>Polystichum munitum</i>) to the west. (Photo facing west)</p>

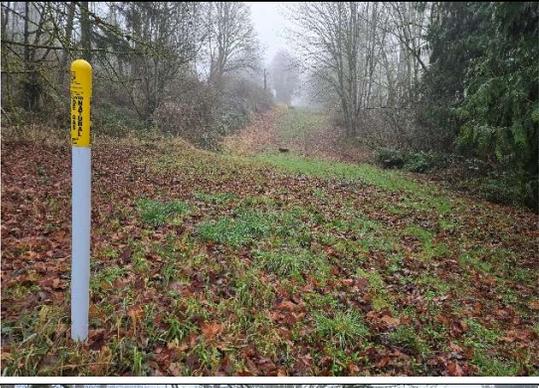
<p>OBS-2 (Upland)</p>	<p>Located at the junction of the mapped wetland polygons, at the center of a mowed and maintained utility corridor. The area is sloped on either side and vegetated with red alder, big leaf maple (<i>Acer macrophyllum</i>), Western red cedar (<i>Thuja plicata</i>), Douglas fir (<i>Pseudotsuga menziesii</i>), Himalayan blackberry, and sword fern. (Photo facing south)</p>

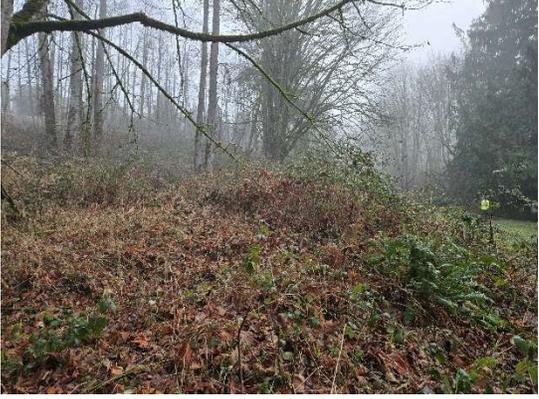
<p>OBS-3 (Upland)</p>	<p>Located at the northern corridor boundary, in the westernmost finger of the City of Monroe’s mapped wetland polygon. Lying on a slope, this area is vegetated by red alder, big leaf maple, Western red cedar, Douglas fir, Himalayan blackberry, and swordfern. (Photo facing east)</p>

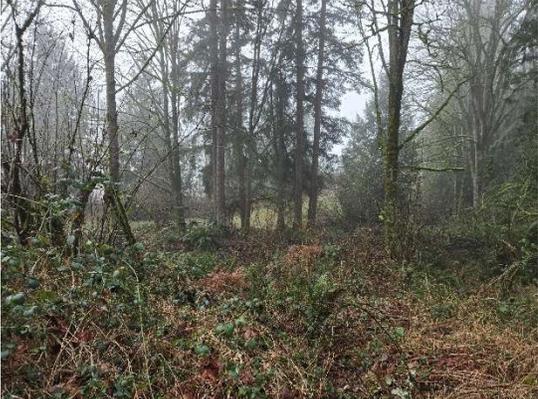
<p>OBS-4 (Upland)</p>	<p>Lying on a steep slope, this area is located within the northernmost finger of the City of Monroe’s mapped wetland polygon. Vegetation consists of red alder, big leaf maple, Western red cedar, Douglas fir, swordfern, and a dense understory of Himalayan blackberry. (Photo facing south)</p>

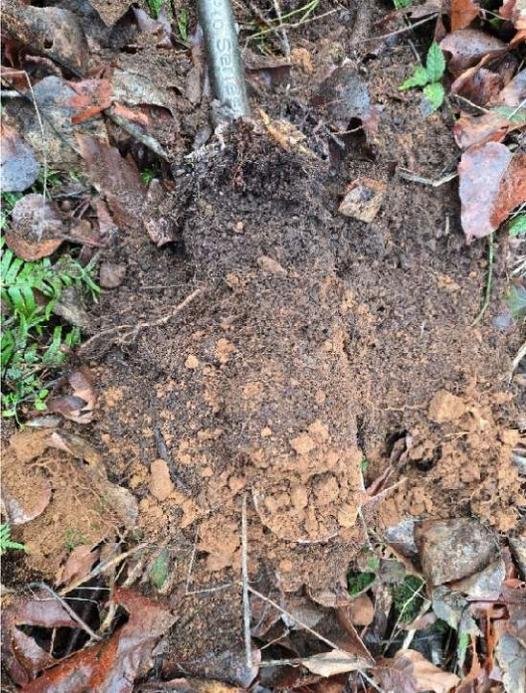
Soil Pit (SP-X)	Summary	Photo
<p>SP-1 (Upland)</p>	<p>Located south of the proposed project corridor within the long, linear wetland polygon mapped by both the City of Monroe and the Snohomish County PDS. With an approximate 20% slope, vegetation consists of big leaf maple, black cottonwood (<i>Populus balsamifera</i>), Indian plum (<i>Oemleria cerasiformis</i>), red huckleberry (<i>Vaccinium parvifolium</i>), swordfern, and trailing blackberry (<i>Rubus ursinus</i>). Soils did not exhibit any hydric soil indicators, and no wetland hydrology indicators were observed. See Appendix B for the full data sheet.</p>

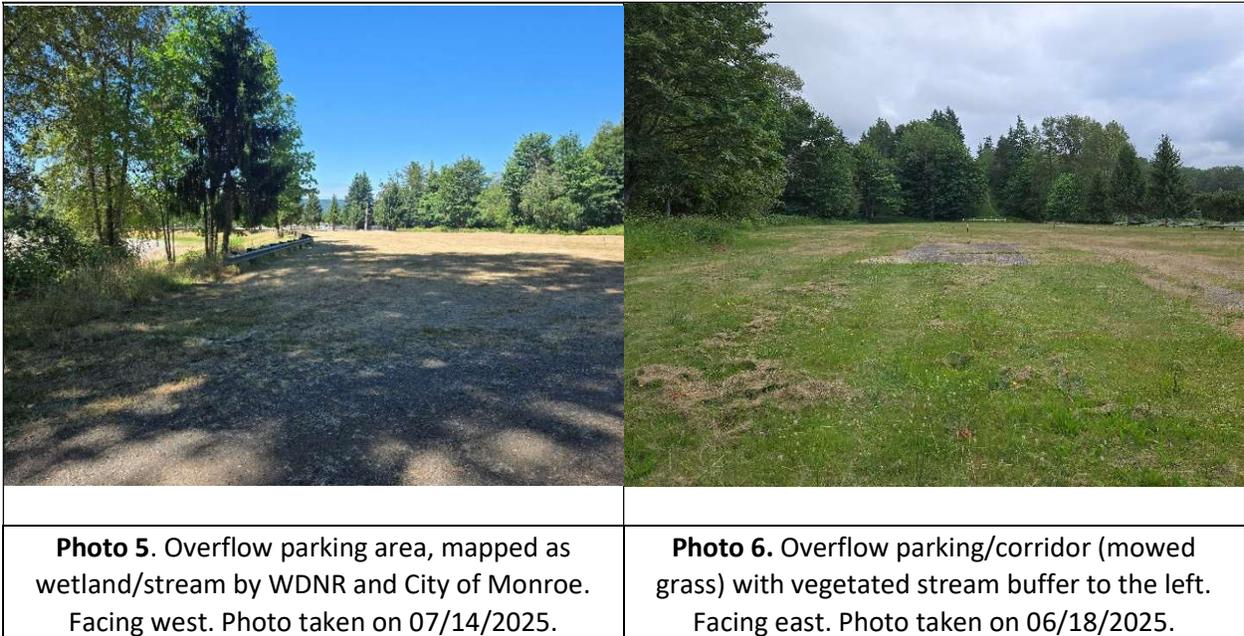
The linear wetland feature mapped by the WDNR (**Appendix A/Figure 5e**), which aligns with an unclassified stream shown on City of Monroe mapping, was also not identified during site visits. There are no culverts, nor any critical area features. This area currently functions as overflow parking for the Evergreen Equestrian Park and is characterized by gravel fill, concrete patches, metal posts, and vegetation typical of disturbed conditions (**Photos 5 and 6**).

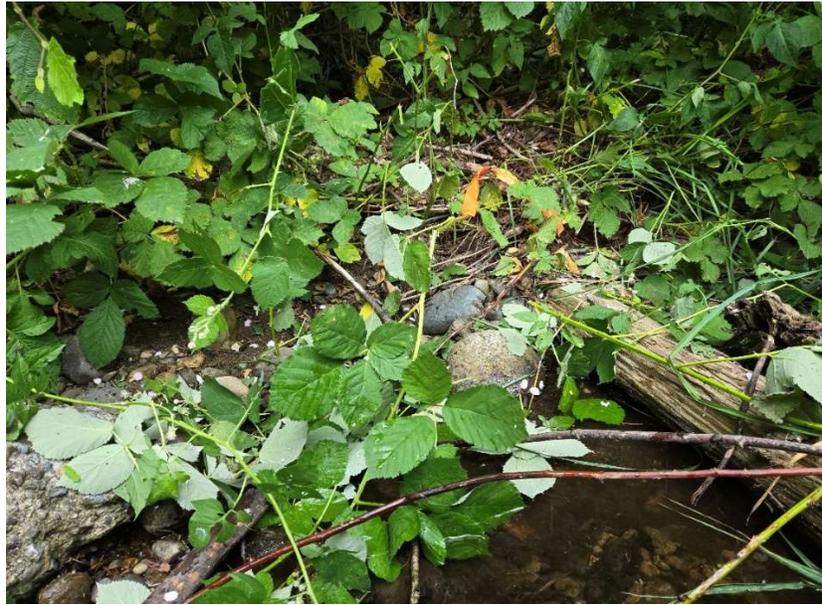
During field visits in June 2025, surface flow approximately three inches deep was observed moving southwest. The stream channel has a defined bed and bank, with visible signs of bedload transport consisting of small gravel to large cobble. The bed is approximately eight feet wide, and the south bank is about four feet deep. The ordinary high-water mark (OHWM) was flagged within the channel approximately nine inches above the streambed (**Photo 7**).

Photo 7. Drainage 1 OHWM. Photo taken on 06/18/2025.

The WDNR classifies this stream as Type F (WDNR 2025). According to MMC 22.80.100, a 200-foot standard buffer is required for Type F streams. Field investigations confirmed minor deviations in the mapped and LiDAR-defined channel alignment north of its entry into the project area, after which the channel generally follows the mapped and LiDAR-indicated course.

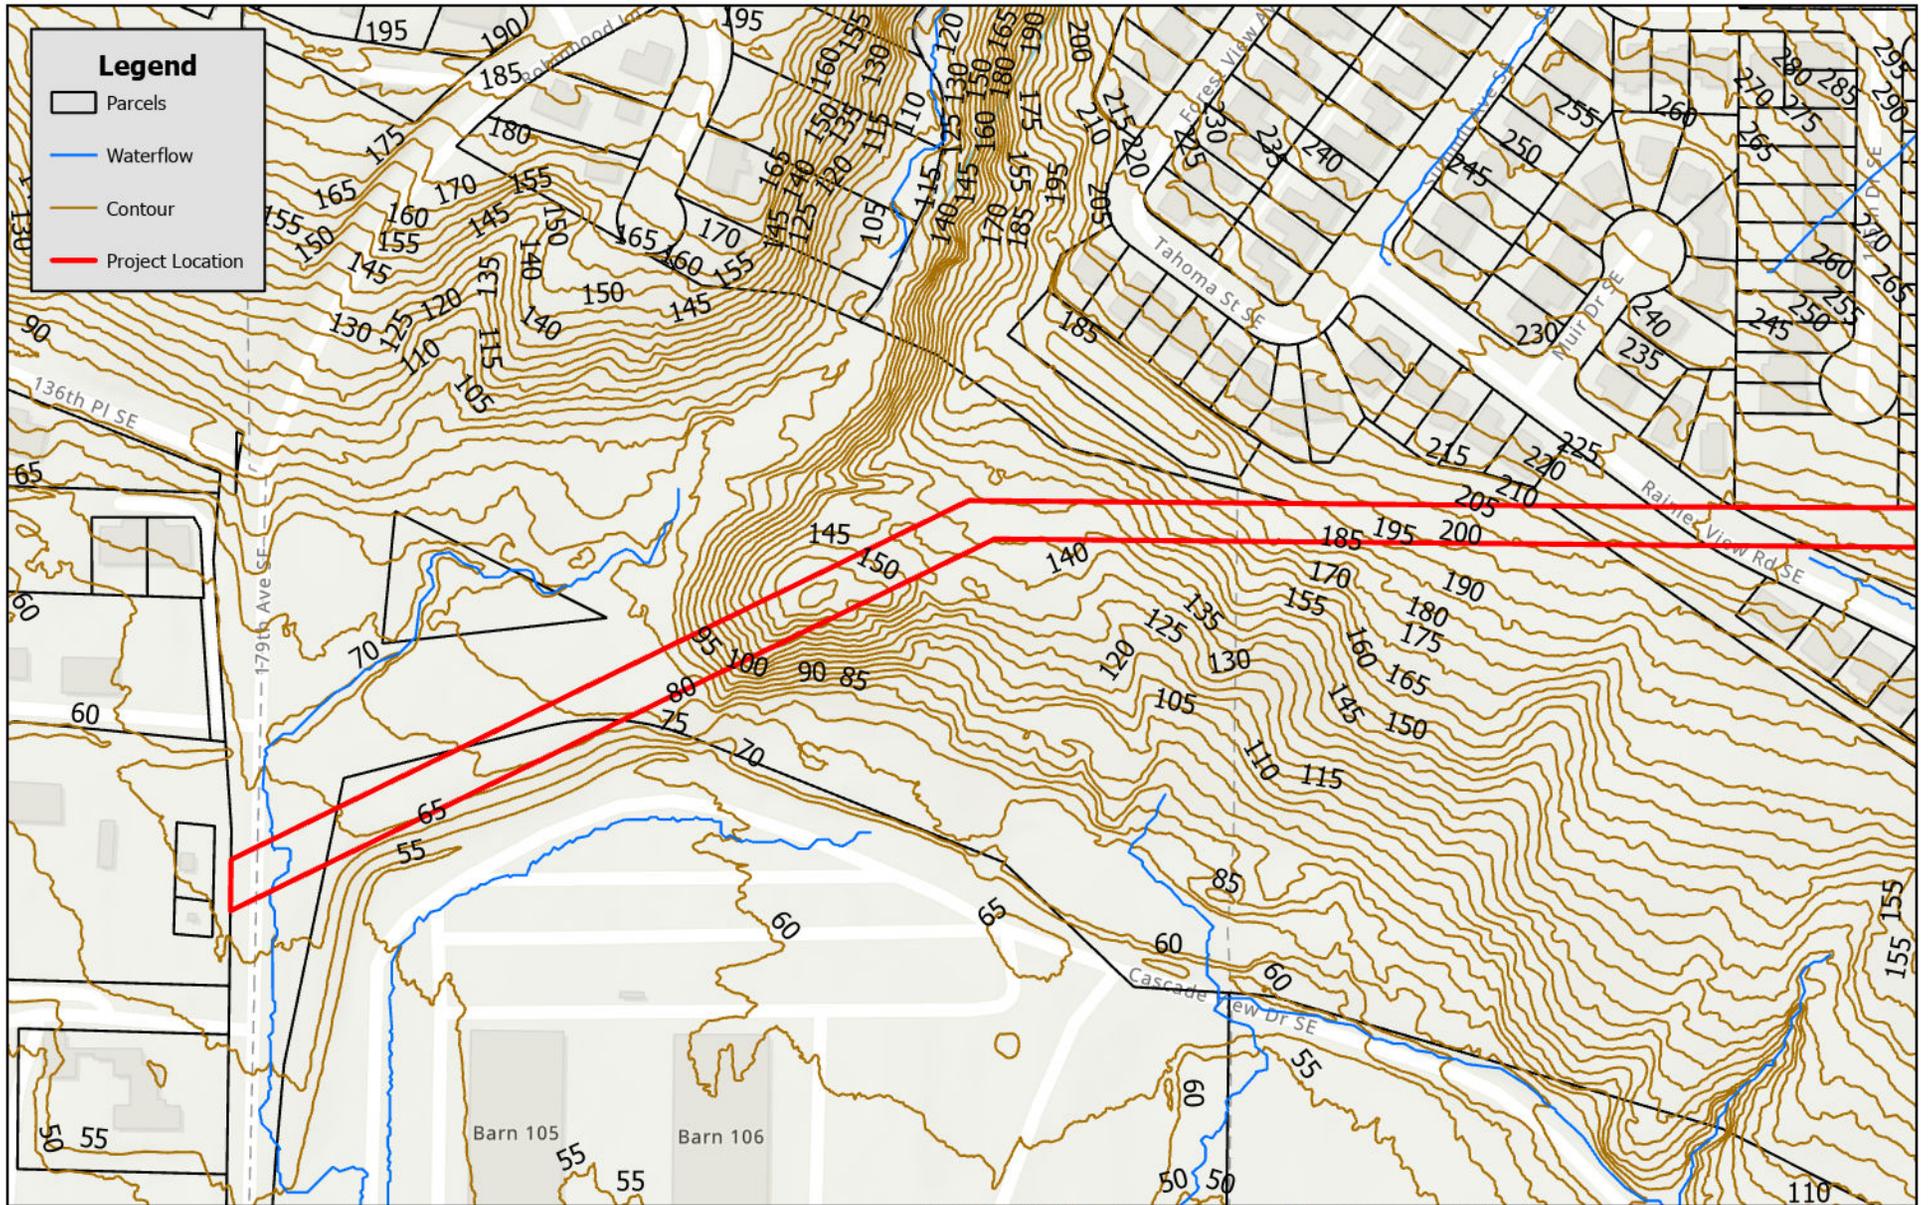
Figure 4a - Water Vector Map
 Trombley Hill AC Water Main Replacement
 Snohomish County, WA

shown within close proximity to the corridor along its southern extent. A water vector map was created using GIS and LIDAR data to produce a slope map that illustrates computed surface flow pathways (**Appendix A/Figure 4a, b, c**). The drainage lines depicted in blue do not represent actual streams; rather, they indicate the general flow of surface water based on the topography. This figure demonstrates that water generally flows northeast to southwest. The tributary to French Creek is depicted along the north side of the corridor through a drainage draw (**Appendix A/Figure 4a**).

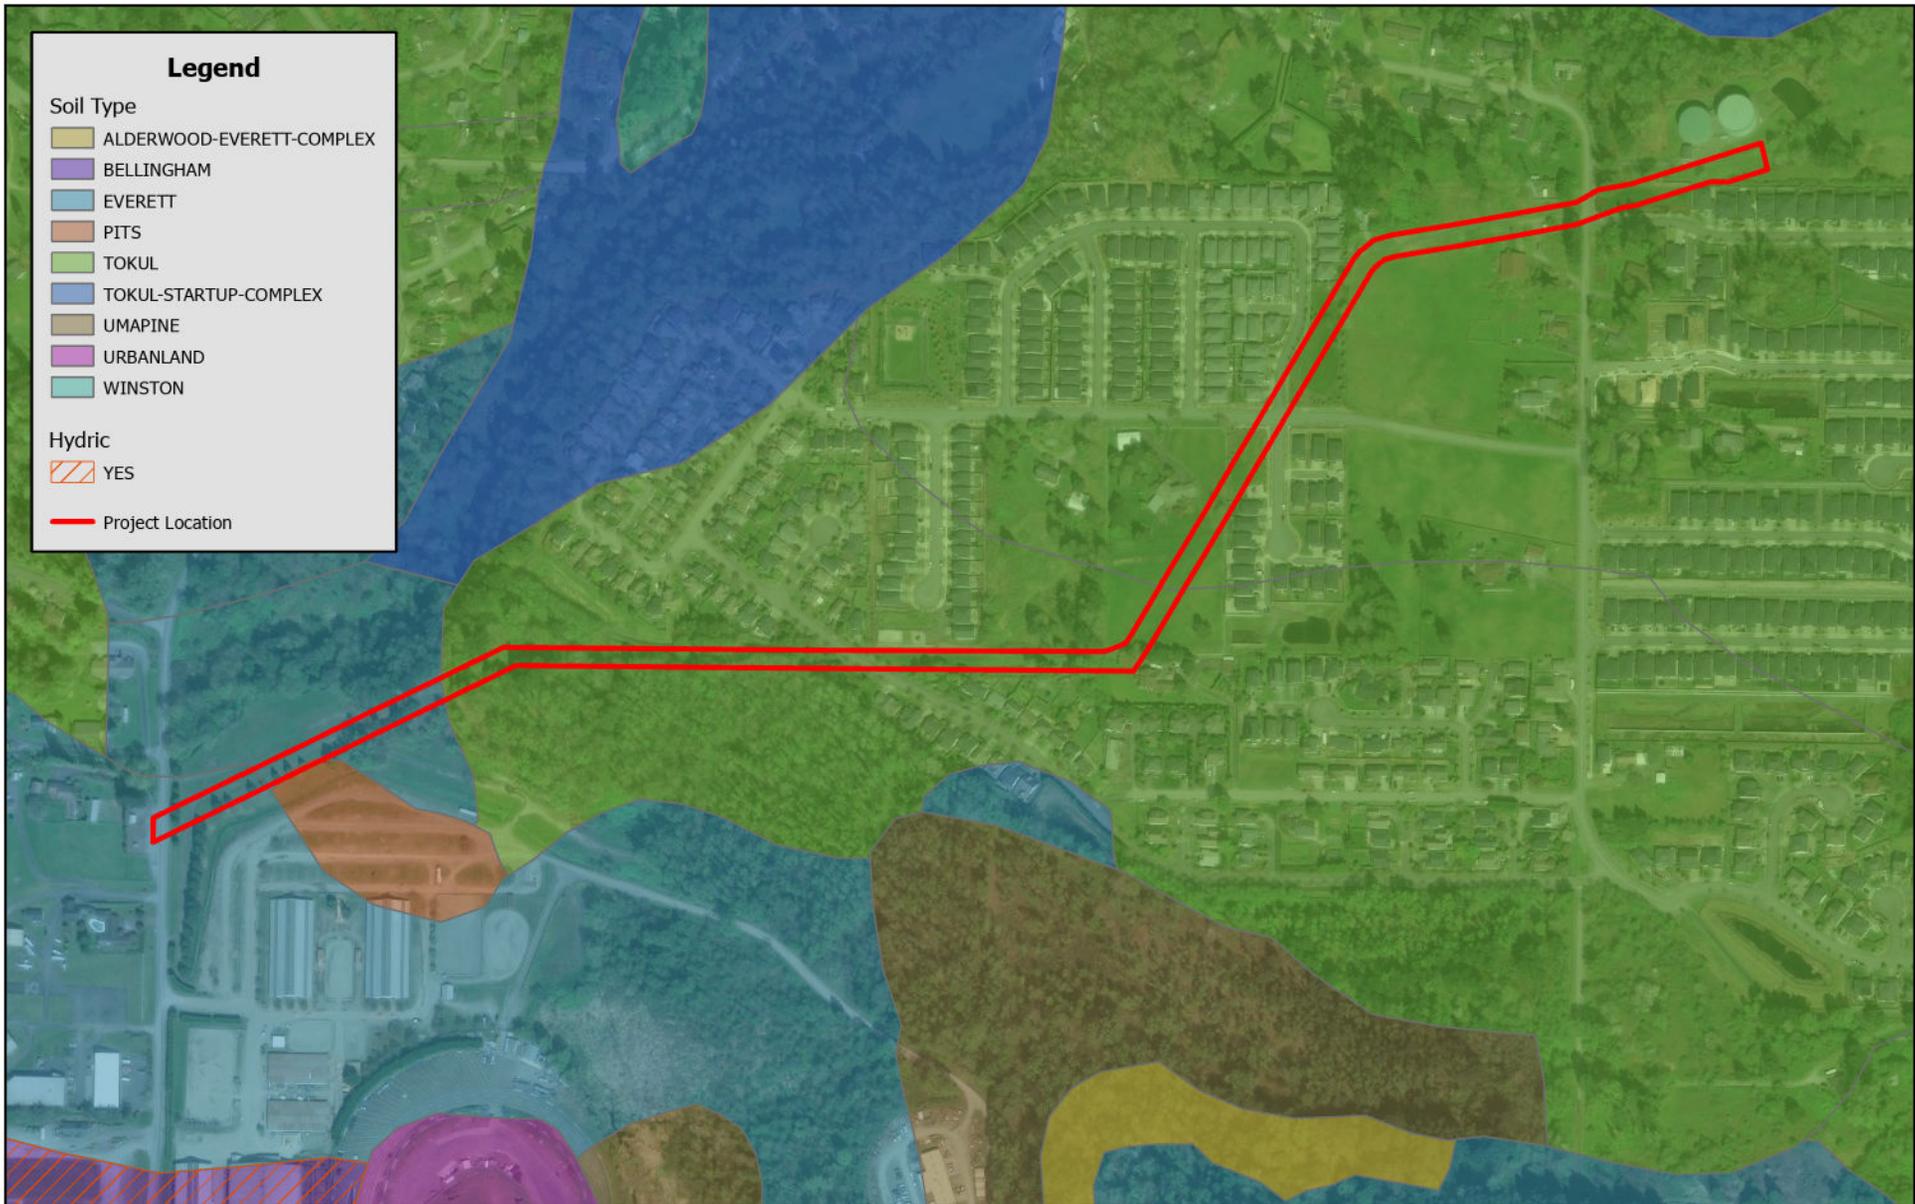
Figure 6 - Soil Survey Map
 Trombley Hill AC Water Main Replacement
 Snohomish County, WA

According to the Natural Resources Conservation Service (NRCS) Soil Survey (2011), a majority of the site is mapped as Tokul with Everett series soil along the south quarter (**Appendix A/Figure 6**). These soil series formed in glacial outwash and glacial till, respectively.

Tokul soils typically feature a surface mantle of gravelly loam over dense glacial till and are moderately well-drained, with moderate to slow permeability due to the underlying compact till. Both soil types are classified as non-hydric; however, Tokul soils may exhibit hydric characteristics in localized depressions or seasonally saturated areas where water accumulates above restrictive layers. Perched or migrating subsurface water may be present in low-lying portions of the site, particularly where compact till or buried restrictive horizons impede drainage. Everett soils are characterized by gravelly sandy loam surface horizons underlain by stratified sandy and gravelly outwash and are somewhat excessively drained with rapid permeability.
