**Drainage Report**  
**MG Properties, LLC Short Plat**  
PN: M2016-00xx

**MG Monroe Properties Inc.**

10X Dickinson Street  
Monroe, WA 98272

Job No: 06-053  
June 2016

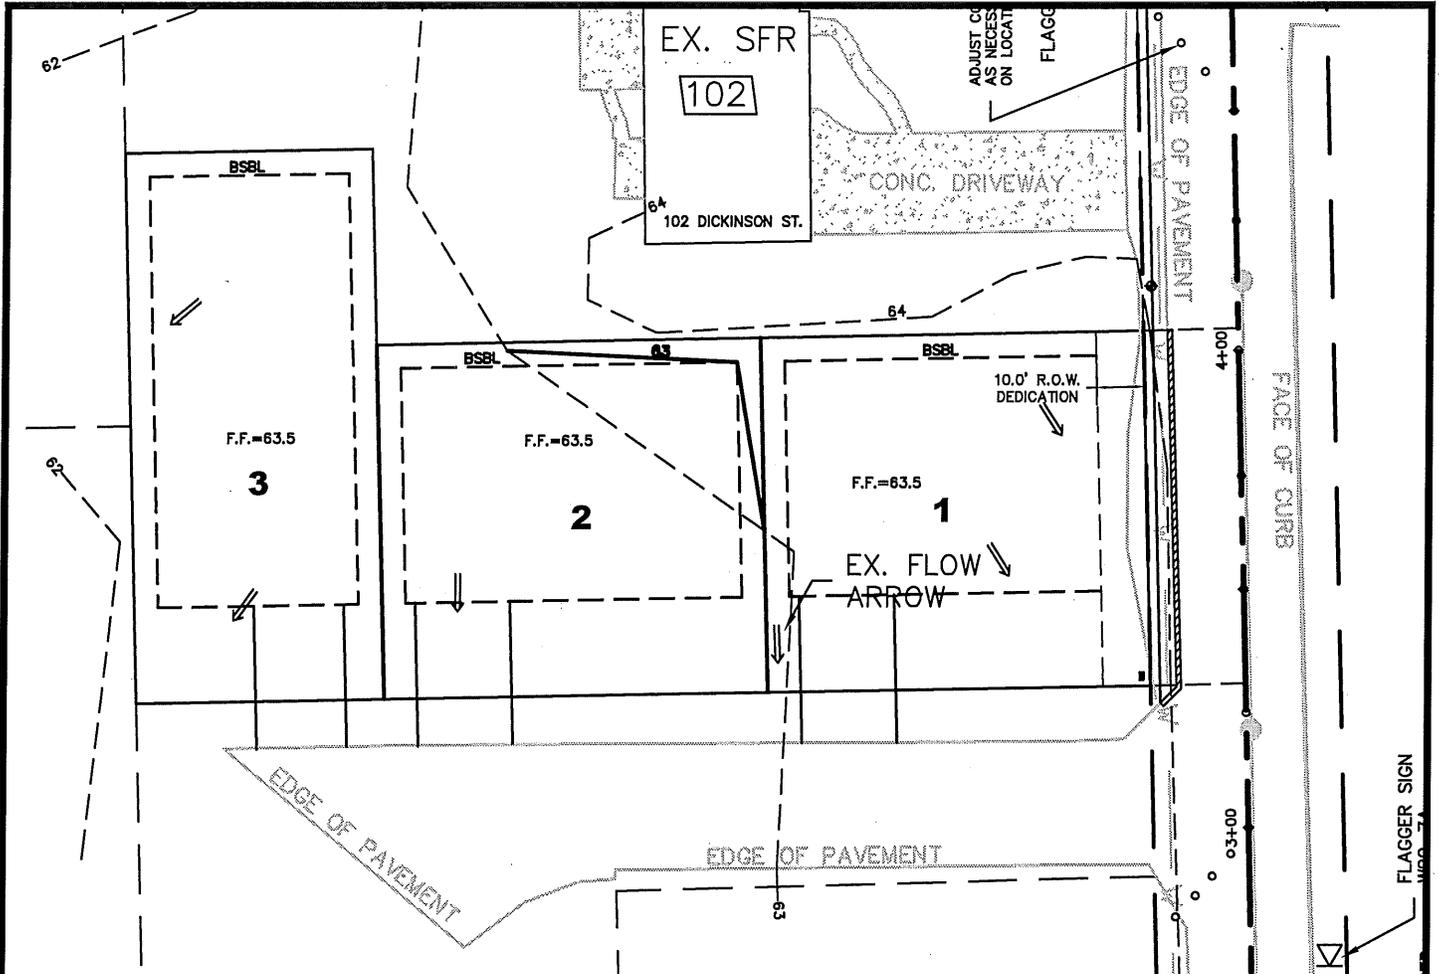
EXISTING BASIN MAP  
ANDERSON 3-LOT S.P.

**GROUND COVER/SOIL TYPE:**

1. THIS SITE IS COVERED IN GRASSES WITH OTHER LANDSCAPING.
2. PROPOSED SITE COVER WILL CONTAIN LANDSCAPING, DRIVEWAYS AND BUILDINGS.
3. SITE SOIL TYPES ARE SULTAN SILT LOAM (TYPE B/C, TILL), WITH GRAVELLY SANDS AT 4-6'.

The existing site is irregular in shape approximately 215-feet long running east-west and 75-feet running north-south. The grades on the site are flat. The vegetation found on the existing property is grasses with some trees.

Grades on the site generally are flat and slope slightly to the south. Runoff if any, would generally sheet flow across the south property line and be collected by the storm system south of the existing drive. A site visit was conducted on May 26, 2006. The weather was overcast with temperatures in the 50's. No surface water was observed on this site.

The soil hydrologic types for this site have been identified as Type C or Till from the Snohomish County Soil Survey Map, see figure 4. The soil type mapped for this site is, Sultan silt loam. Soil tests on this site found a gravelly sands under lying this top layer of silt loam, therefore infiltration will be used for this project. Soil test pits were logged on this and the adjacent site to the north. The soil was classified using the USCS. The 2005 DOE manual provides long term infiltration rates to use for infiltration facility sizing based on the USCS method. For the gravelly sand soils the maximum rate is 10"/hr. However, since no testing was done to confirm this rate additional safety factors will be applied to the rate. For this project an additional safety factor of 2.85 will be used, which results in a design infiltration rate of 3.5"/hr. The gravelly sand soils were found in a range of 4-6.5' below existing grade. Refer to Appendix A for a copy of the soil logs on this and the adjacent site.

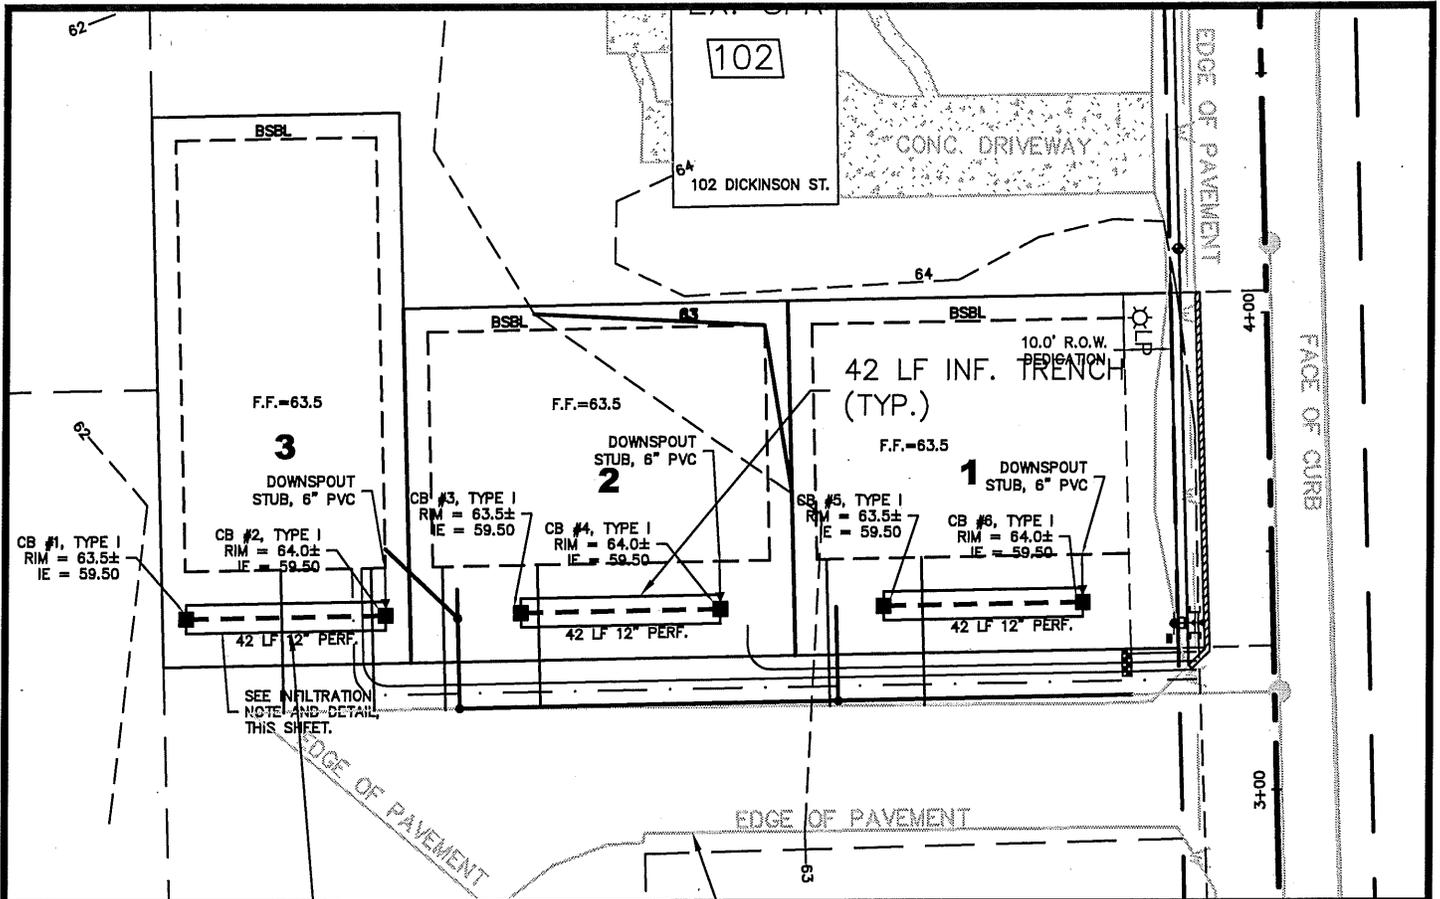
DEVELOPED BASIN MAP  
 ANDERSON 3-LOT S.P.

DRIVE TO BE OVERLAPPED WITH 2" ASPHALT.

INDIVIDUAL INFILTRATION TRENCH SIZED FOR EACH LOT.

The storm drainage system has been sized to account for three future buildings and driveways to be constructed on the new lots. Each lot was assumed to have 3,600 sf of future impervious area. Approximately 60% of each lot was assumed to be impervious surface with the remaining 40% to be landscaped. The proposed infiltration systems will be sized to infiltrate up to the 100-year storm event. Due to the developed nature of the parcels around this project and the flat grades, very little off-site runoff was found entering this site.

All of the project was assumed to be disturbed and the infiltration trenches were sized for both the new impervious and pervious areas. The off-site impervious areas will be allowed to flow in the existing path since the should is already in place and just paved to meet the current City Standards.

The infiltration trench has been designed using the WWHM2 and meets the current State and City standards.
