Monroe West

Drainage Report

Job No: 24-0086

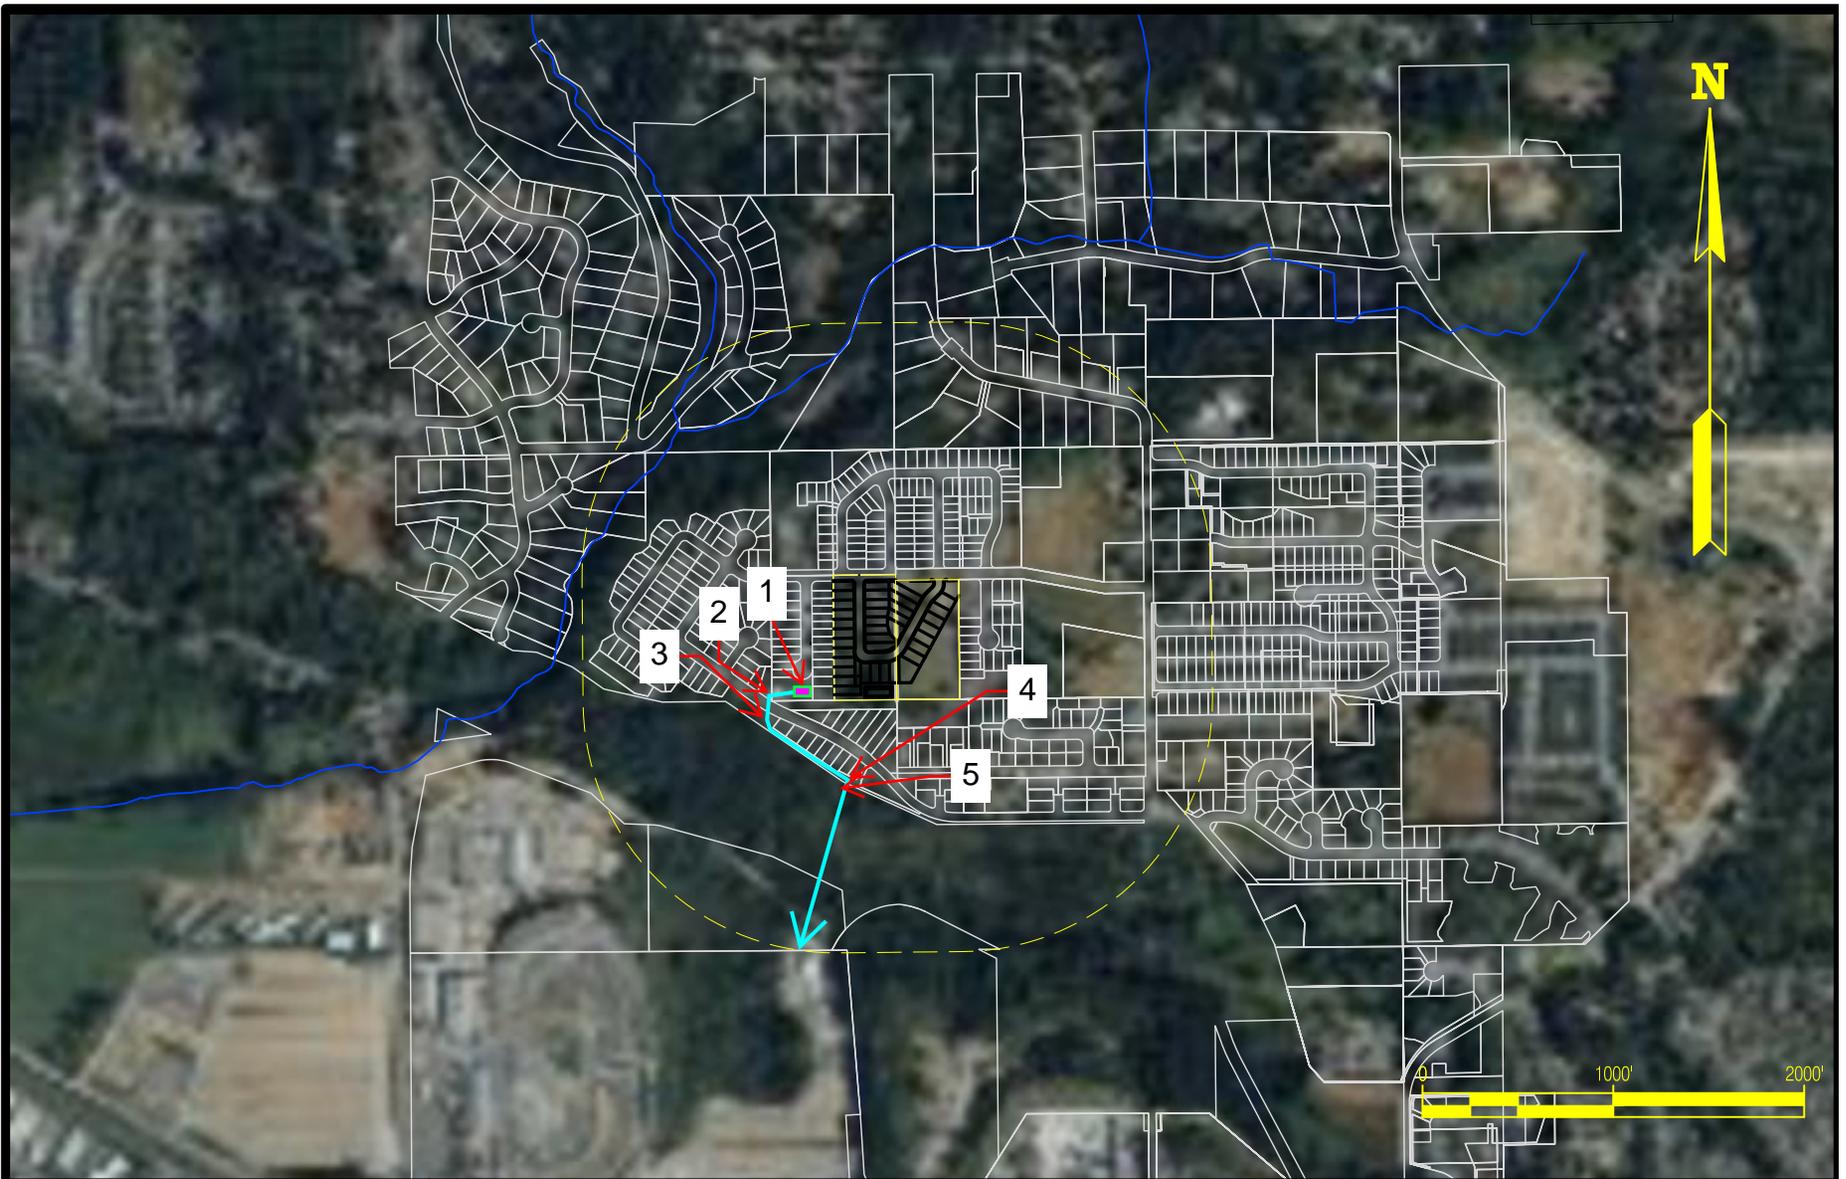
1. Downstream Analysis Map
2. Downstream Analysis Site Visit Pictures
3. USDA Soils Map & Description

One flow path has been identified leaving the southwest corner of the project site. Water flows off the steep grade into an existing stormwater catch basin and travels into the existing stormwater detention center (Image 1) sitting below the cul de sac on 185th Dr SE. Water then travels south across Rainier View Rd SE (Image 2) through existing stormwater infrastructure and then behind the row of houses traveling southeast down Rainier View Rd SE (Image 3) where it eventually discharges down the hill into the wetland area past the ¼ mile boundary of this analysis (Image 4 and 5). See Figure 3.0, “Downstream Analysis Map” in Appendix 3 for a visual representation of current discharge.

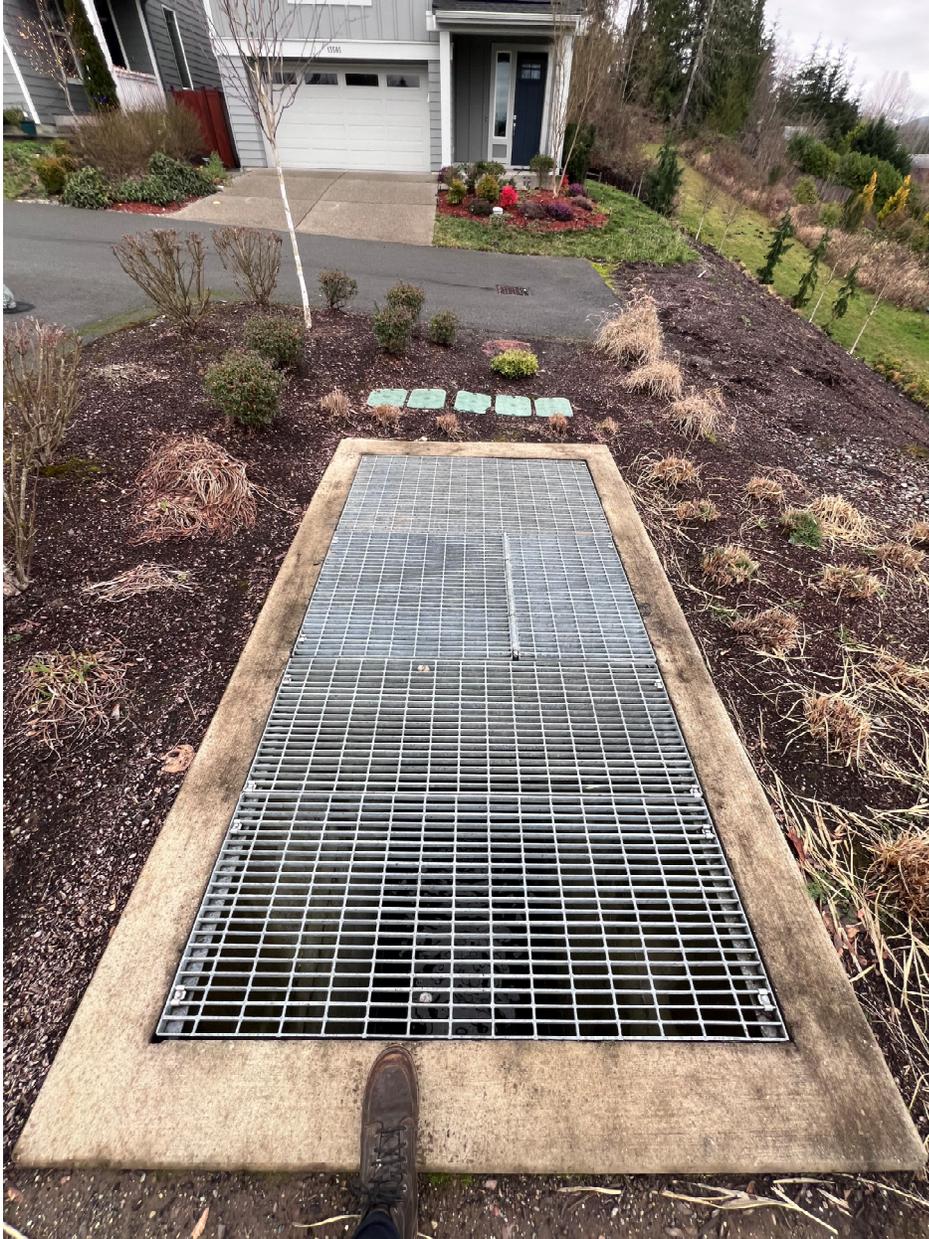
Image 1: Water flows off site to existing detention system east of the southeast corner of the property.

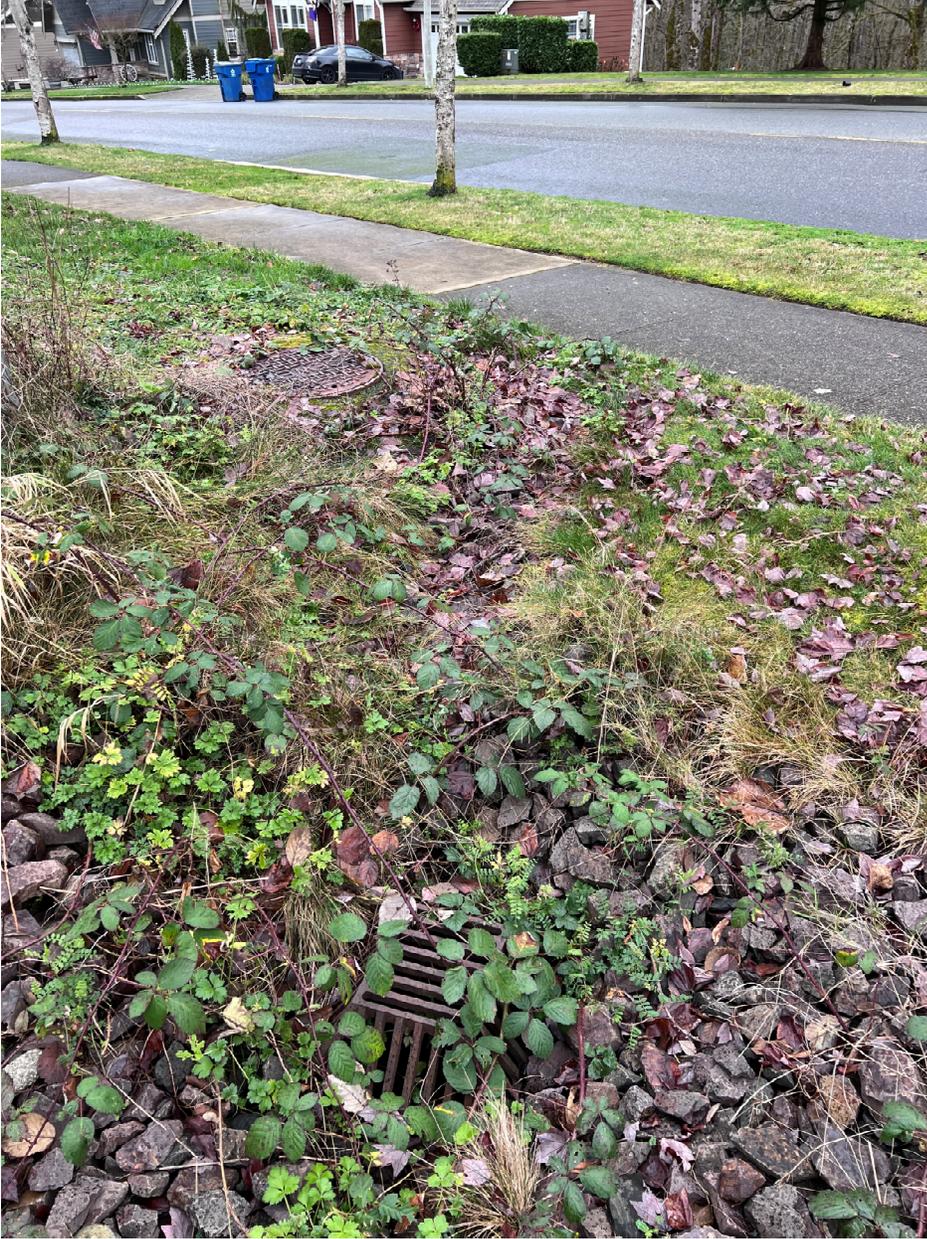
Image 2: Water flows south across Rainier View Rd SE

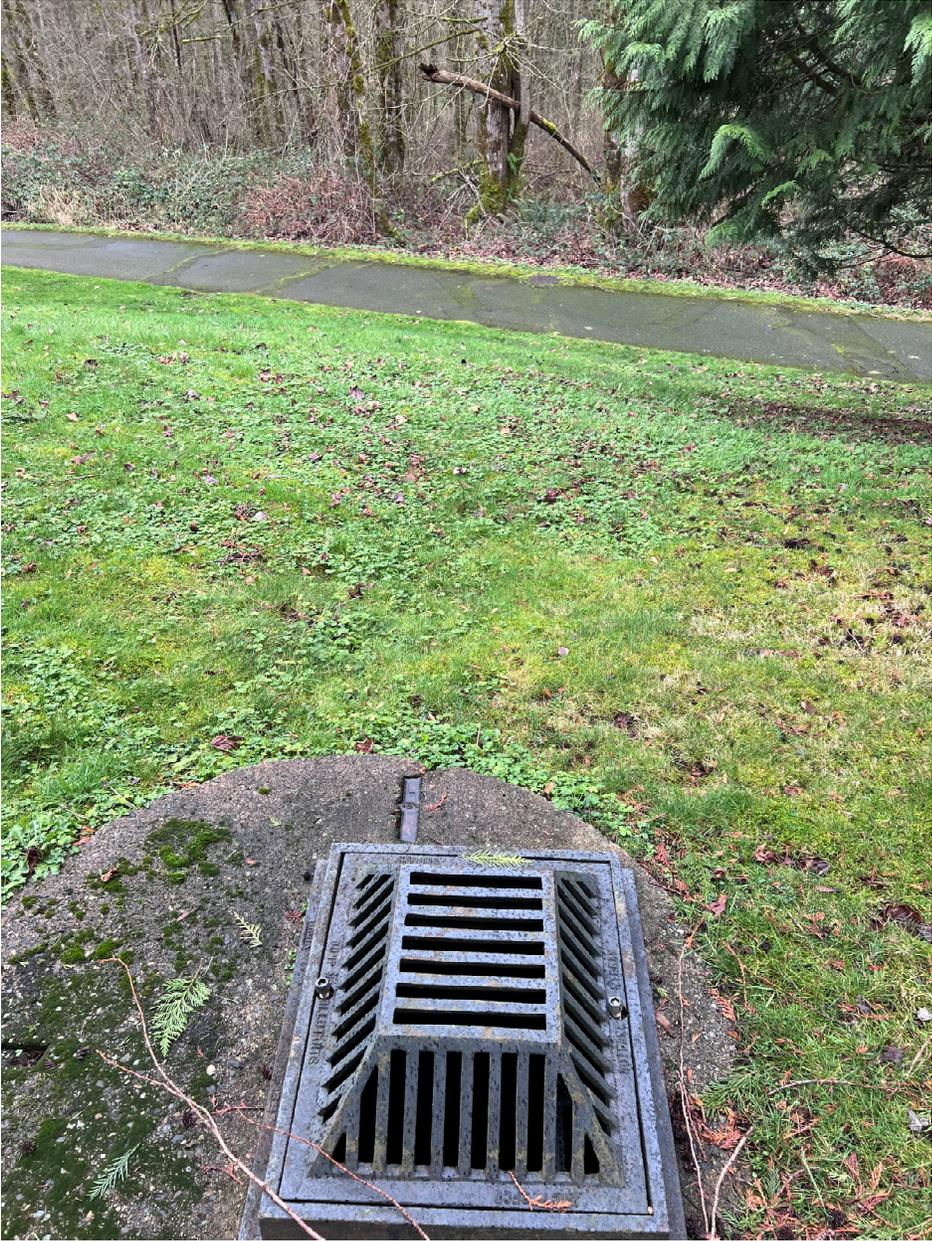
Image 3: Flows then travel southeast following this path behind houses south of Rainier View Rd SE

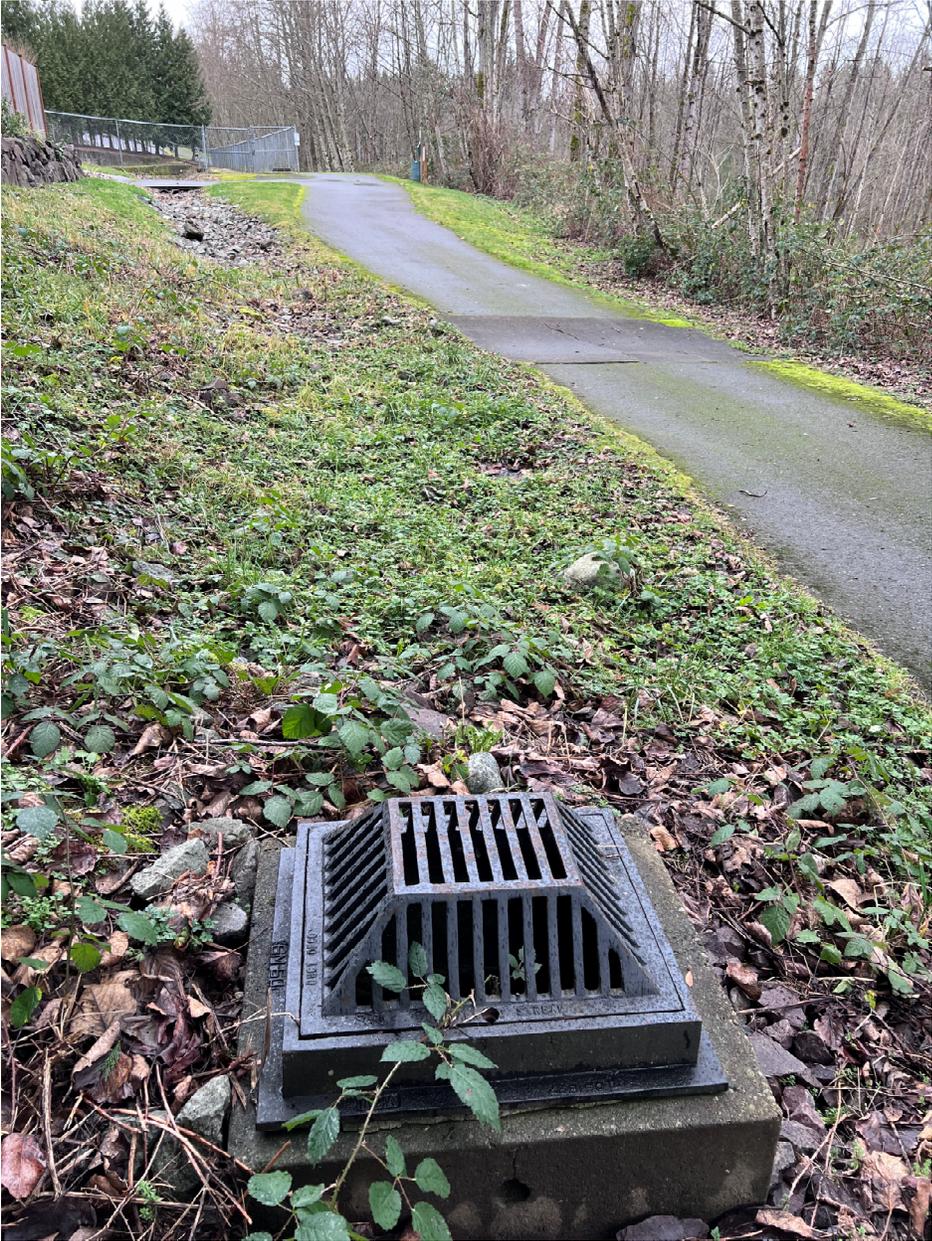
Image 4: flows then converge with another site

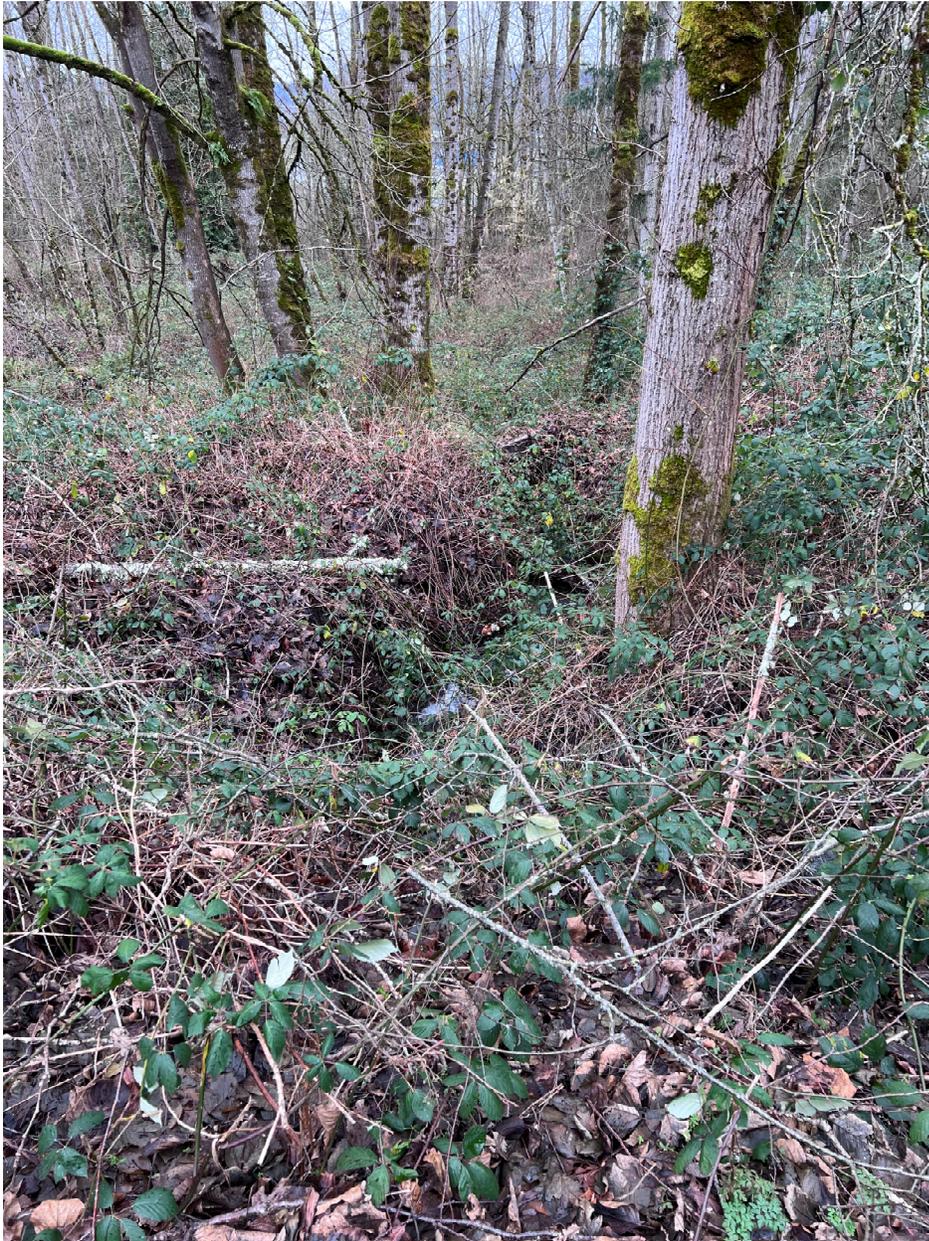
Image 5: flows then discharge down the hill side into a wetland area

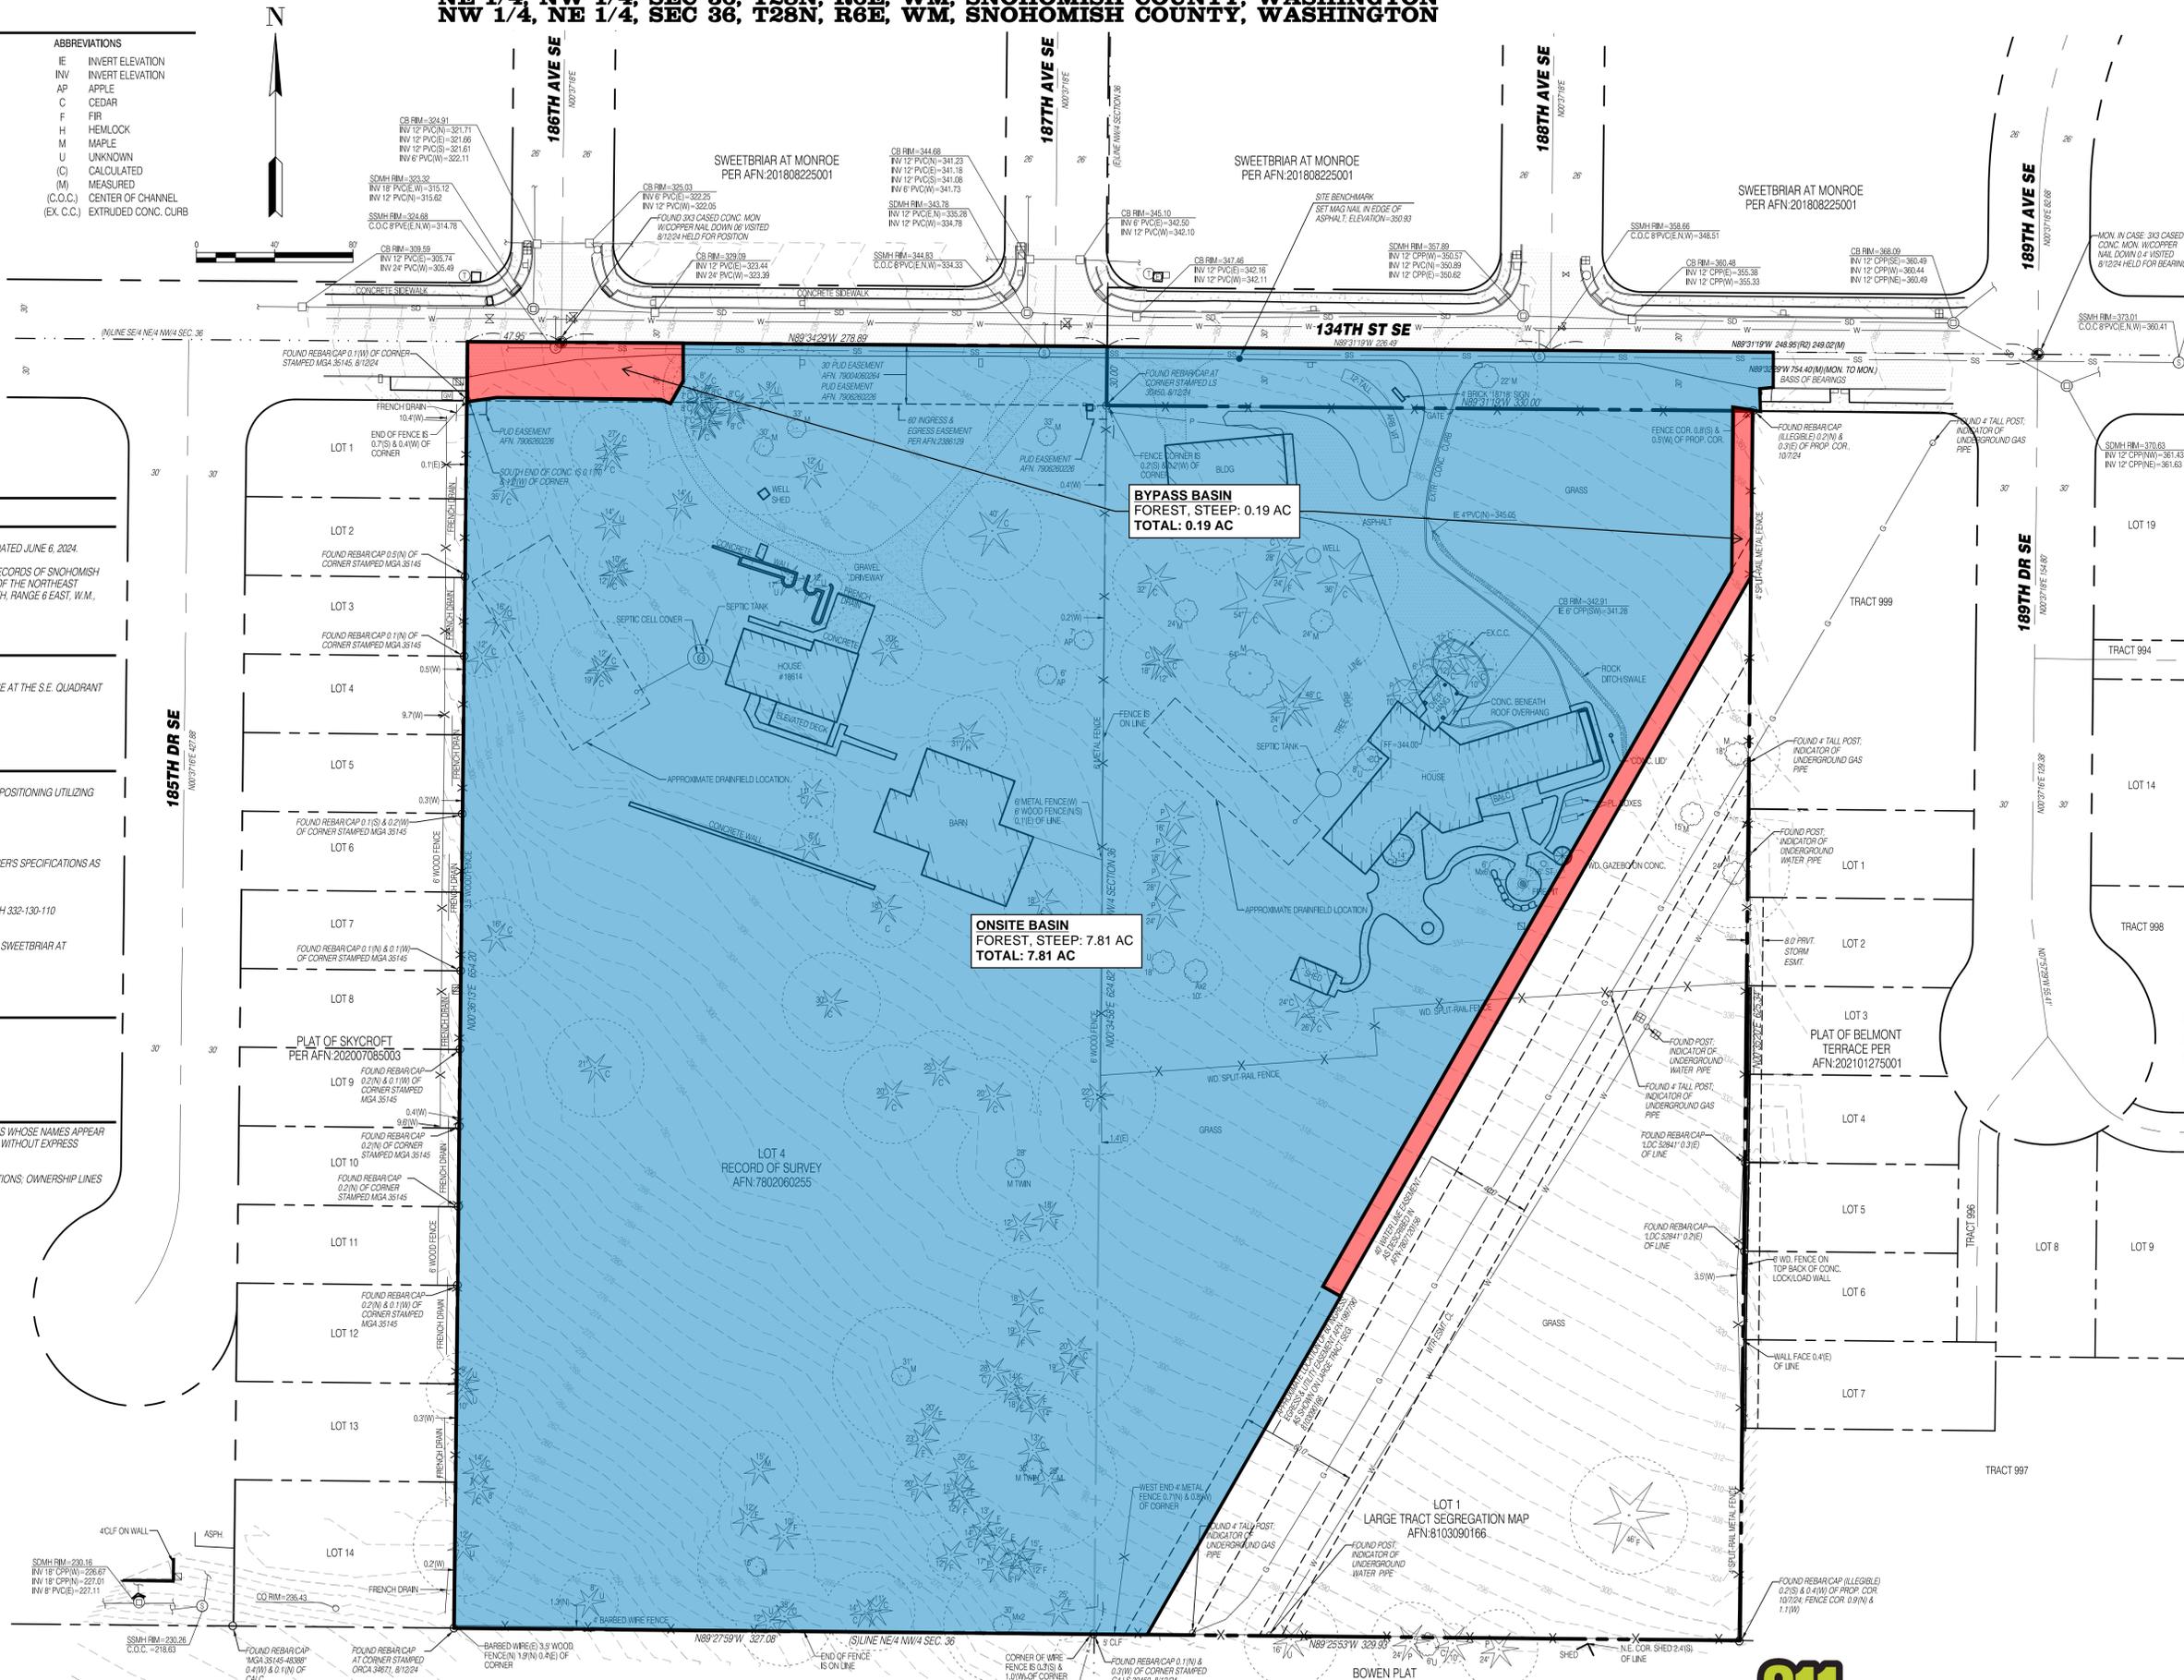
1. Predeveloped Hydrology Map
2. Developed Hydrology Map
3. StormFilter Detail
4. WWHM2012 Output – Detention Vault

The pre-developed and developed conditions were modeled in WWHM for the purpose of peak flow determination for direct discharge. Based on the site location, the WWHM used the Everett Gage with a Precipitation Scale factor of 1.200. For visual representation of the listed basins, see Figure 4.0, "Predeveloped Hydrology Map".

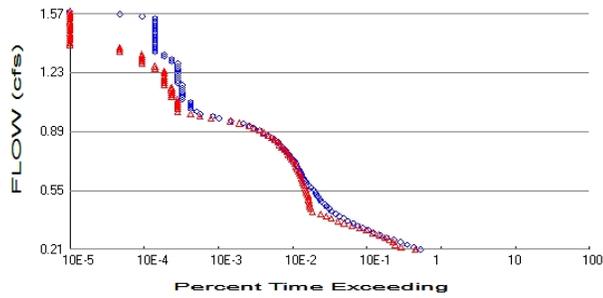
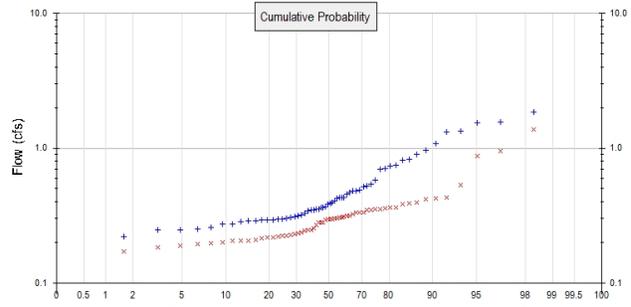
POC 1

+ Predeveloped x Mitigated

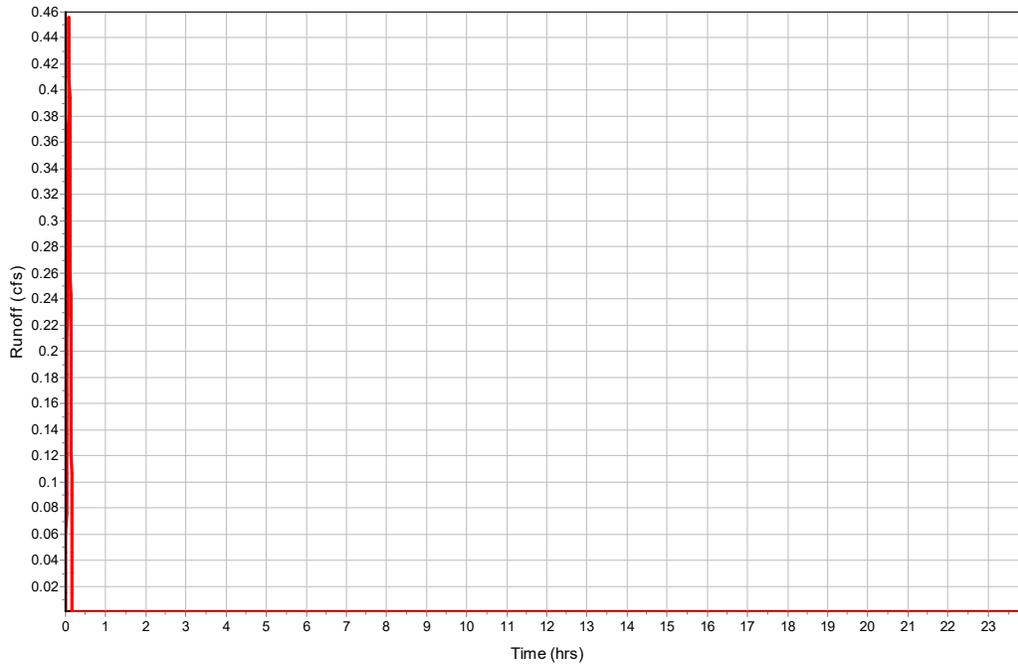
Runoff Hydrograph

Total Rainfall (in) 0.75
Total Runoff (in) 0.54
Peak Runoff (cfs) 0.46
Rainfall Intensity 9.041
Weighted Runoff Coefficient 0.72
Time of Concentration (days hh:mm:ss) 0 00:05:00

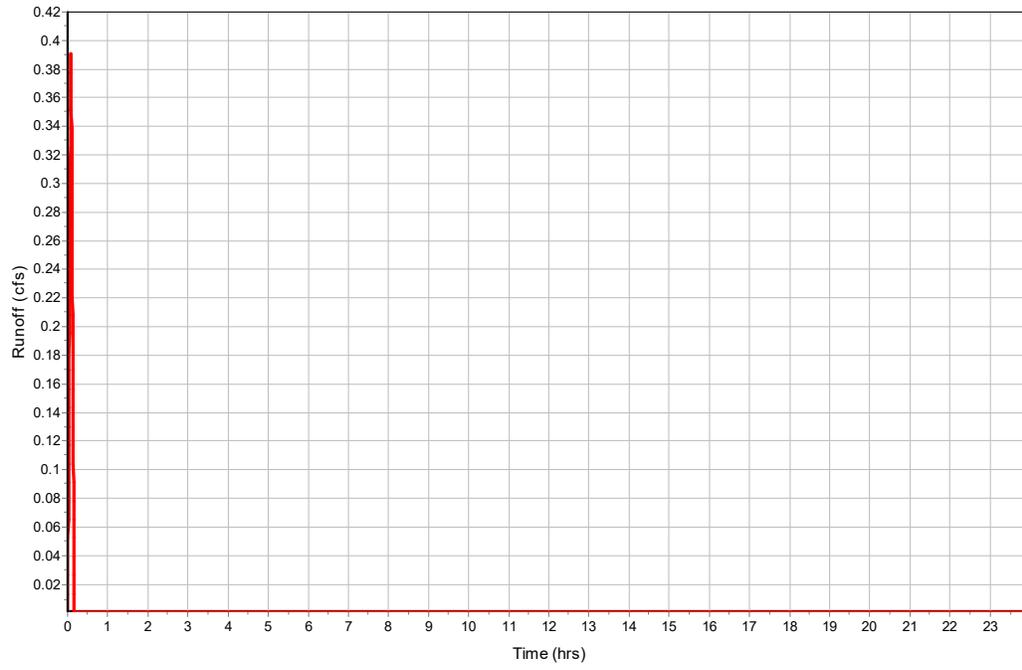
Runoff Hydrograph

Total Rainfall (in) 0.75
Total Runoff (in) 0.54
Peak Runoff (cfs) 0.39
Rainfall Intensity 9.041
Weighted Runoff Coefficient 0.72
Time of Concentration (days hh:mm:ss) 0 00:05:00

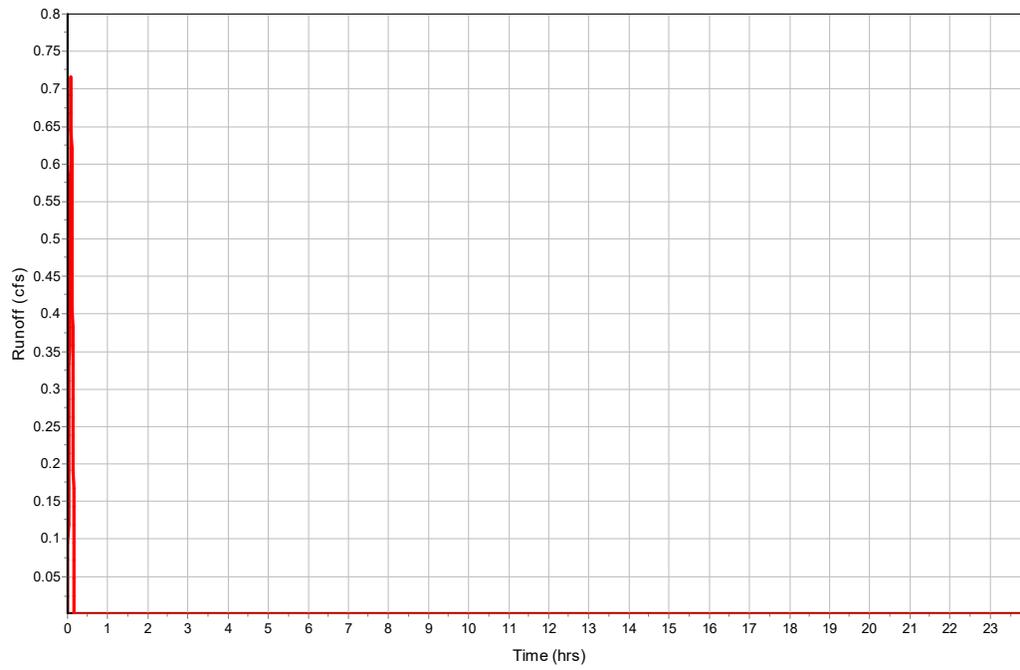
Runoff Hydrograph

Total Rainfall (in) 0.75
Total Runoff (in) 0.54
Peak Runoff (cfs) 0.72
Rainfall Intensity 9.041
Weighted Runoff Coefficient 0.72
Time of Concentration (days hh:mm:ss) 0 00:05:00

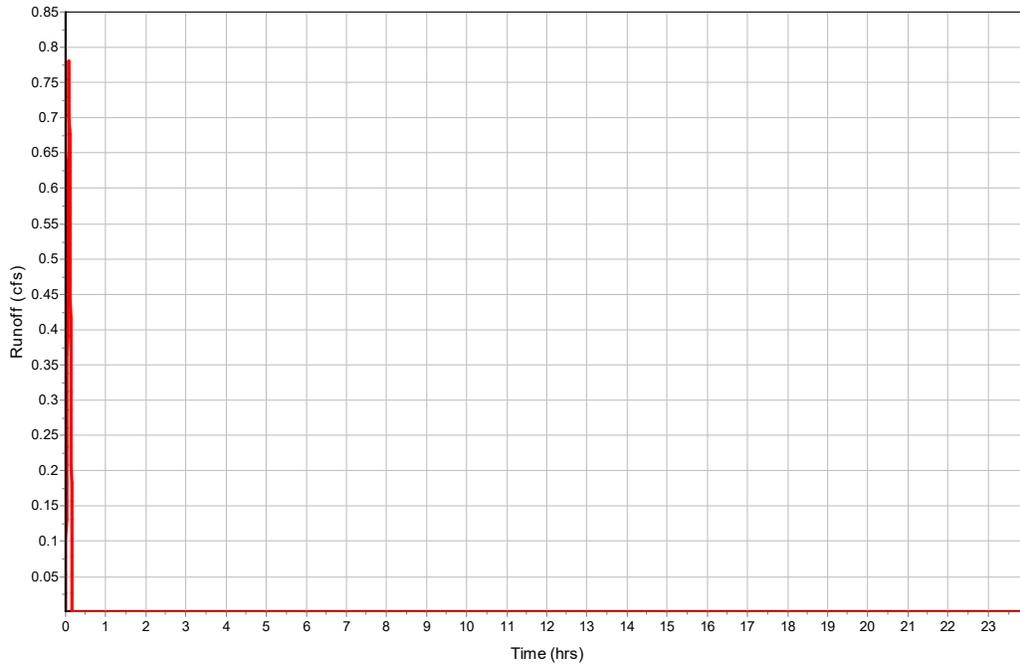
Runoff Hydrograph

Total Rainfall (in) 0.75
Total Runoff (in) 0.54
Peak Runoff (cfs) 0.78
Rainfall Intensity 9.041
Weighted Runoff Coefficient 0.72
Time of Concentration (days hh:mm:ss) 0 00:05:00

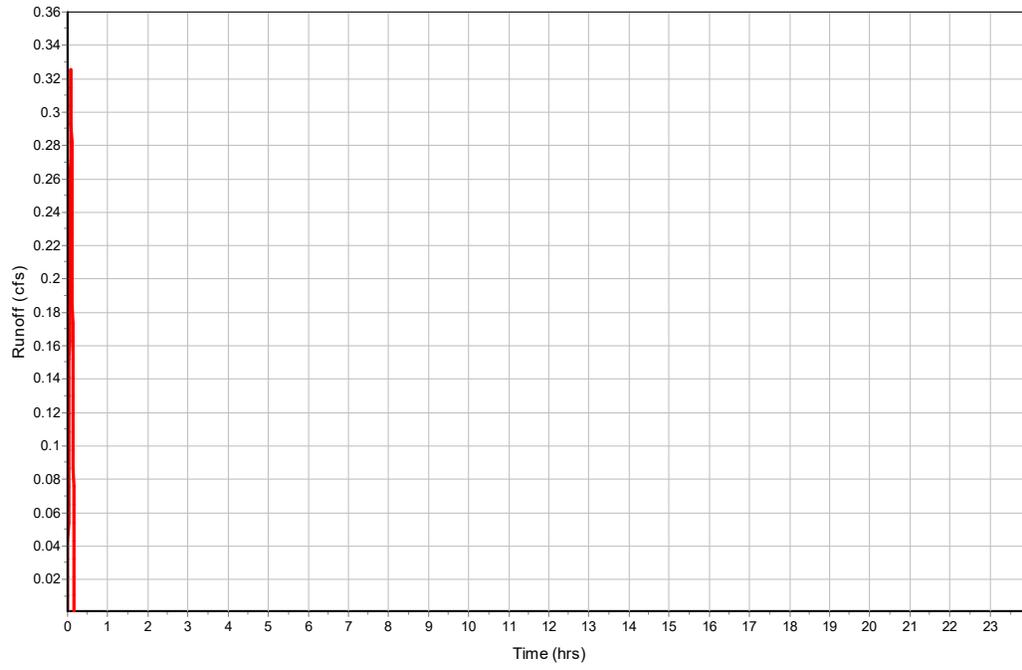
Runoff Hydrograph

Total Rainfall (in) 0.75
Total Runoff (in) 0.54
Peak Runoff (cfs) 0.33
Rainfall Intensity 9.041
Weighted Runoff Coefficient 0.72
Time of Concentration (days hh:mm:ss) 0 00:05:00

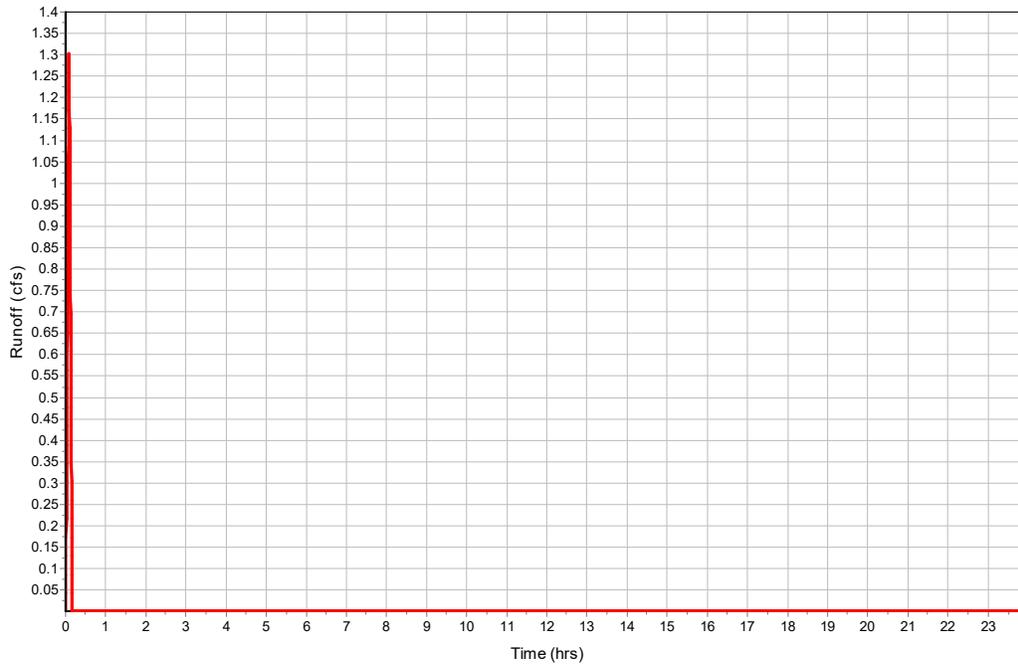
Runoff Hydrograph

Total Rainfall (in) 0.75
Total Runoff (in) 0.54
Peak Runoff (cfs) 1.3
Rainfall Intensity 9.041
Weighted Runoff Coefficient 0.72
Time of Concentration (days hh:mm:ss) 0 00:05:00

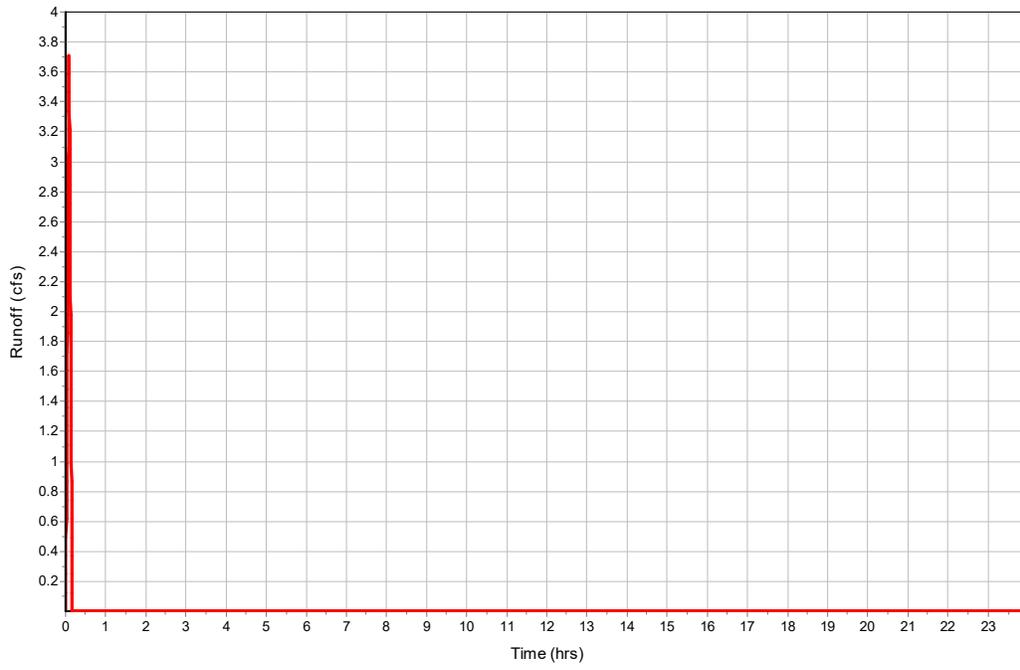
Runoff Hydrograph

Total Rainfall (in) 0.75
Total Runoff (in) 0.54
Peak Runoff (cfs) 3.71
Rainfall Intensity 9.041
Weighted Runoff Coefficient 0.72
Time of Concentration (days hh:mm:ss) 0 00:05:00

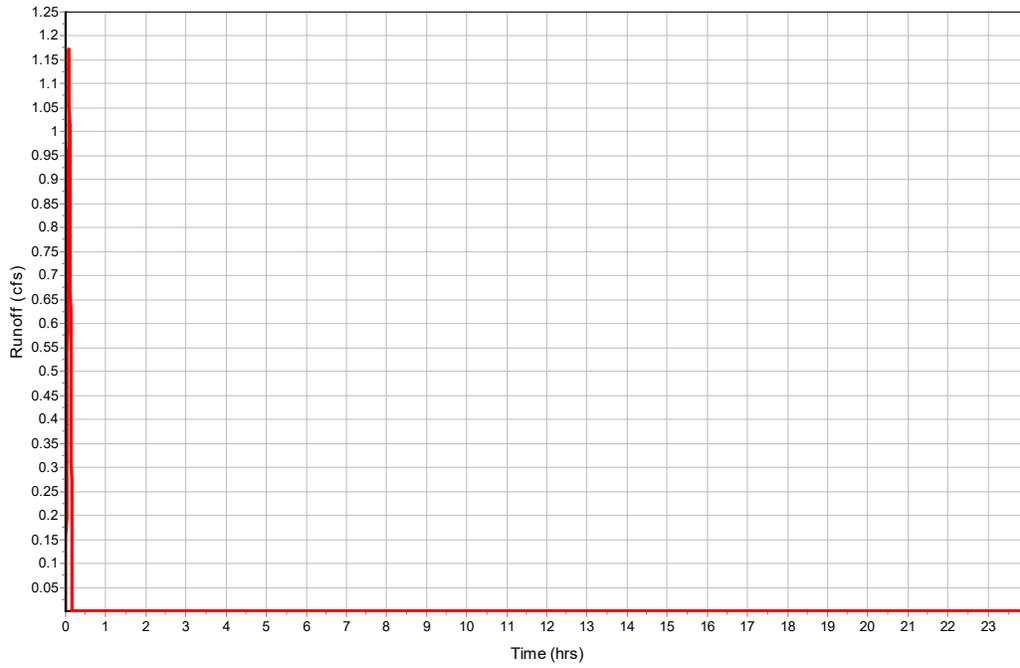
Runoff Hydrograph

Total Rainfall (in) 0.75
Total Runoff (in) 0.54
Peak Runoff (cfs) 1.17
Rainfall Intensity 9.041
Weighted Runoff Coefficient 0.72
Time of Concentration (days hh:mm:ss) 0 00:05:00

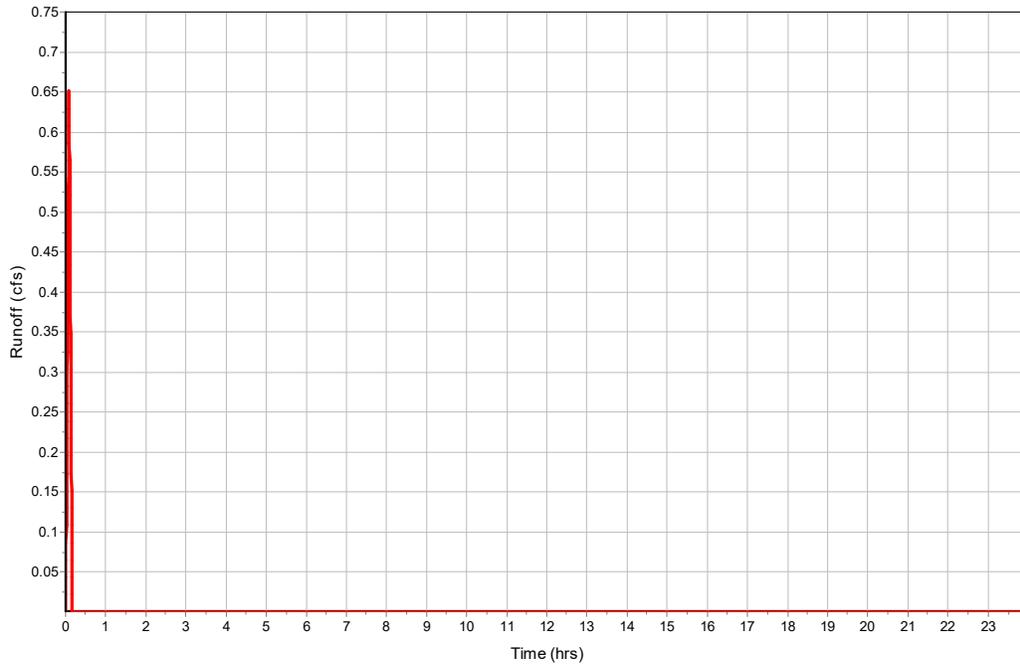
Runoff Hydrograph

Total Rainfall (in) 0.75
Total Runoff (in) 0.54
Peak Runoff (cfs) 0.65
Rainfall Intensity 9.041
Weighted Runoff Coefficient 0.72
Time of Concentration (days hh:mm:ss) 0 00:05:00

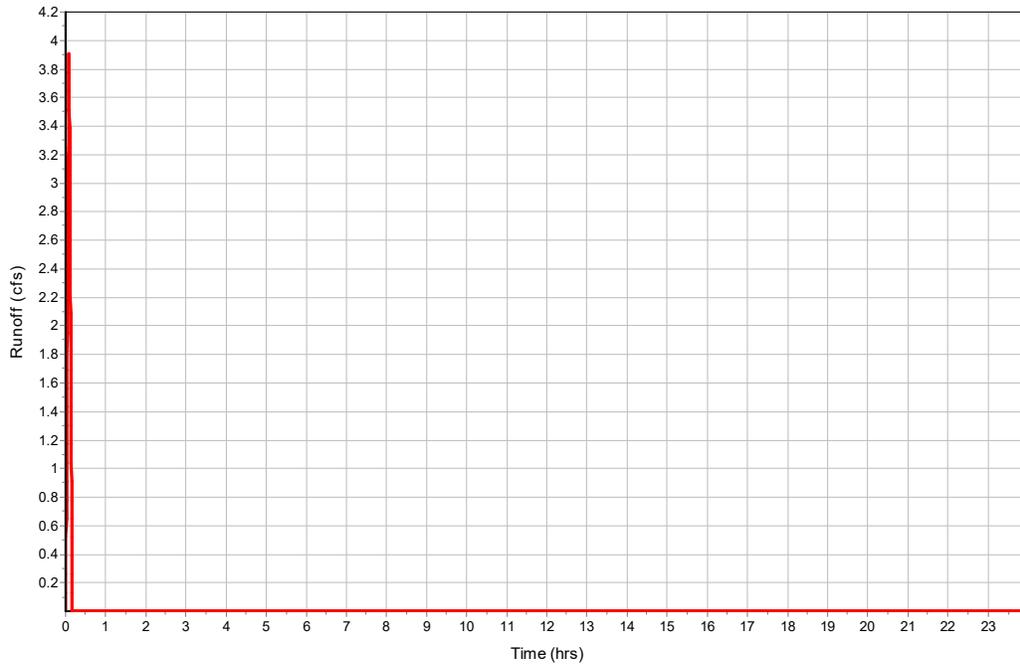
Runoff Hydrograph

Total Rainfall (in) 0.75
Total Runoff (in) 0.54
Peak Runoff (cfs) 3.91
Rainfall Intensity 9.041
Weighted Runoff Coefficient 0.72
Time of Concentration (days hh:mm:ss) 0 00:05:00

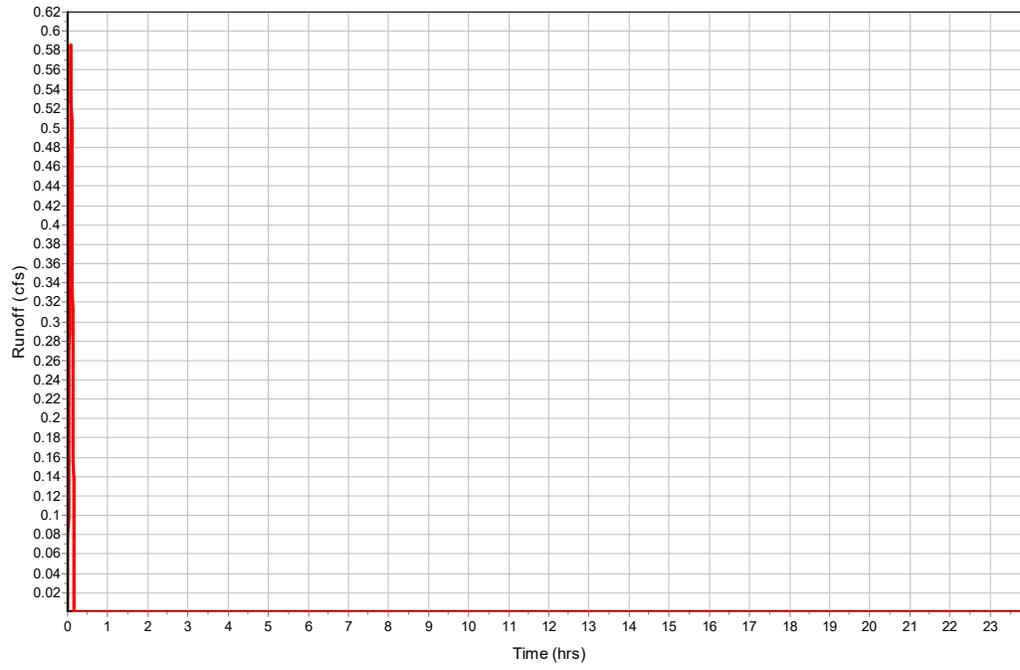
Runoff Hydrograph

Total Rainfall (in) 0.75
Total Runoff (in) 0.54
Peak Runoff (cfs) 0.59
Rainfall Intensity 9.041
Weighted Runoff Coefficient 0.72
Time of Concentration (days hh:mm:ss) 0 00:05:00

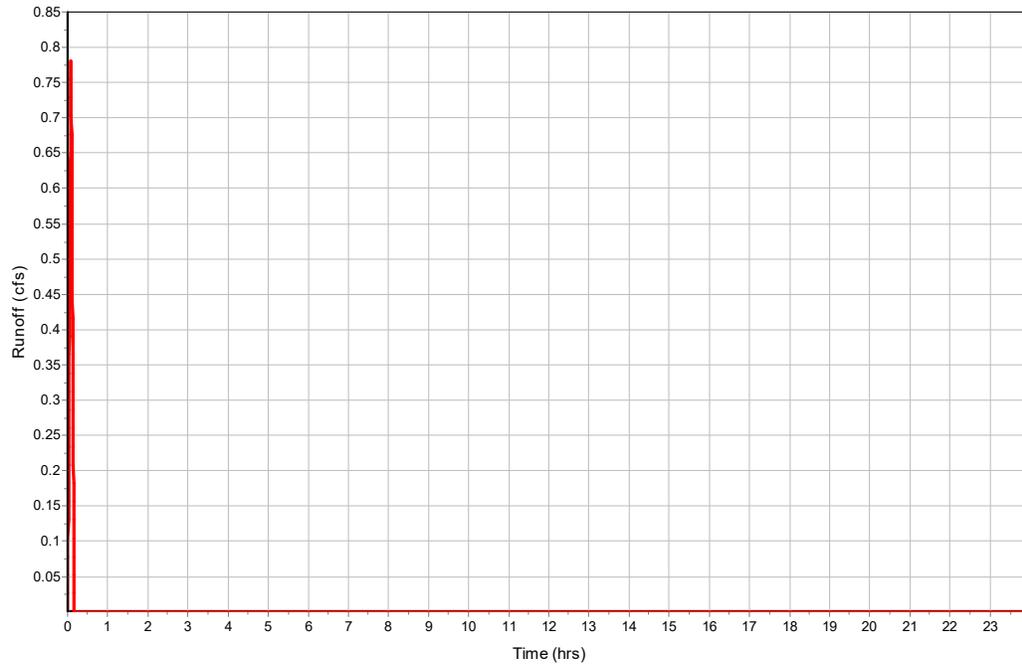
Runoff Hydrograph

Total Rainfall (in) 0.75
Total Runoff (in) 0.54
Peak Runoff (cfs) 0.78
Rainfall Intensity 9.041
Weighted Runoff Coefficient 0.72
Time of Concentration (days hh:mm:ss) 0 00:05:00

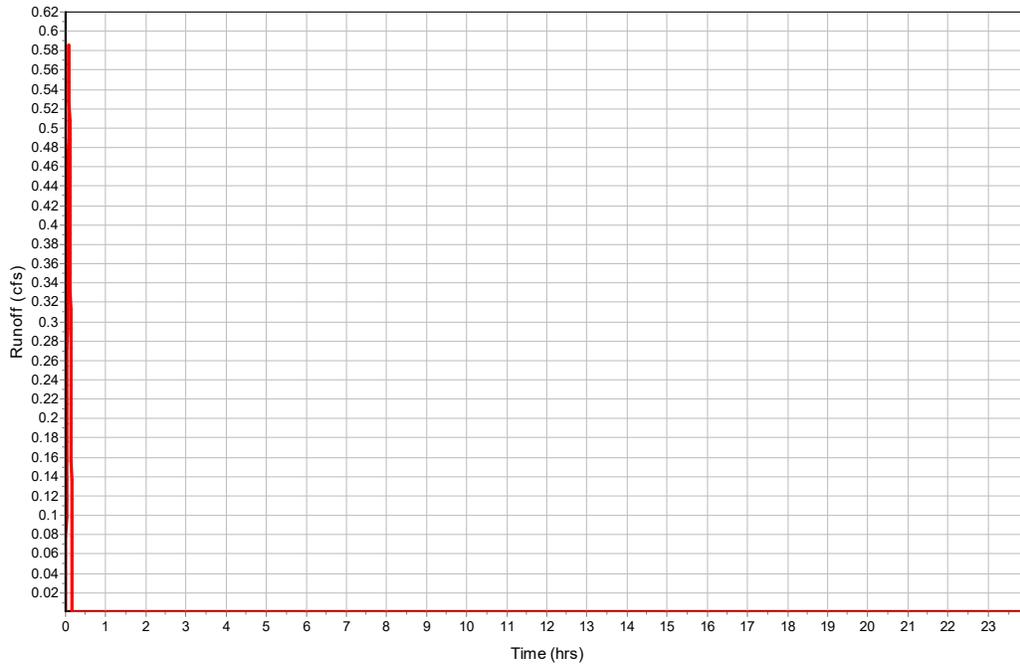
Runoff Hydrograph

Total Rainfall (in) 0.75
Total Runoff (in) 0.54
Peak Runoff (cfs) 0.59
Rainfall Intensity 9.041
Weighted Runoff Coefficient 0.72
Time of Concentration (days hh:mm:ss) 0 00:05:00

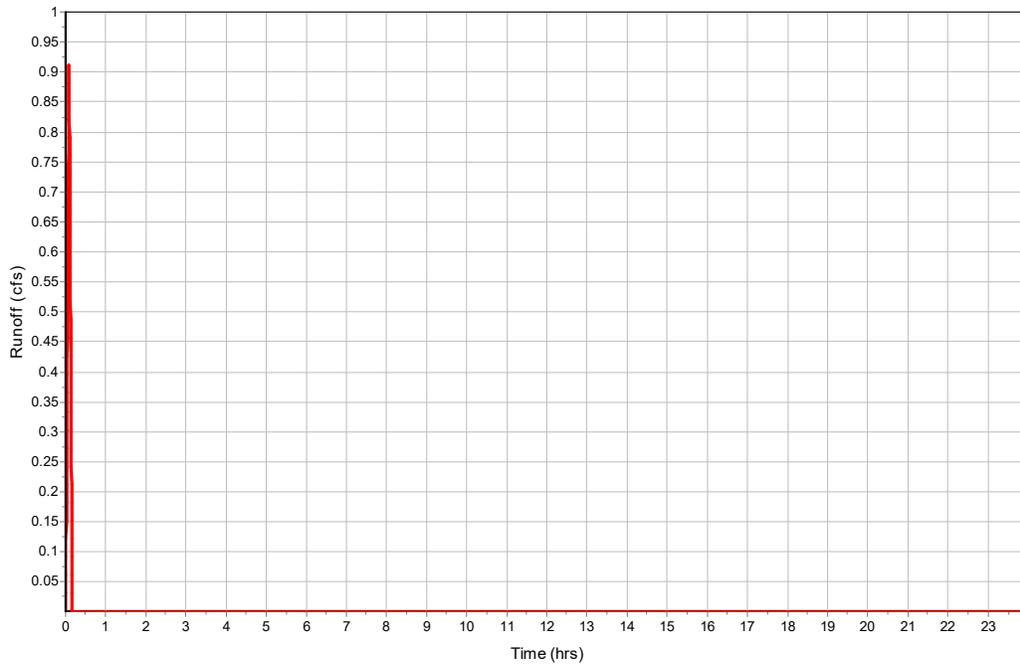
Runoff Hydrograph

Total Rainfall (in) 0.75
Total Runoff (in) 0.54
Peak Runoff (cfs) 0.91
Rainfall Intensity 9.041
Weighted Runoff Coefficient 0.72
Time of Concentration (days hh:mm:ss) 0 00:05:00
