Monroe West

Drainage Report

Job No: 24-0086

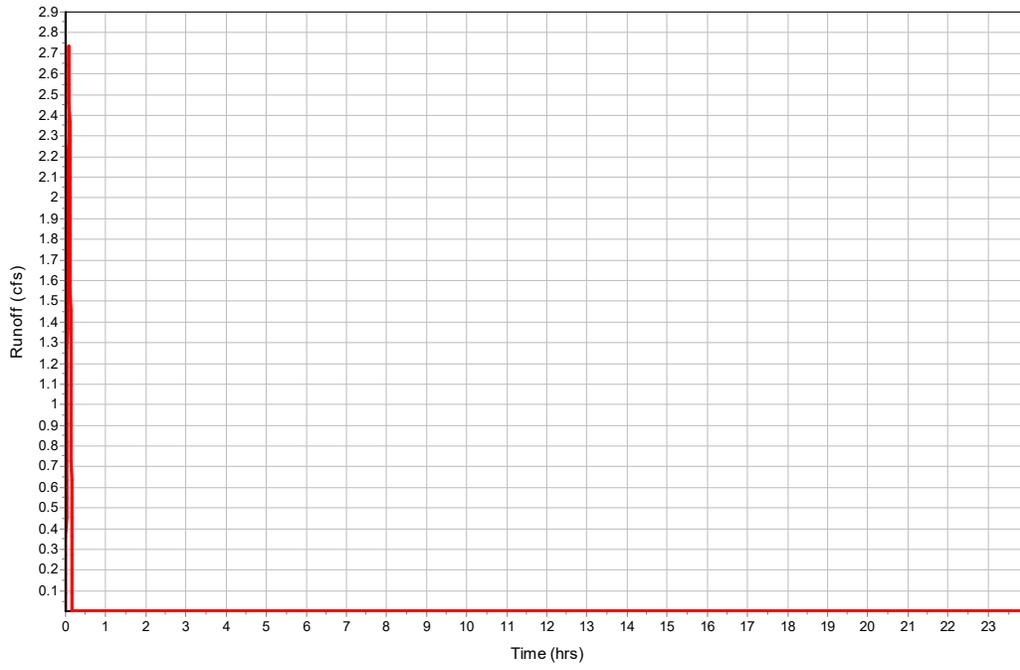
Runoff Hydrograph

Total Rainfall (in) 0.75
Total Runoff (in) 0.54
Peak Runoff (cfs) 2.73
Rainfall Intensity 9.041
Weighted Runoff Coefficient 0.72
Time of Concentration (days hh:mm:ss) 0 00:05:00

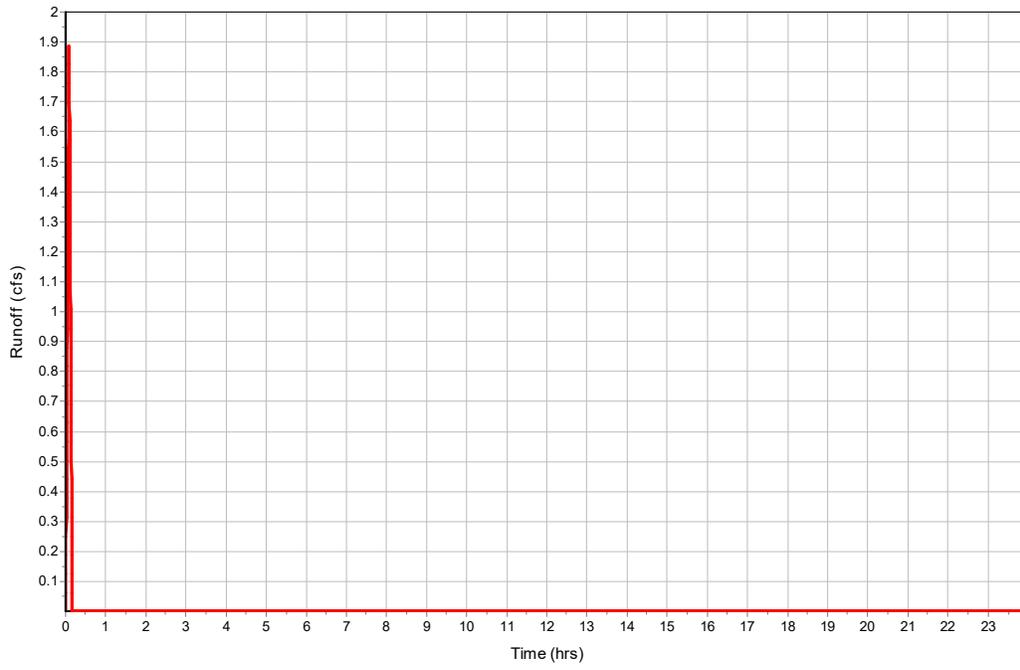
Runoff Hydrograph

Total Rainfall (in) 0.75
Total Runoff (in) 0.54
Peak Runoff (cfs) 1.89
Rainfall Intensity 9.041
Weighted Runoff Coefficient 0.72
Time of Concentration (days hh:mm:ss) 0 00:05:00

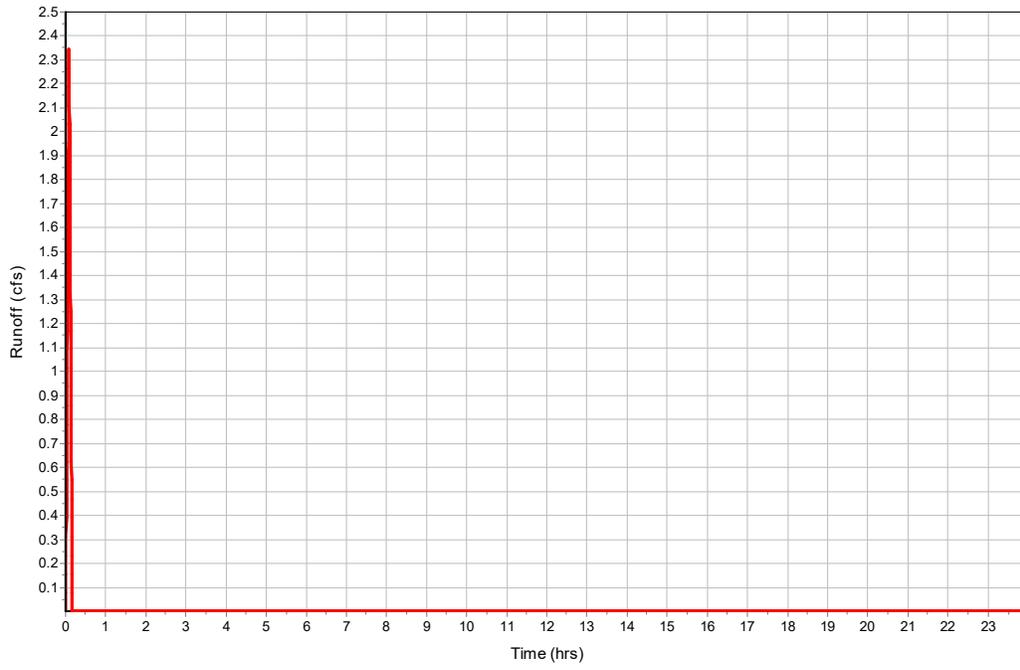
Runoff Hydrograph

Total Rainfall (in) 0.75
Total Runoff (in) 0.54
Peak Runoff (cfs) 2.34
Rainfall Intensity 9.041
Weighted Runoff Coefficient 0.72
Time of Concentration (days hh:mm:ss) 0 00:05:00

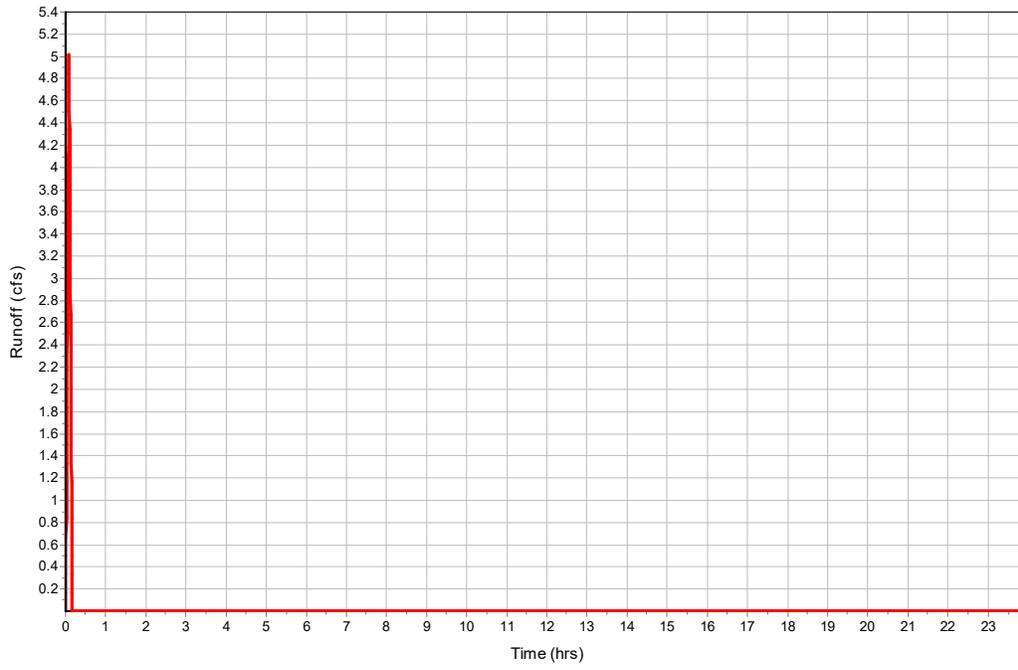
Runoff Hydrograph

Total Rainfall (in) 0.75
Total Runoff (in) 0.54
Peak Runoff (cfs) 5.01
Rainfall Intensity 9.041
Weighted Runoff Coefficient 0.72
Time of Concentration (days hh:mm:ss) 0 00:05:00

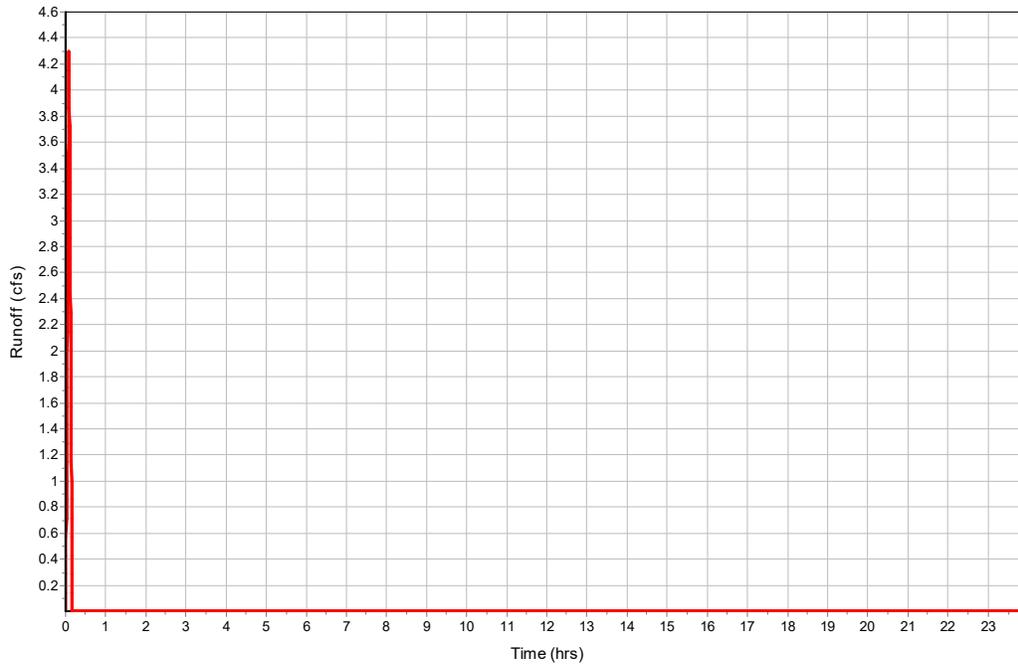
Runoff Hydrograph

Total Rainfall (in) 0.75
Total Runoff (in) 0.54
Peak Runoff (cfs) 4.3
Rainfall Intensity 9.041
Weighted Runoff Coefficient 0.72
Time of Concentration (days hh:mm:ss) 0 00:05:00

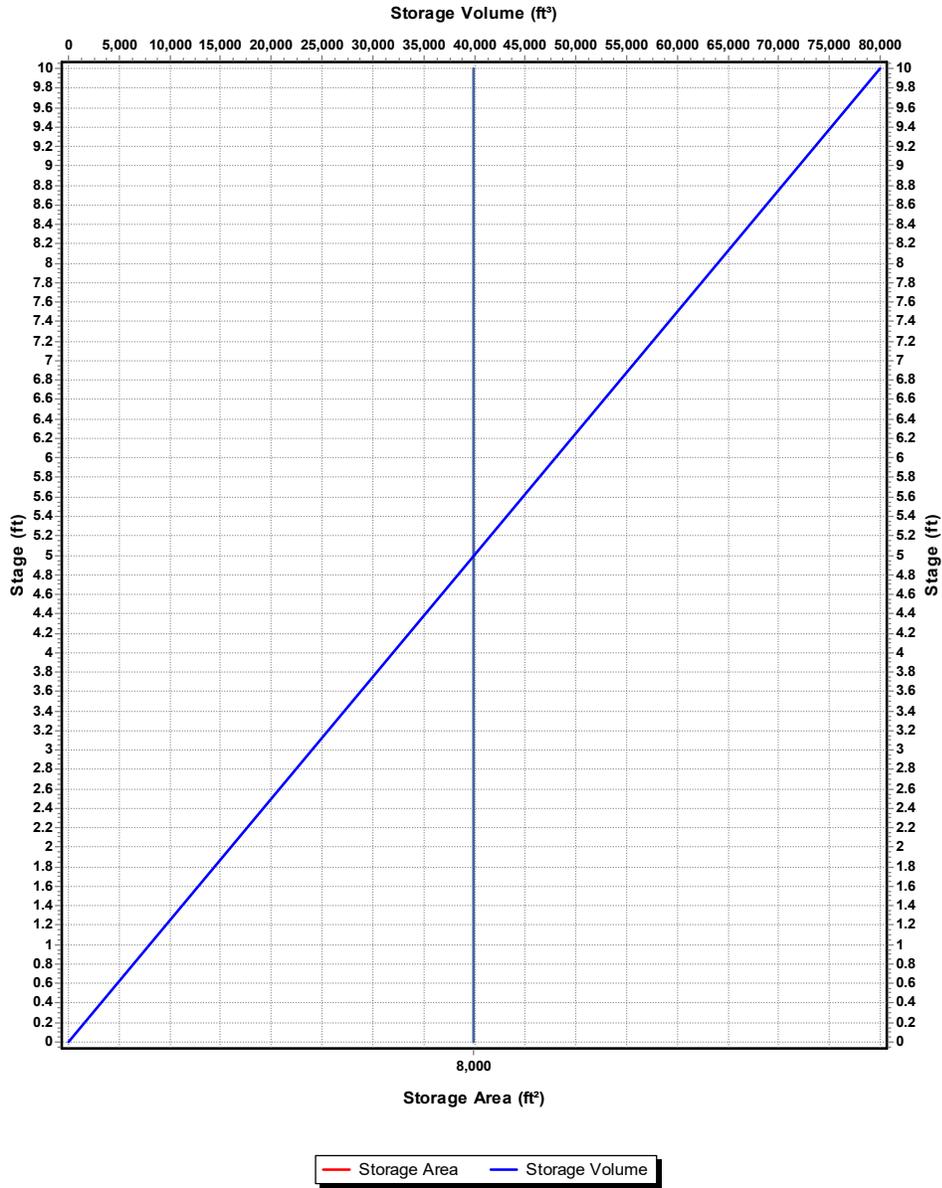
Storage Area Volume Curves

Stage	Storage	Storage
(ft)	Area	Volume
	(ft ²)	(ft ³)
0	8000	0
10	8000	80000

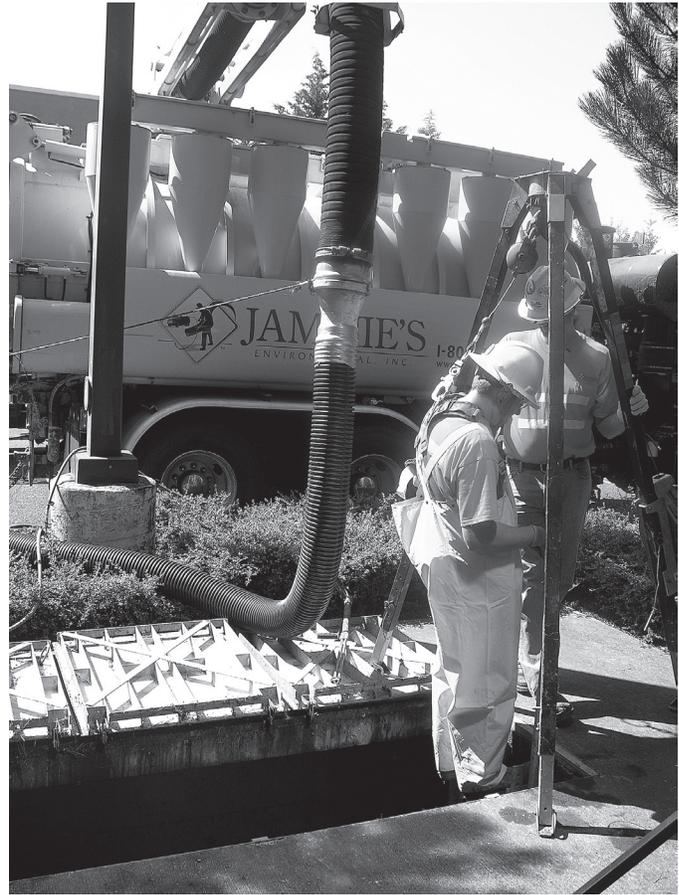
Using appropriate hoisting equipment, attach a cable from the boom, crane, or tripod to the loose cartridge. Contact Contech Engineered Solutions for suggested attachment devices.

- B. Remove the used cartridges (up to 250 lbs. each) from the vault.

Important: Care must be used to avoid damaging the cartridges during removal and installation. The cost of repairing components damaged during maintenance will be the responsibility of the owner.
