*Subsurface Exploration, Geologic Hazard, and  
Geotechnical Engineering Report*

## **TROMBLEY HILL AC WATER MAIN REPLACEMENT**

Monroe, Washington

Project No. 20250076E001

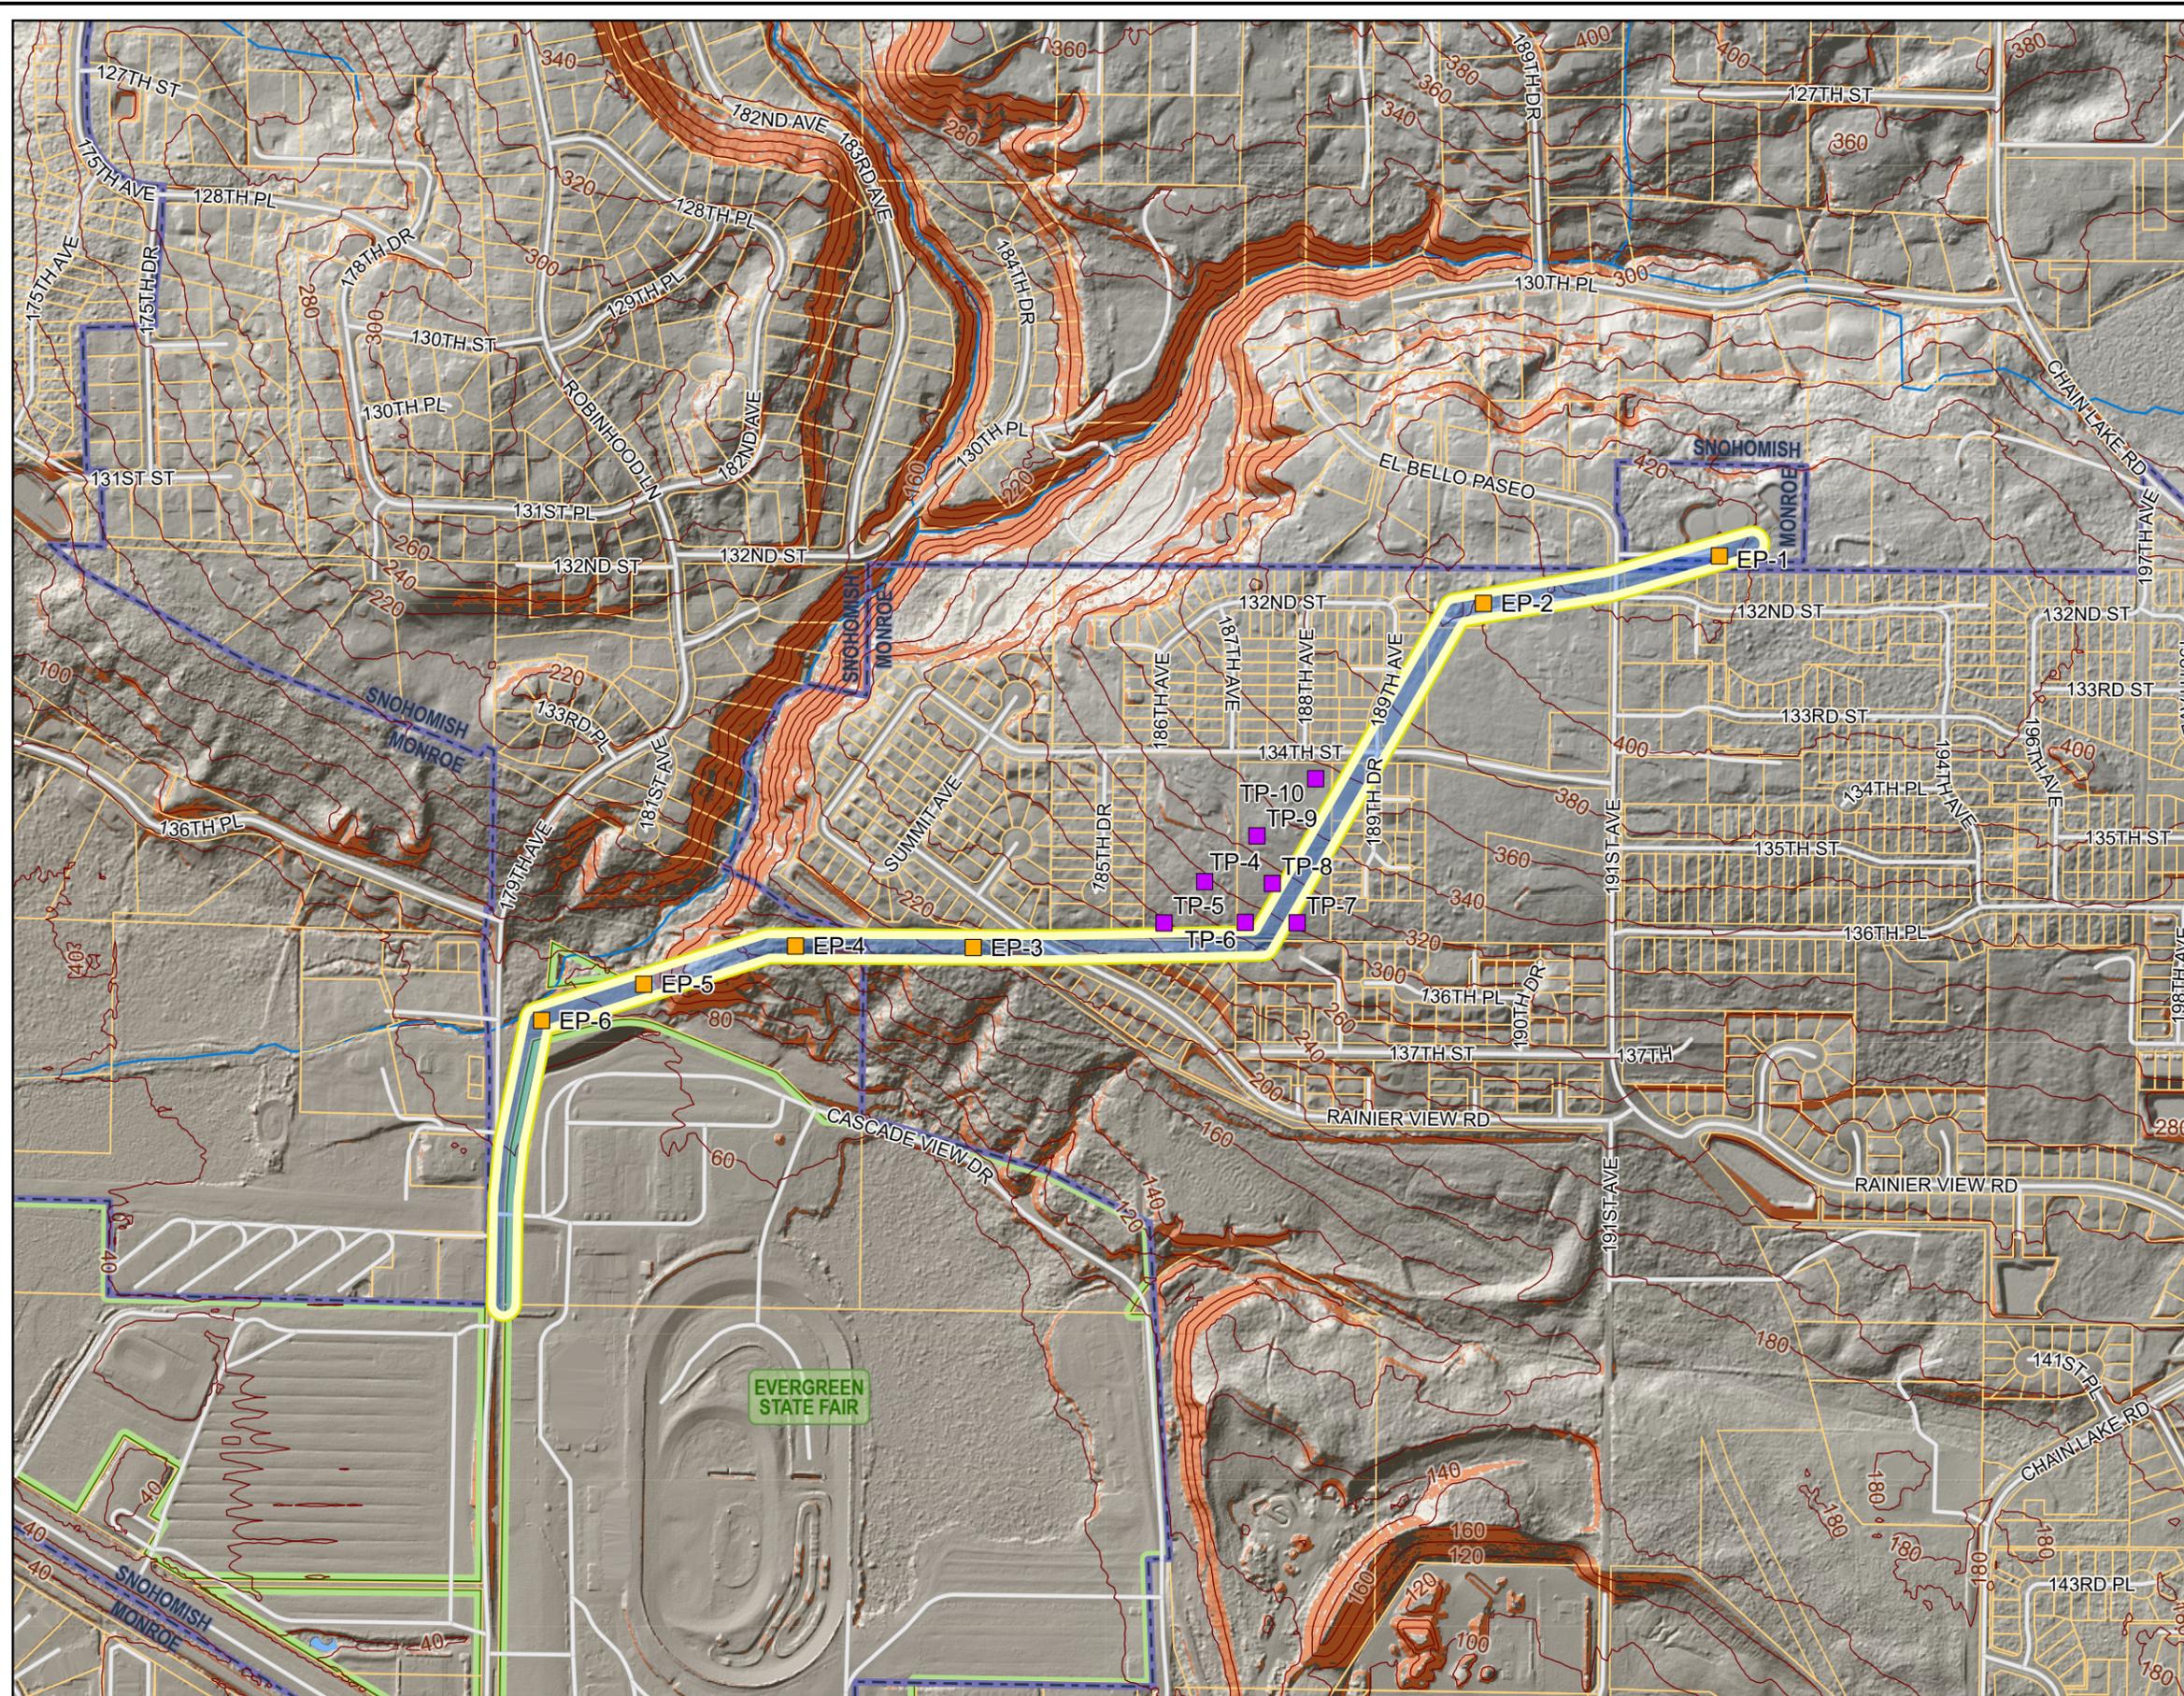
PROJECT NO. 20250076E001	DATE 7/25	FIGURE 4
-----------------------------	--------------	-------------

- LEGEND**
- SITE
  - EXPLORATION PIT (AESI, 2025)
  - EXPLORATION PIT (TERRA ASSOCIATES, INC., 2024)
  - CONTOUR 20 FT
  - CRITICAL SLOPE AREA (>40%)
  - WATER EASEMENT
  - CITY BOUNDARY
  - PARCEL
  - COUNTY PARK

The exploration pits were excavated with a track-mounted excavator under subcontract to AESI on June 30, 2025. The pits permitted direct, visual observation of subsurface conditions. Materials encountered in the exploration pits were studied and classified in the field by a geologist from our firm. The exploration pits were backfilled with the excavator and lightly tamped in layers after examination and logging. Samples collected from the exploration pits were classified in the field and representative portions placed in watertight containers. The samples were then transported to our laboratory for further visual classification. The approximate locations of the exploration pits, noted as EP-1 through EP-6, are displayed on Figures 2, 3, and 4.

Our site reconnaissance included traversing the steeply sloping terrain along the utility easement as well as portions of the adjacent slopes. No evidence of historic landslide activity was observed along the steep slopes within the project area. No evidence of emergent seepage was noted along the slopes within the project area and groundwater was not encountered within any of the explorations completed as part of our study. Based on our review of topographic mapping along the project alignment, the proposed water main replacement intersects or is adjacent to slopes with inclinations of 40 percent or steeper over heights of 10 feet or more. Slopes in the project area with these geometries meet the criteria to be designated as Landslide Hazard Areas as defined by Section 22.80.130.B.2 of the MMC and are highlighted on Figure 4 of this report.
