# Preliminary Storm Drainage Report

Kestrel Ridge PRD

CPH Project No. 0026-19-016

Monroe, WA

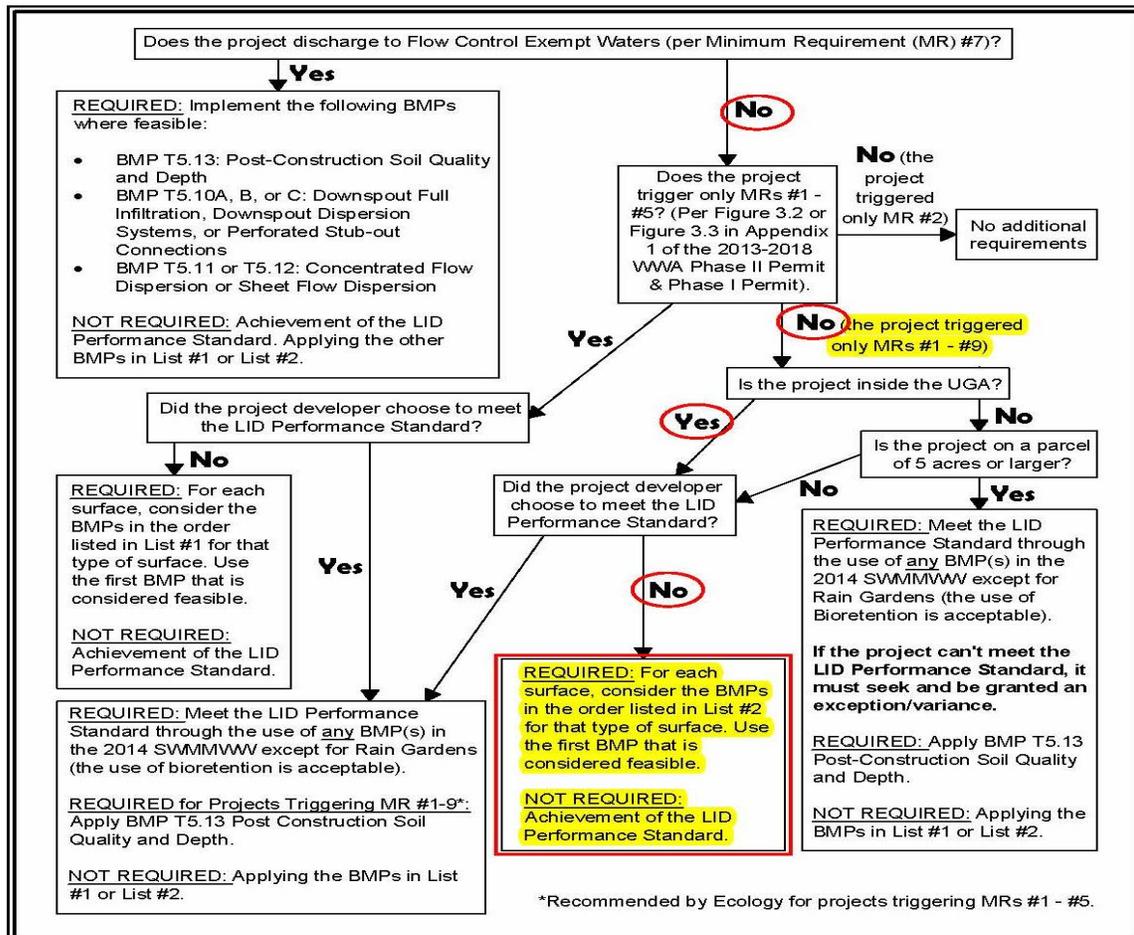
**Figure I-2.5.1  
Flow Chart for Determining LID MR #5  
Requirements**

Minimum Requirement #5 addresses the application of on-site stormwater management BMPs with the intent to “infiltrate, disperse, and retain stormwater runoff on-site to the extent feasible without causing flooding or erosion impacts.” Requirements for this project are specified on Table I-2.5.1 and Figure I-2.5.1. These are included here with the relevant text highlighted.

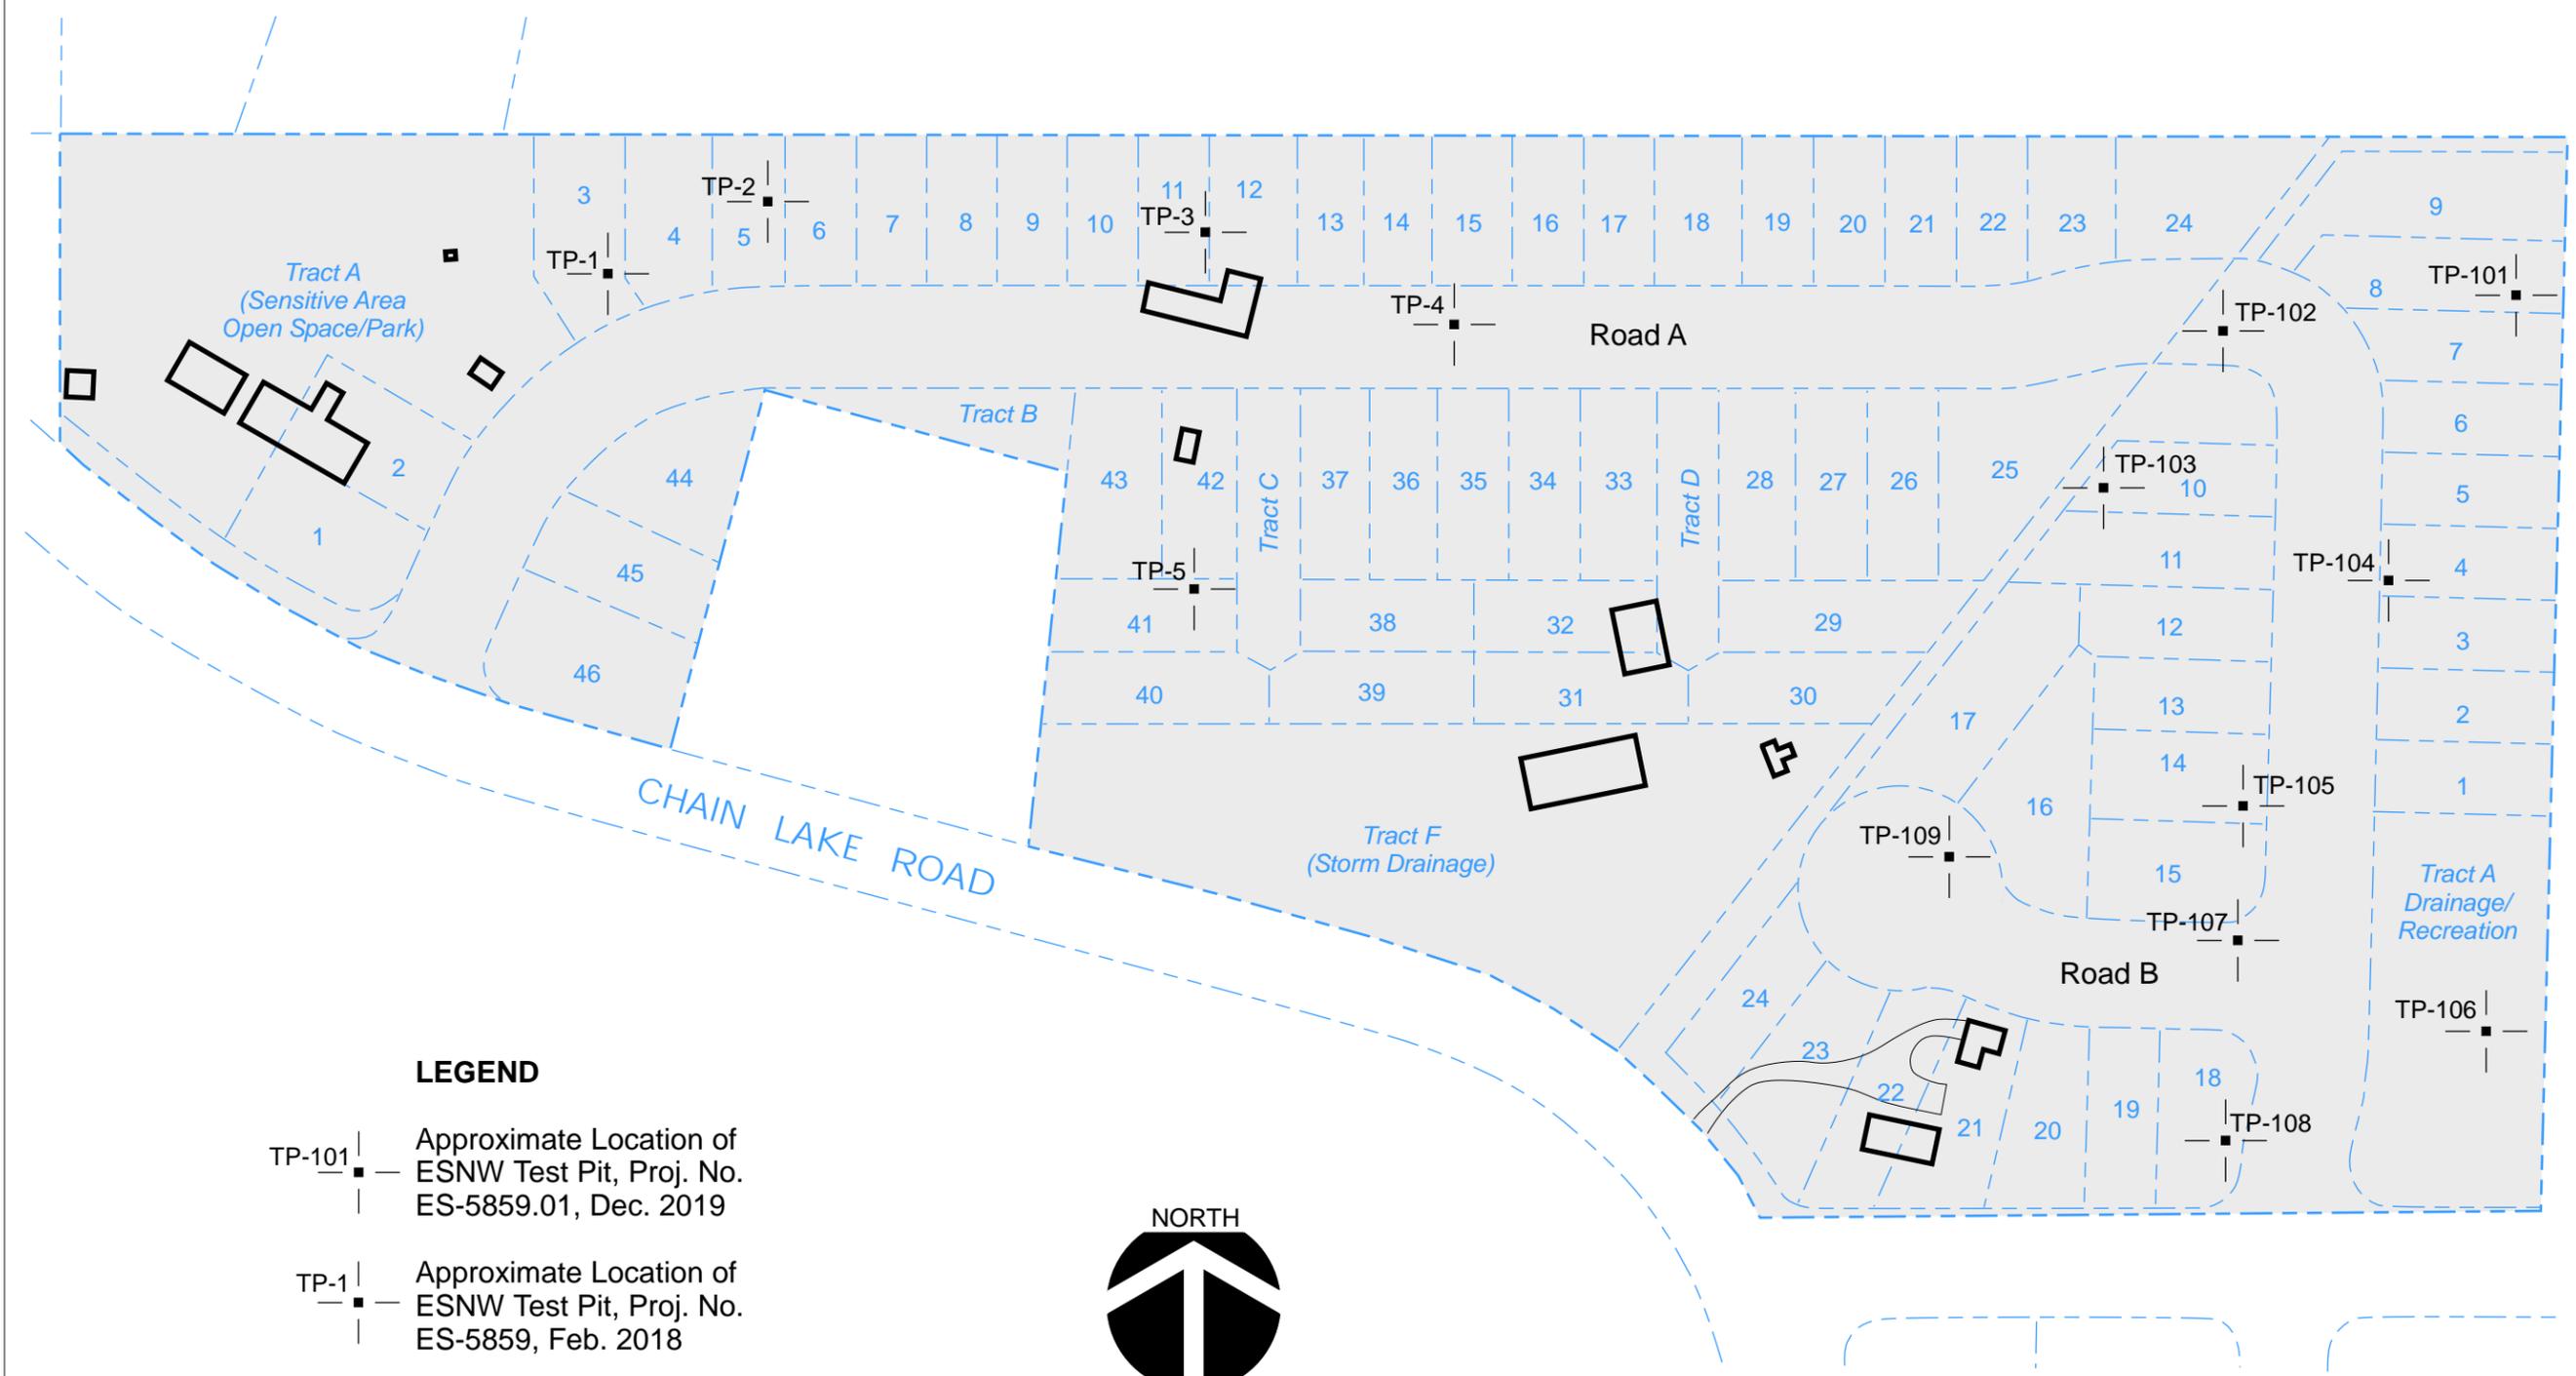
- TP-101 | Approximate Location of ESNW Test Pit, Proj. No. ES-5859.01, Dec. 2019
- TP-1 | Approximate Location of ESNW Test Pit, Proj. No. ES-5859, Feb. 2018
- Subject Site
- Existing Building
- 10 Proposed Lot Number

A representative of ESNW observed, logged, and sampled five test pits, excavated at accessible locations within the site boundaries, on February 2, 2018 and again on December 6, 2019 using a mini-trackhoe and operator retained by our firm. The explorations were completed for purposes of assessment and classification of site soils as well as characterization of groundwater conditions within areas proposed for new development. The approximate locations of the explorations are depicted on Plate 2 (Test Pit Location Plan). Please refer to the test pit logs provided in Appendix A for a more detailed description of subsurface conditions. Representative soil samples collected at the test pit locations were evaluated in general accordance with Unified Soil Classification System (USCS) and United States Department of Agriculture (USDA) methods and procedures.

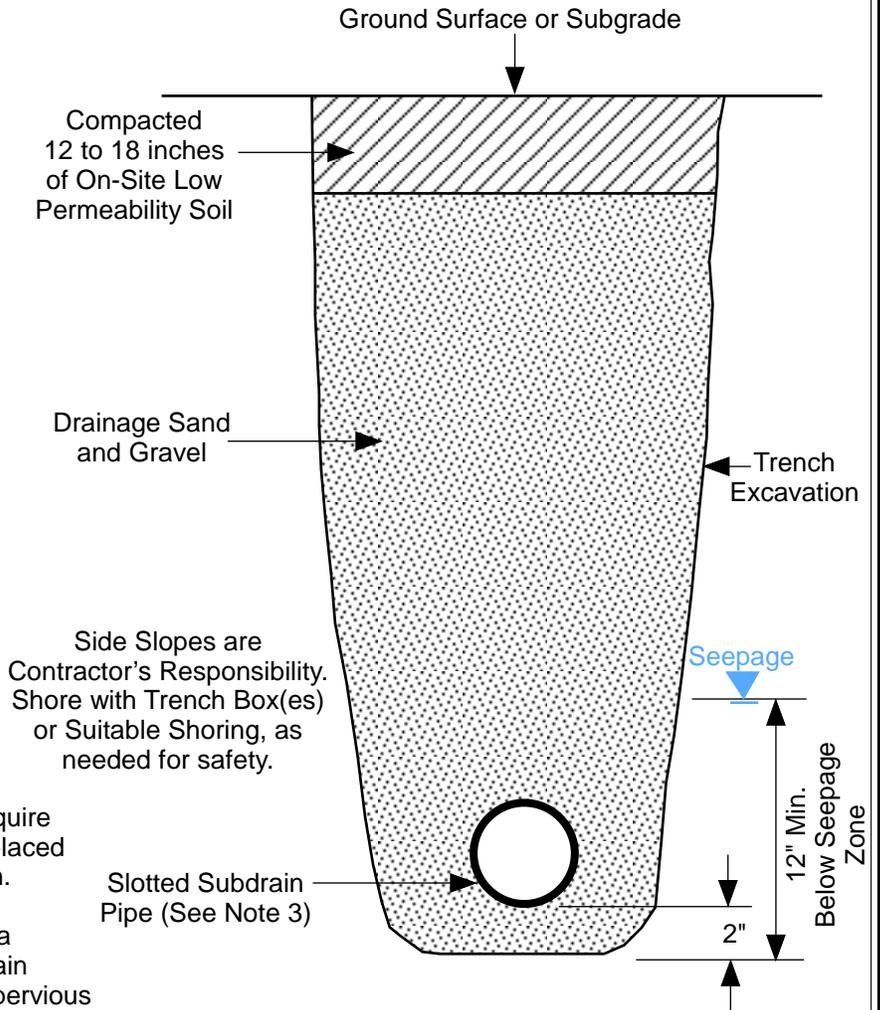
<b>Earth Solutions NW<sub>LLC</sub></b> Geotechnical Engineering, Construction Observation/Testing and Environmental Services	
	Typical Interceptor Trench Detail Kestrel Ridge Monroe, Washington	
Drwn. MRS	Date 12/24/2019	Proj. No. 5859.01
Checked SSR	Date Dec. 2019	Plate 3

1. Possible caving soil conditions may require that the subdrain pipe and backfill be placed concurrently with the trench excavation.
2. Extend pipe by means of a tightline to a suitable discharge point. Where subdrain pipe changes to a tightline, provide impervious dam (concrete or clay) so as to force all water into the tightline.
3. Slotted subdrain pipe; tight joints; sloped to drain (6"/100' min. slope); provide clean-outs; min. diameter: 6".
4. Slotted pipe to have 1/8" maximum slot width.

**TYPICAL CROSS SECTION**

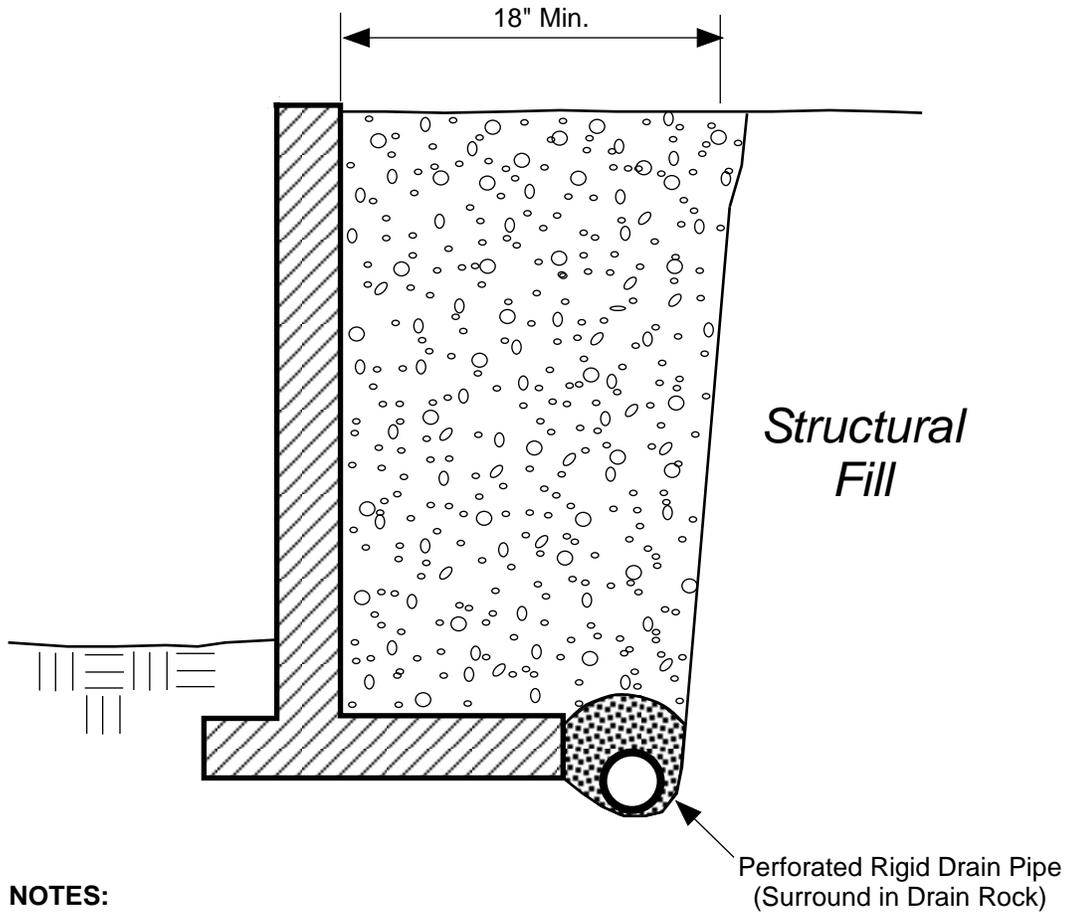
<b>Earth Solutions NW<sub>LLC</sub></b> Geotechnical Engineering Construction Observation/Testing and Environmental Services	
<b>Retaining Wall Drainage Detail</b> <b>Kestrel Ridge</b> <b>Monroe, Washington</b>			
Drwn. MRS	Date 12/24/2019	Proj. No. 5859.01	
Checked SSR	Date Dec. 2019	Plate 4

- Free-draining Backfill should consist of soil having less than 5 percent fines. Percent passing No. 4 sieve should be 25 to 75 percent.
- Sheet Drain may be feasible in lieu of Free-draining Backfill, per ESNW recommendations.
- Drain Pipe should consist of perforated, rigid PVC Pipe surrounded with 1-inch Drain Rock.

Retaining walls should be backfilled with free-draining material or suitable sheet drain that extends along the height of the wall and a distance of at least 18 inches behind the wall. The upper 12 inches of the wall backfill can consist of a less permeable soil, if desired. A perforated drainpipe should be placed along the base of the wall and connected to an approved discharge location. A typical retaining wall drainage detail is provided on Plate 4. If drainage is not provided, hydrostatic pressures should be included in the wall design.

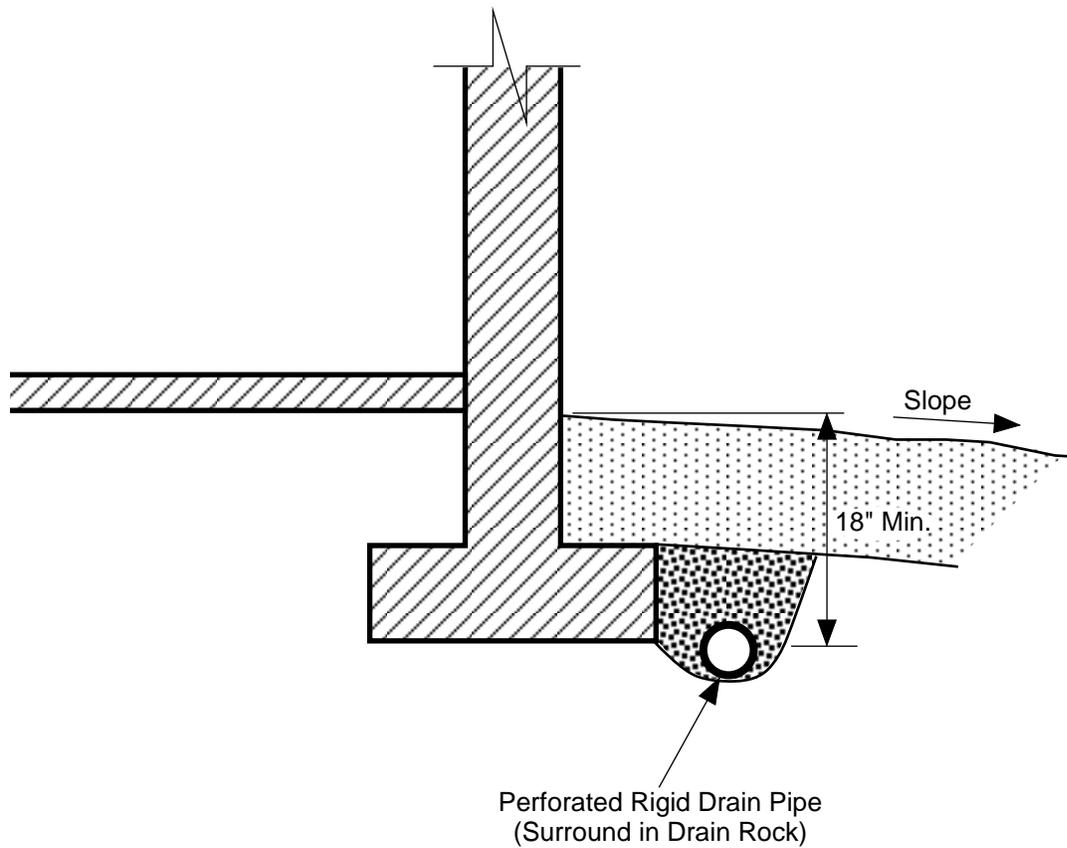
<b>Earth Solutions NW<sub>LLC</sub></b> Geotechnical Engineering, Construction Observation/Testing and Environmental Services	
	<b>Footing Drain Detail</b> <b>Kestrel Ridge</b> <b>Monroe, Washington</b>	
Drwn. MRS	Date 12/24/2019	Proj. No. 5859.01
Checked SSR	Date Dec. 2019	Plate 5

- Do NOT tie roof downspouts to Footing Drain.
- Surface Seal to consist of 12" of less permeable, suitable soil. Slope away from building.

Finish grades must be designed to direct surface water away from the new structures and/or slopes. Water must not be allowed to pond adjacent to the new structure and/or slopes. In our opinion, foundation drains should be installed along the building perimeter footings. A typical foundation drain detail is provided on Plate 5. If structures will include crawlspace configurations, we recommend installing conveyance measures to allow water to exit the building perimeter in the event water enters the foundation area.

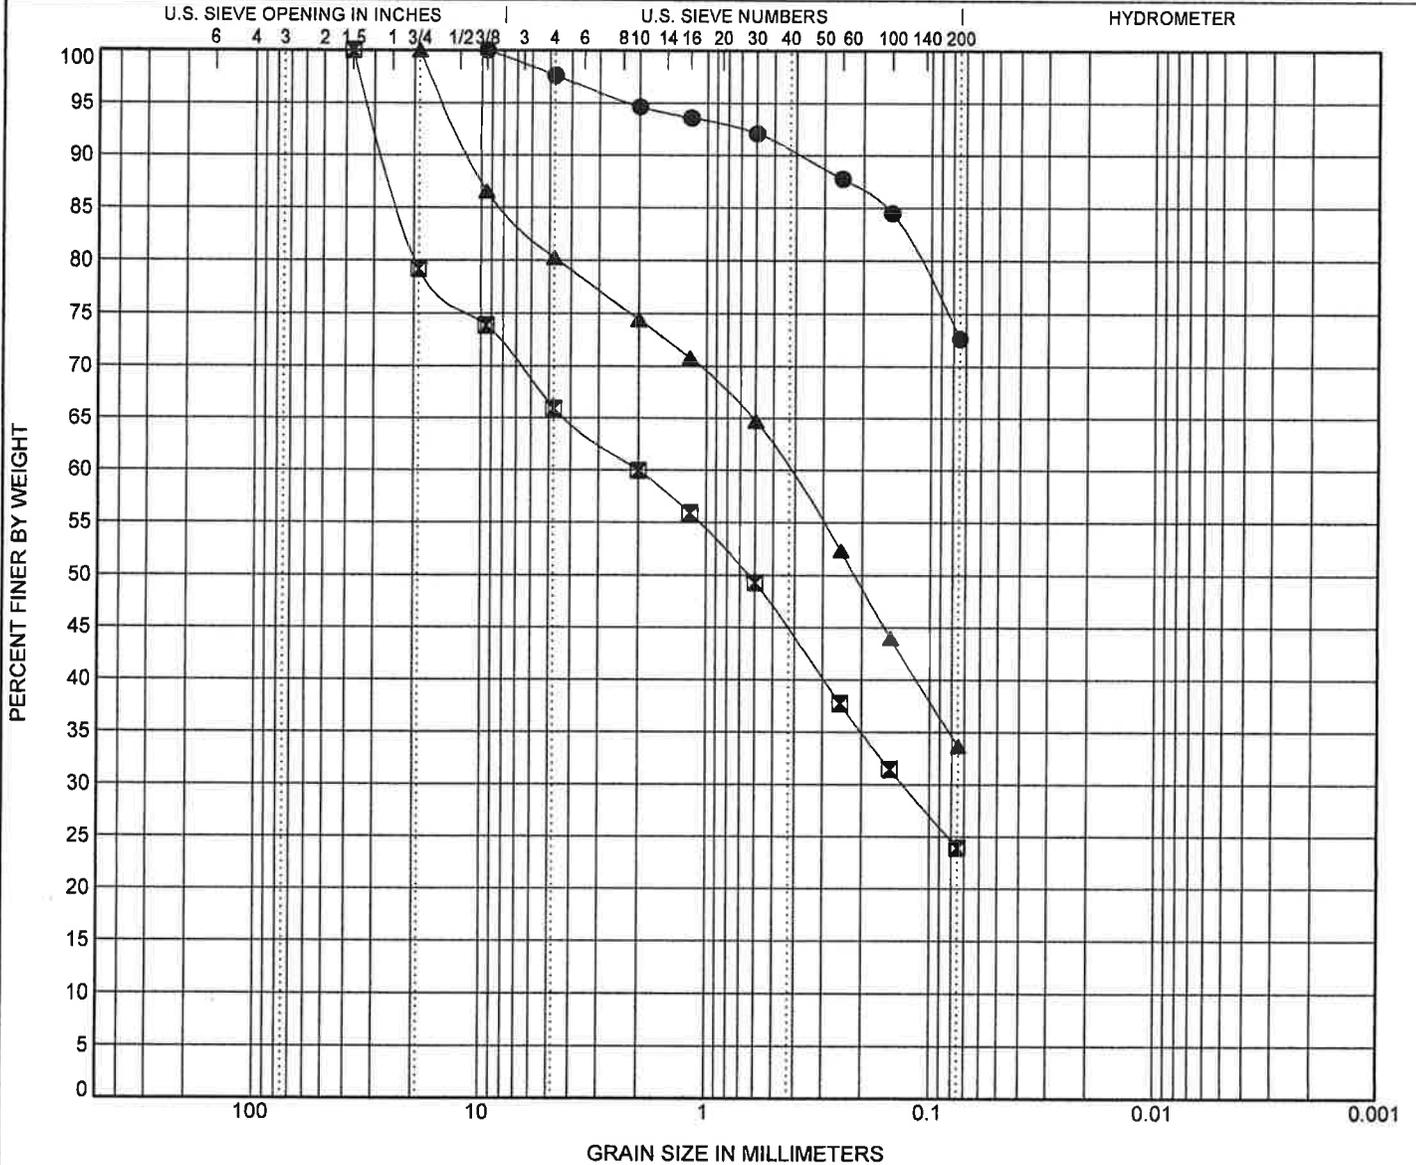
Specimen Identification	Classification	Cc	Cu
● TP-1 3.00ft.	USDA: Brown Slightly Gravelly Loam. USCS: ML with Sand.		
☒ TP-4 7.00ft.	USDA: Gray Very Gravelly Sandy Loam. USCS: SM with Gravel.		
▲ TP-5 4.00ft.	USDA: Gray Gravelly Fine Sandy Loam. USCS: SM with Gravel.

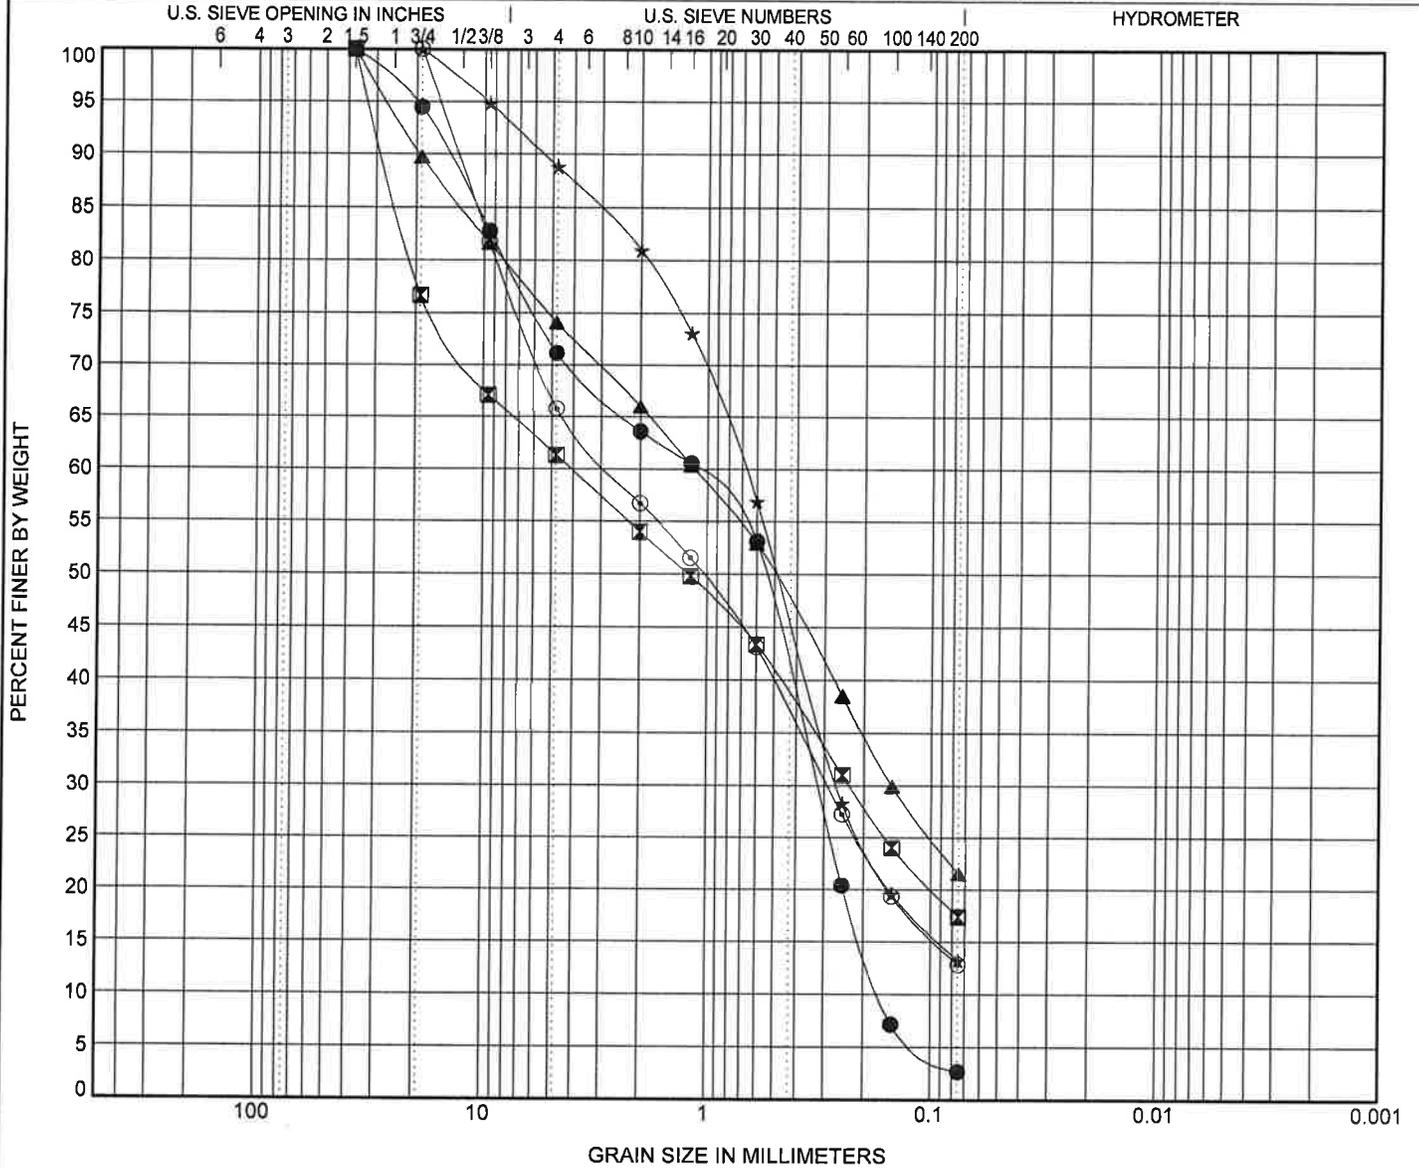
Specimen Identification	Classification						Cc	Cu
● TP-101 4.00ft.	USDA: Brown Very Gravelly Sand. USCS: SP with Gravel.						0.56	6.71
☒ TP-103 3.00ft.	USDA: Brown Very Gravelly Sandy Loam. USCS: SM with Gravel.							
▲ TP-103 7.50ft.	USDA: Gray Gravelly Sandy Loam. USCS: SM with Gravel.							
★ TP-104 7.00ft.	USDA: Gray Gravelly Loamy Coarse Sand. USCS: SM.							
⊙ TP-106 9.00ft.	USDA: Gray Very Gravelly Sandy Loam. USCS: SM with Gravel.

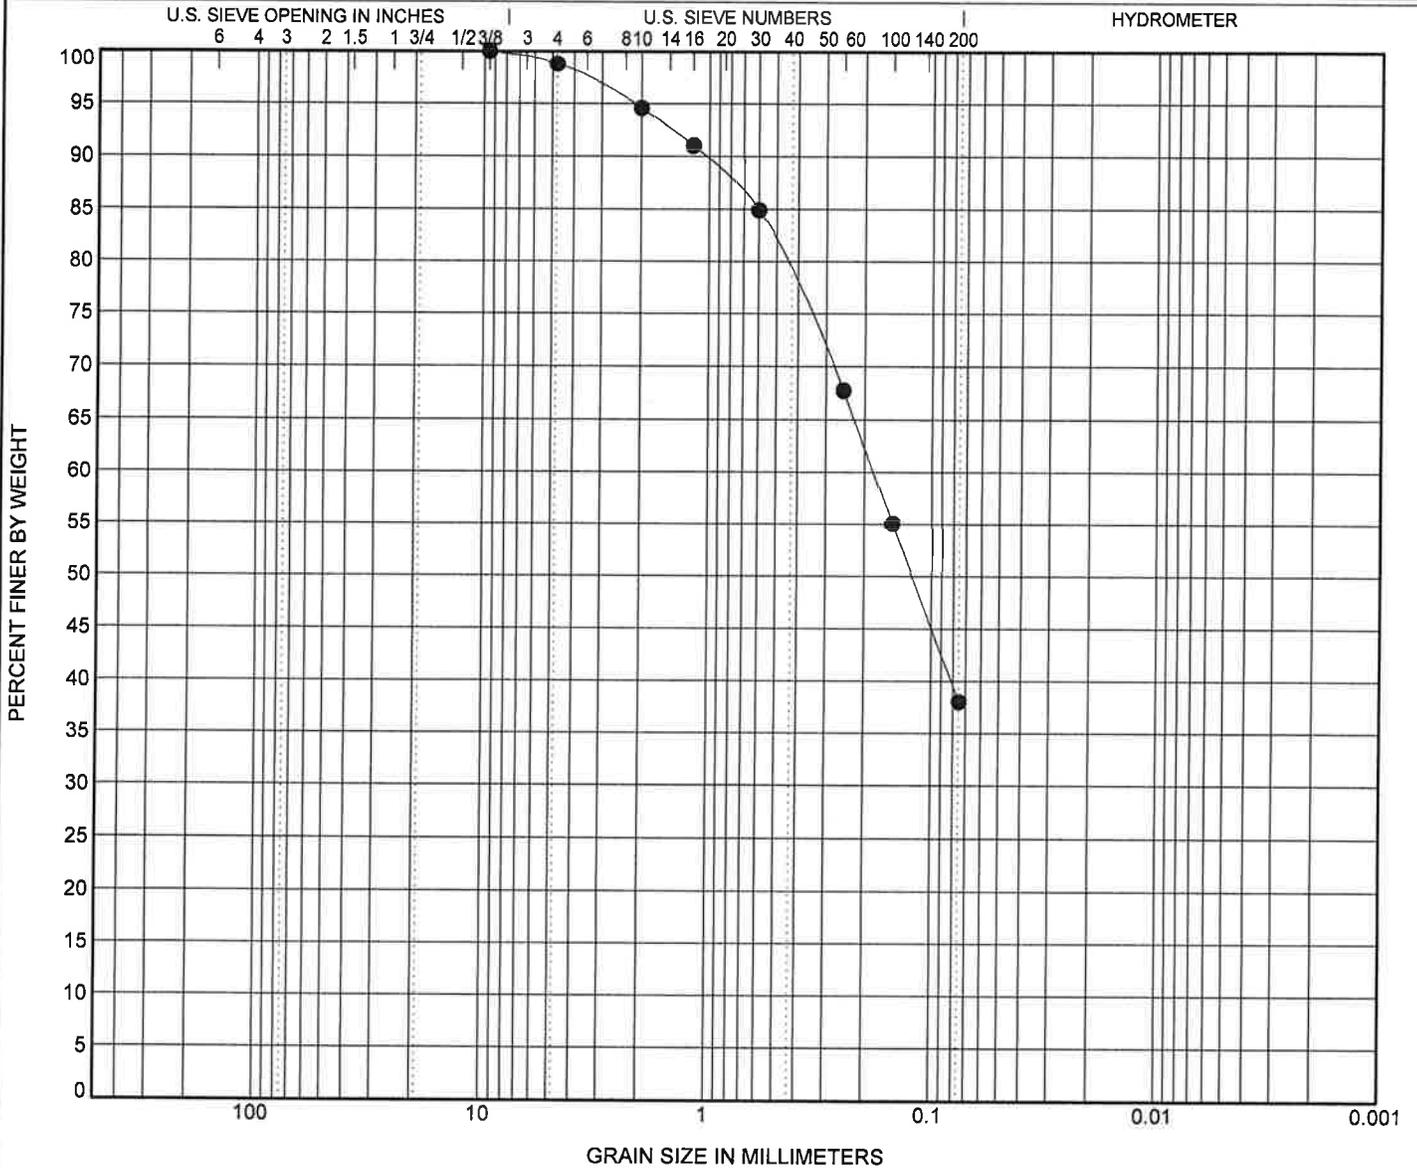
Specimen Identification		Classification							Cc	Cu
●	TP-108 3.00ft.	USDA: Gray Slightly Gravelly Fine Sandy Loam. USCS: SM.								
Specimen Identification		D100	D60	D30	D10	LL	PL	PI	%Silt	%Clay
●	TP-108 3.0ft.	9.5	0.183						38.0

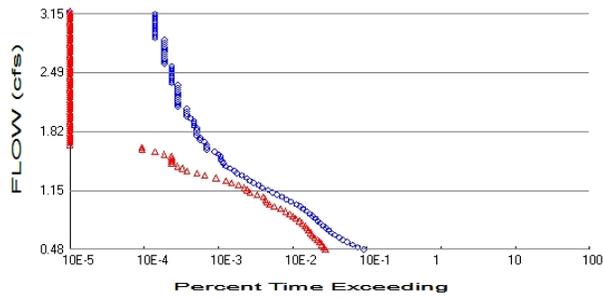
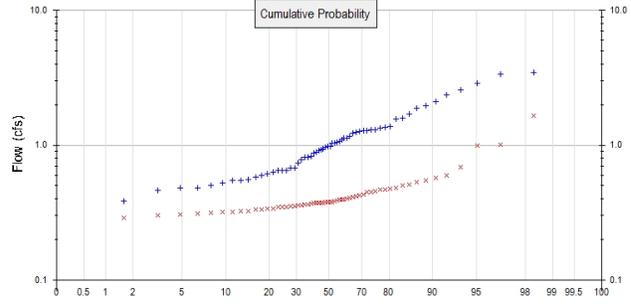
## POC 1

+ Predeveloped x Mitigated

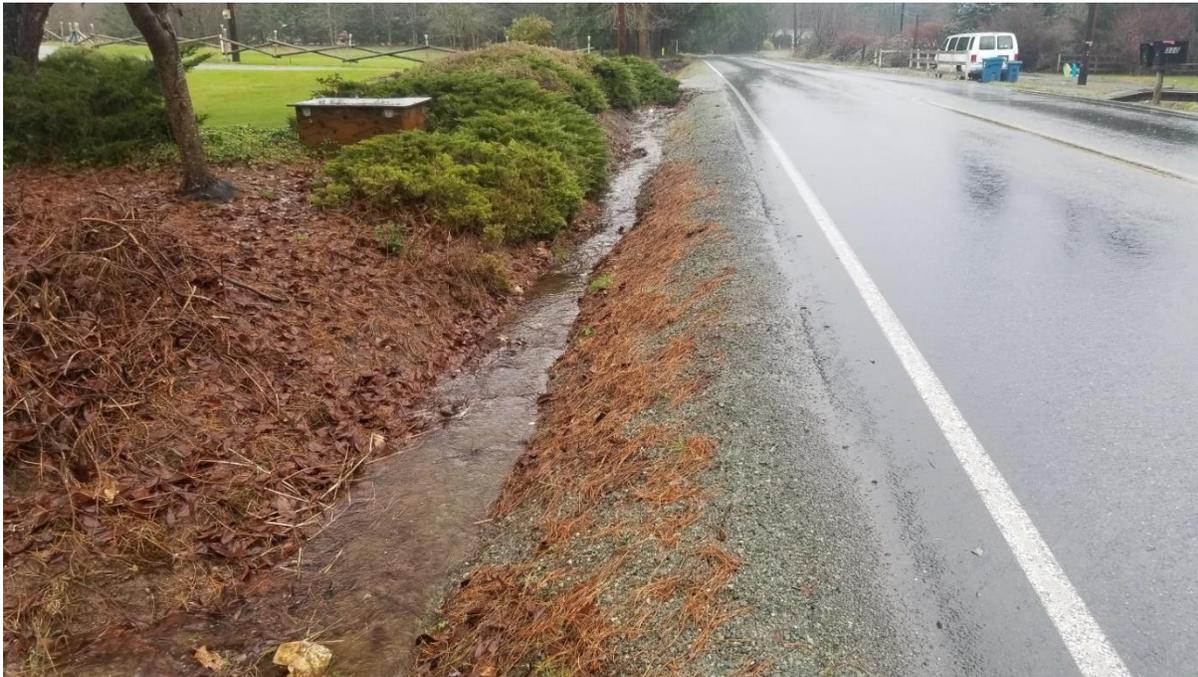
**Photo #1:** Roadside ditch adjacent to the north side of Chain Lake Road, bordering the southern boundary of the project site.

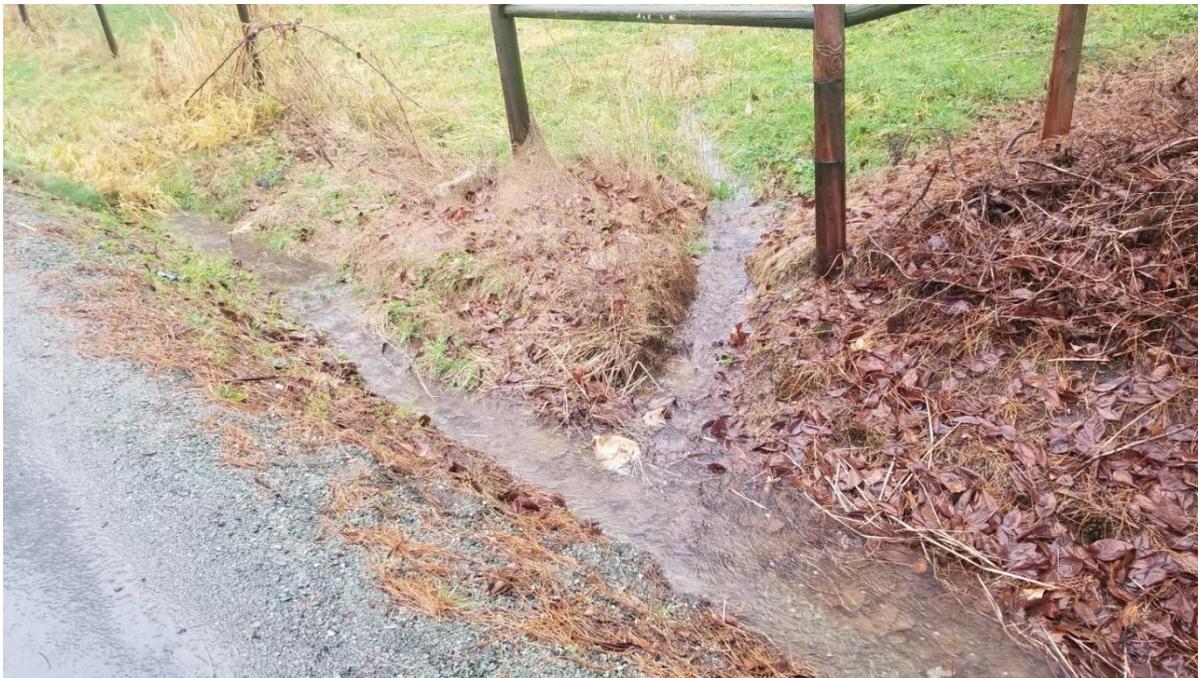
**Photo #2:** Concentrated flows entering the ditch from the project site.

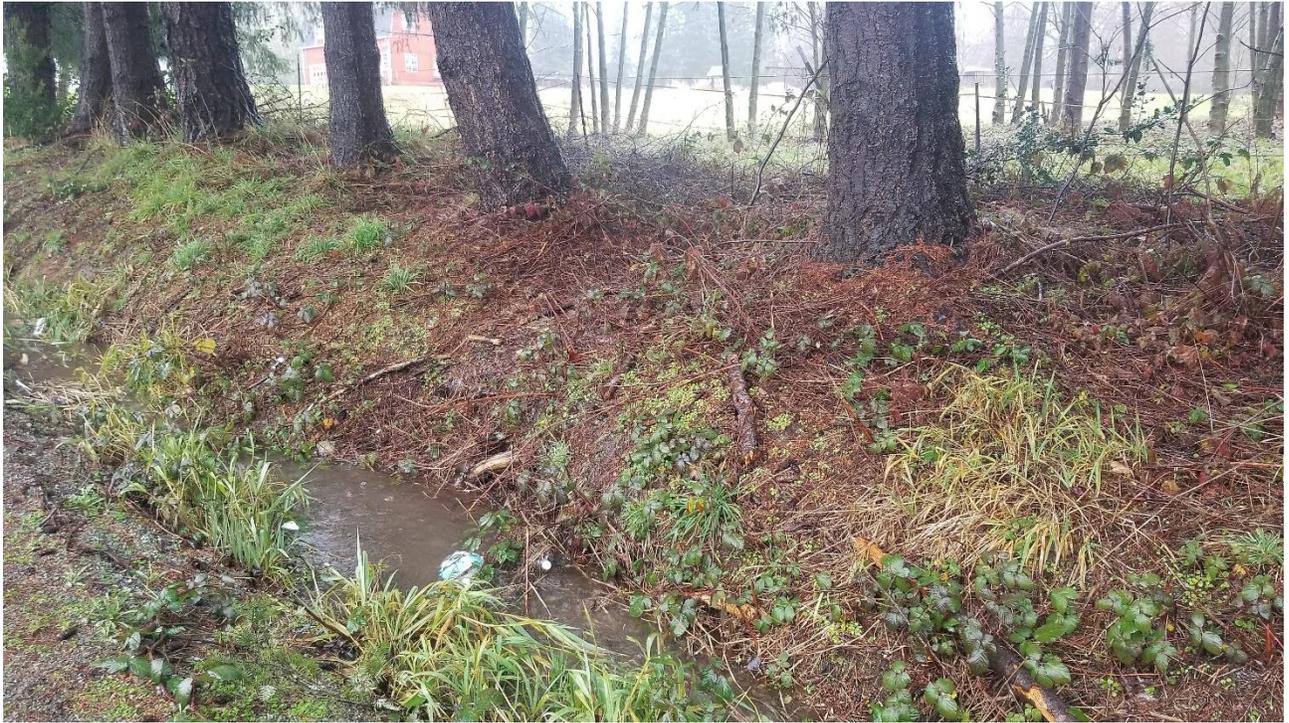
**Photo #3:** Concentrated flows entering the ditch from the project site.

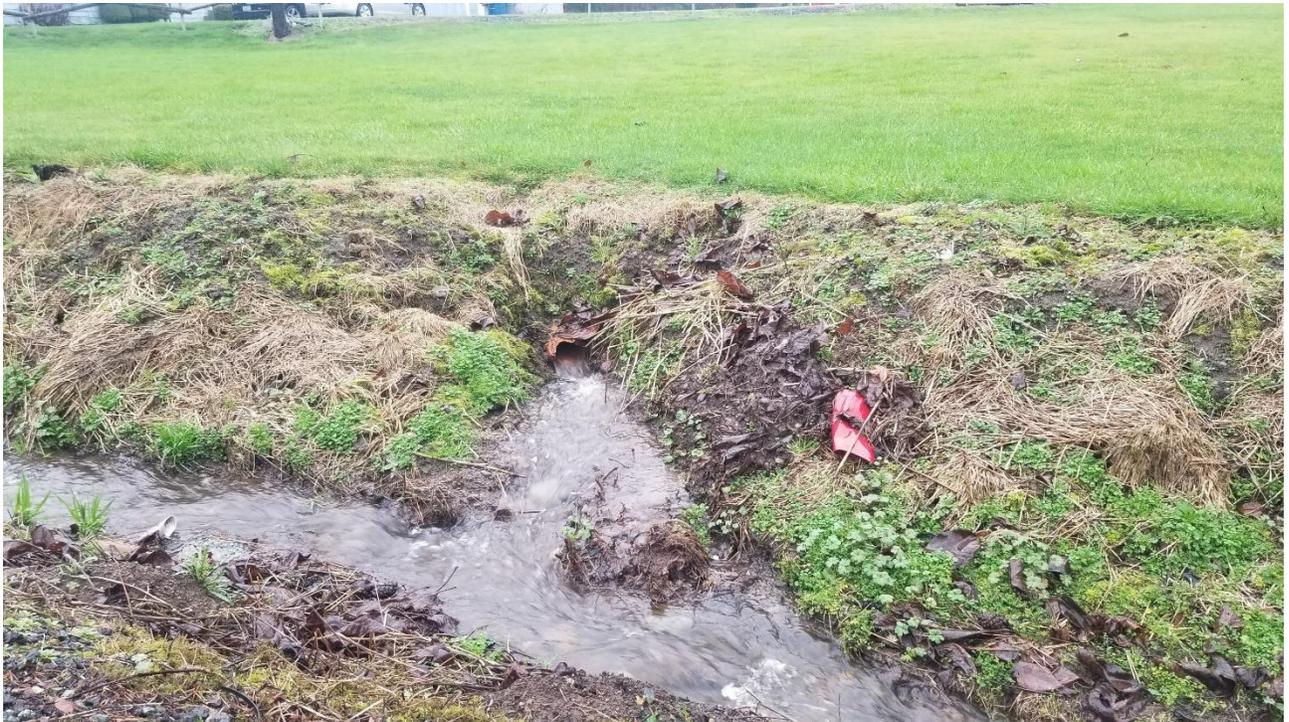
**Photo #4:** Flows entering the ditch from the property adjacent to proposed lots 40, 41, and 43.

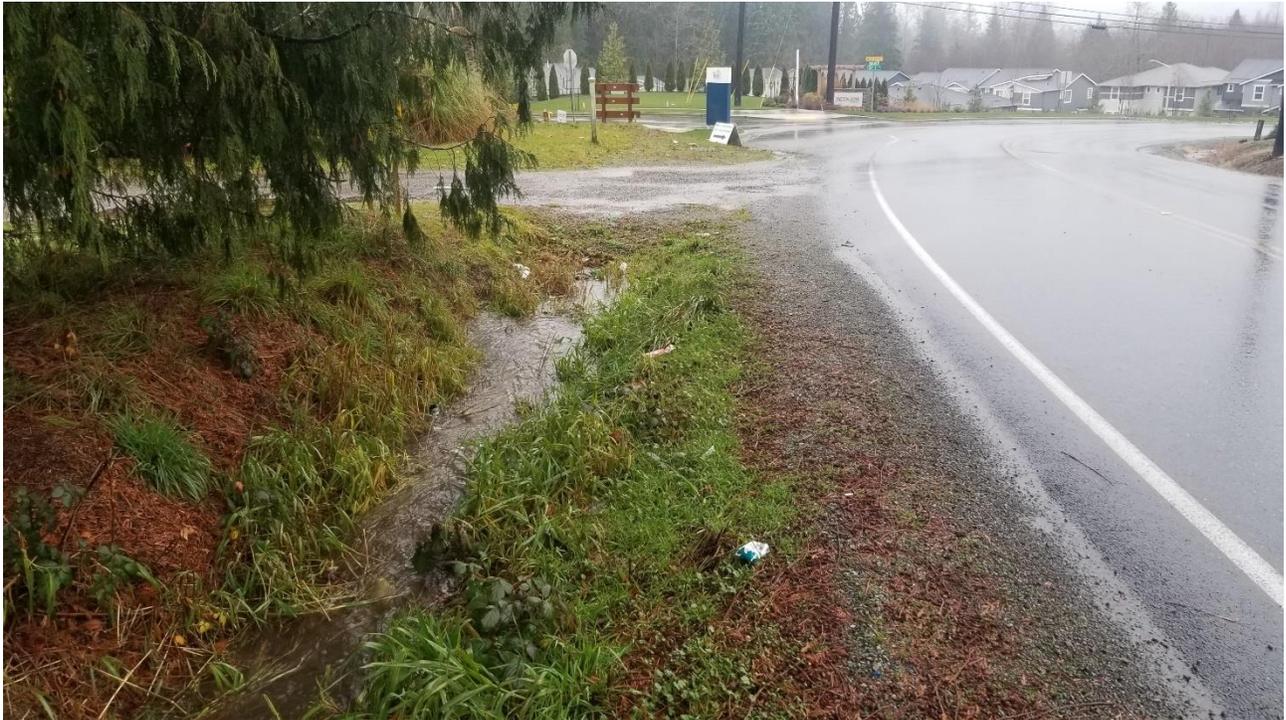
**Photo #5:** Flows entering a culvert that conveys runoff under 134<sup>th</sup> Street SE.

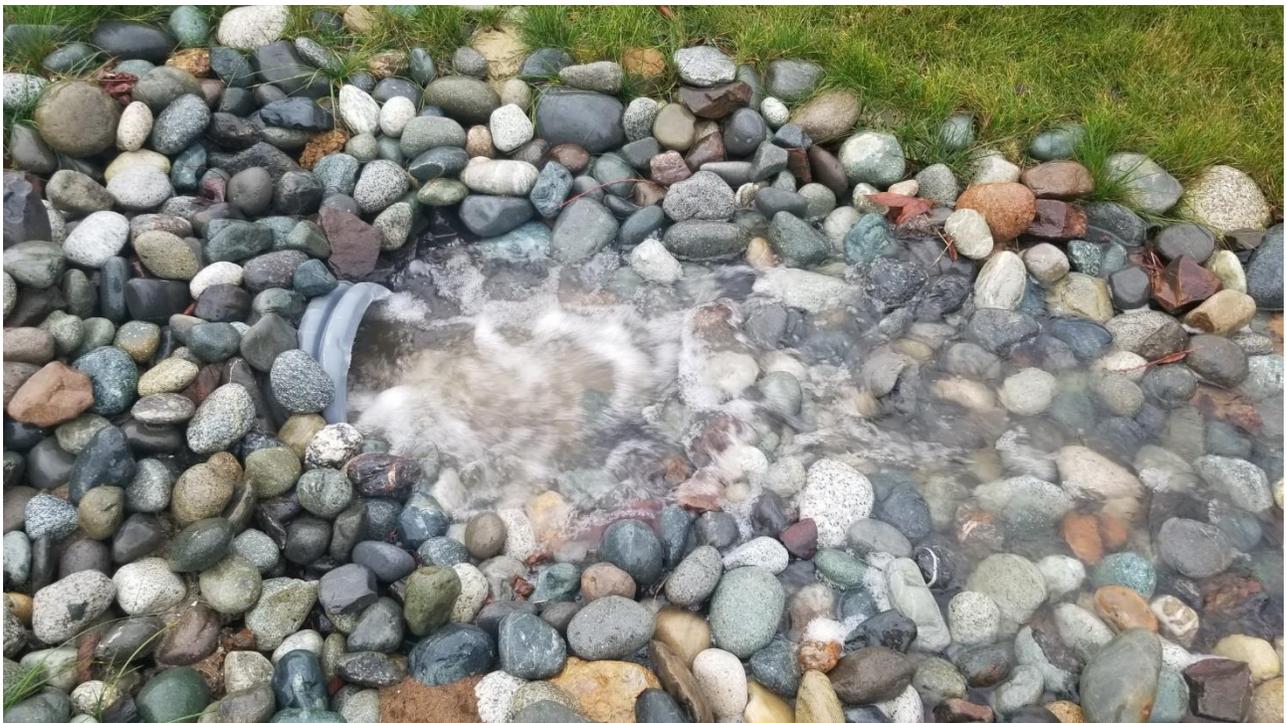
**Photo #6:** Flow entering the rock lined swale.

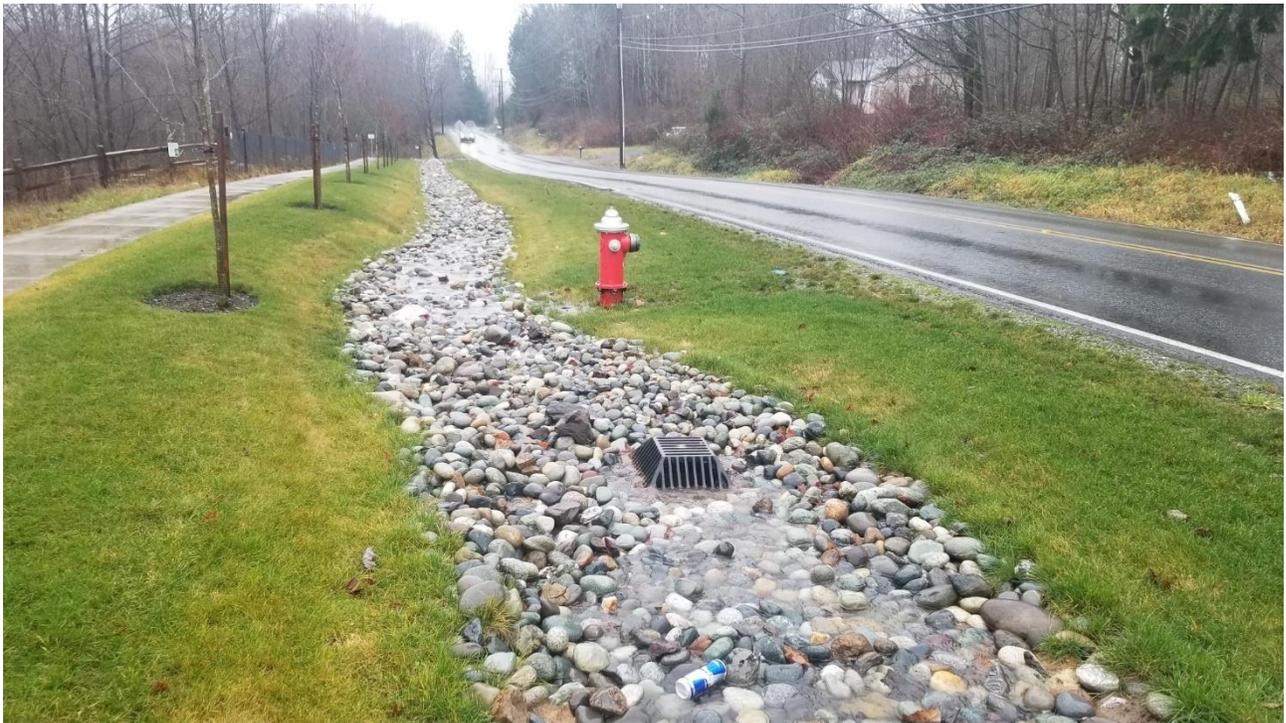
**Photo #7:** Rock lined swale conveying flows to two catch basin drains.

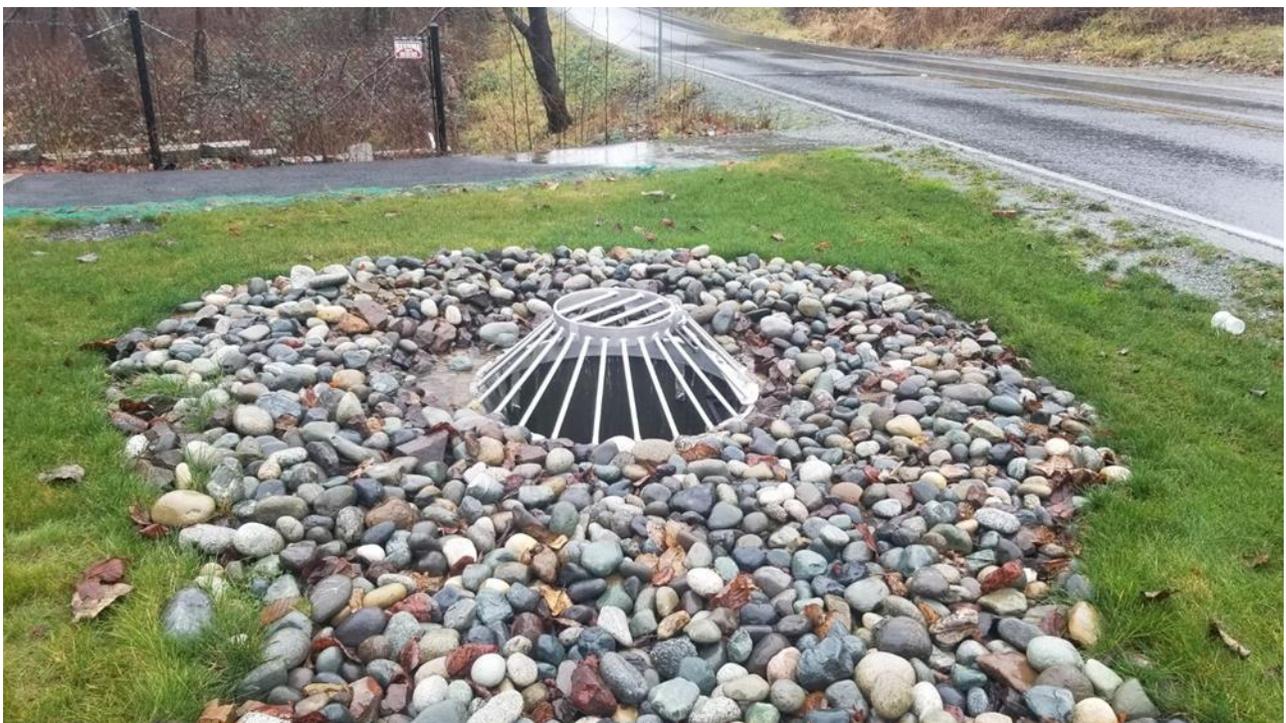
**Photo #8:** Large drain at the end of the rock lined swale. Flows enter drain approximately 0.25 miles downstream from project site and are conveyed east.

The on-site basin runoff flows into an existing ditch on the north side of Chain Lake Road. This ditch conveys runoff southeast through a series of culverts until reaching 134<sup>th</sup> Street SE. The series of ditch sections and culverts were all observed flowing with minimal blockages and no flooding. Some debris and leaves filled some portions of ditch but did not appear to present any problems. Near the intersection of Chain Lake Road and 134<sup>th</sup> Street SE, runoff from the roadside ditch appears to enter an underground culvert pipe crossing under 134<sup>th</sup> Street SE and discharging flows to a rock lined swale located in the frontage of the Easton Cove development, adjacent to the northeast side of Chain Lake Road. The swale conveys flows south into a series catch basins. Approximately 0.25 miles downstream

of the project site, the flows from the swale drain east into a sensitive area tract. The tract was observed with water flowing into it from the two catch basins as well as standing surface water.

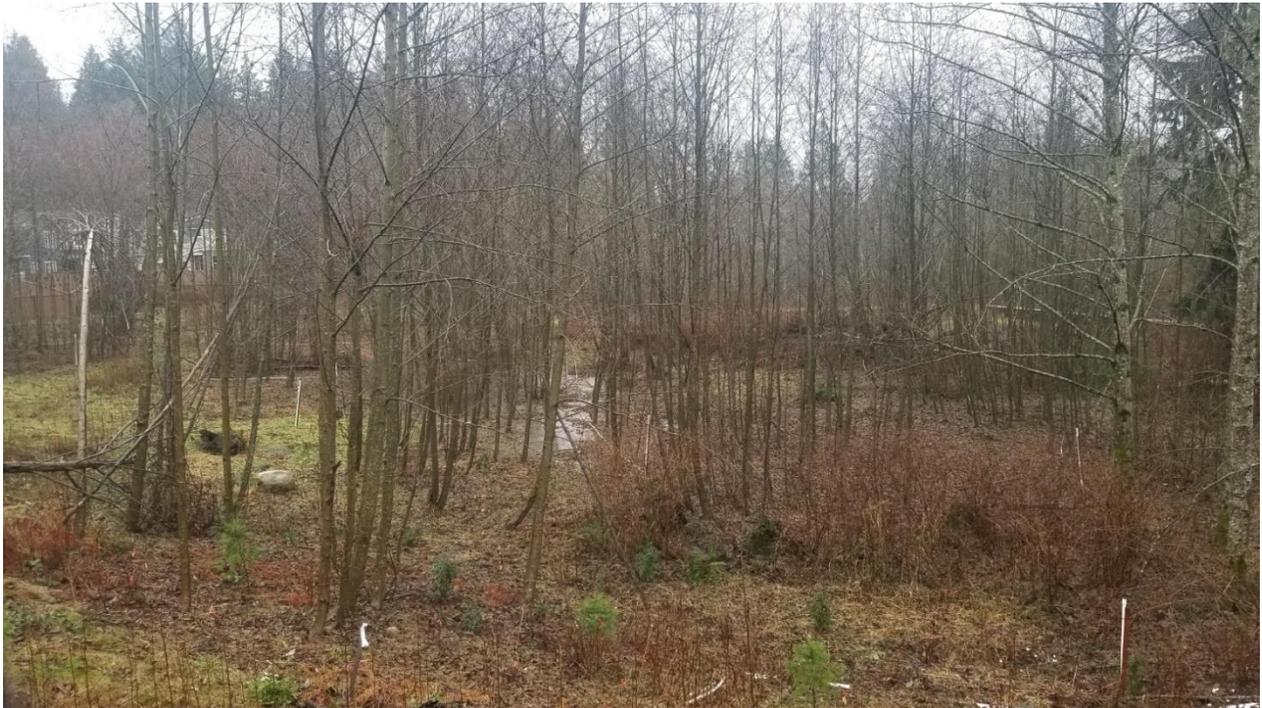
**Photo #9:** Sensitive area tract located approximately 0.25 miles downstream of the project site where flows discharge to from rock lined swale.
