# Preliminary Storm Drainage Report

Kestrel Ridge PRD

CPH Project No. 0026-19-016

Monroe, WA

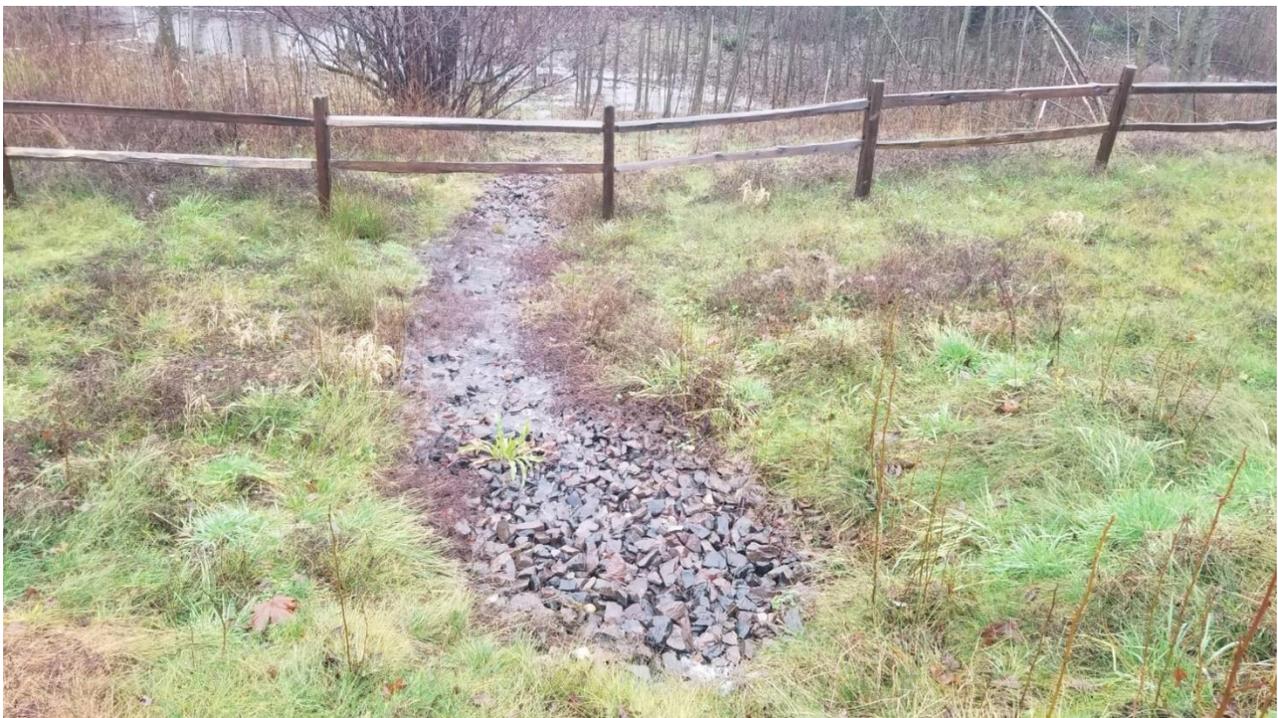
**Photo #10:** Flows conveyed from rock lined swale, east towards a sensitive area tract.
